**GEOPHYSICAL INVESTIGATION OF CAUSES AND CHARACTERISTICS OF ROAD FAILURE ALONG PART OF ILARA-IPOGUN, ONDO STATE, NIGERIA.**

Authors: Festus Olusola Eebo & Obaloluwa Abiodun  
Federal University of Technology, Akure Nigeria.

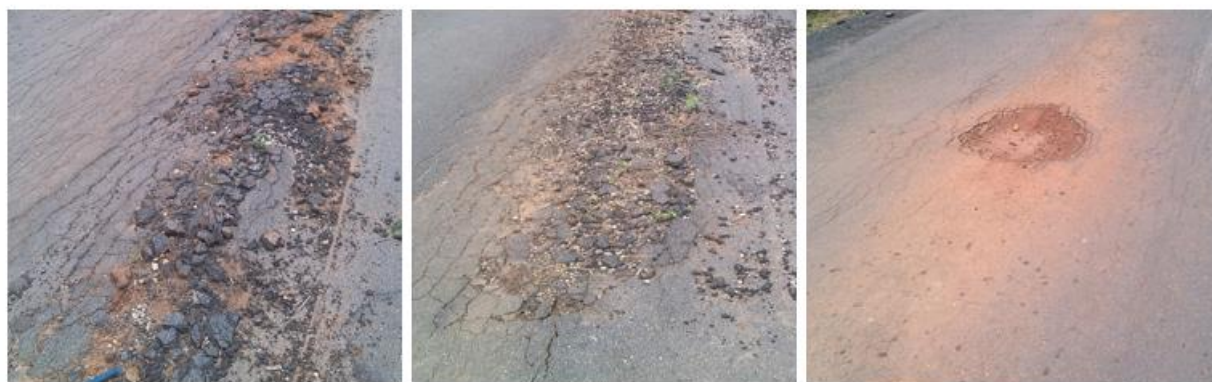
Plate 1.0: Shows the failed segment of the road.

The road portion investigated in this study is along Ilara-Ipogun road in Ondo State. It has failed repeatedly over the years, despite efforts made to rehabilitate it by resurfacing it with bituminous materials.

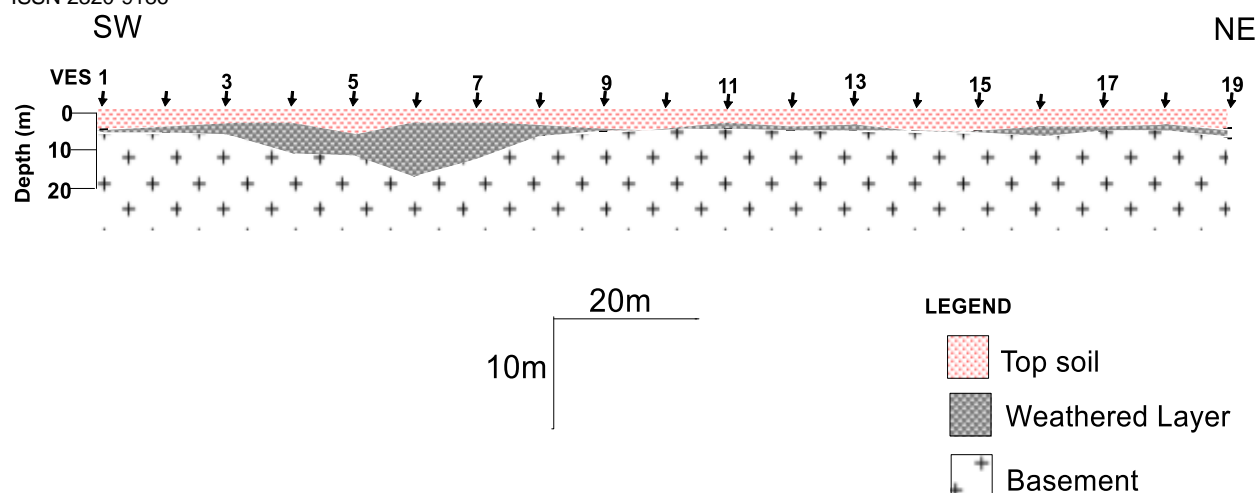
Fig 4.3: Geo-electric Section Along the Study Road.

It is observed from the geo-electric section and the 2-D resistivity structure that there is a depression between stations 0-19 (0-190m) and 24-28 (240-280m) which could be indicative of a fracture/faulted Basement bedrock. The suspected geological features between station 24 (240m) and 28 (280) was not delineated by the geoelectric section

Clayey composition of the weathered materials characterized by low resistivity values on the geoelectric section/Dipole-dipole pseudo section. The resultant swelling and shrinkage is of the clayey material believed to be responsible for the various cracks/deformation noticed along the studied segment of the road. Although some parts of this segment is still stable, but they are still vulnerable to failed since they have same characteristic with the already failed section.

- (i) That geophysical investigation showed be undertake at all the failed segments noted along the road.
- (ii) That if possible, road cut into clayey substructure should be avoided or evacuated and refill with competent materials like laterite..
- (iii) That road pavement suspected to be underlain by bedrock with linear feature such as fractured, fault should be properly reinforced.

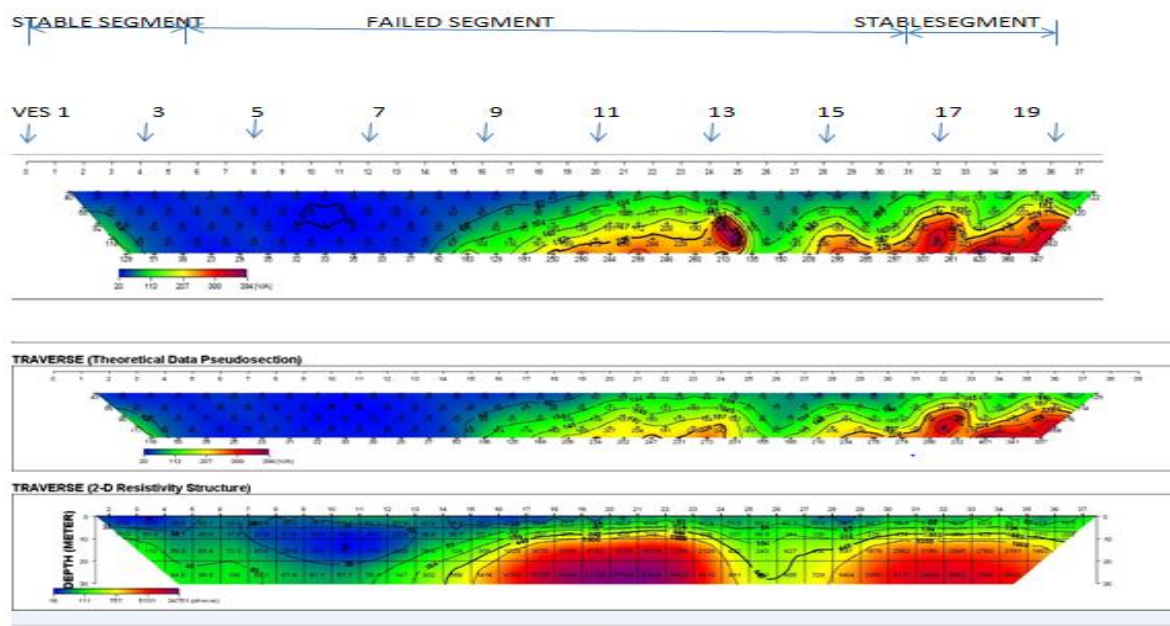
**Fig 4.4: 2-D Modeling of Dipole-Dipole Data along the Investigated Road Segment.**

The combine horizontal profiling/vertical electrical sounding data were presented as 2-D inverted resistivity structure. These models cover distance from 0-380m along the road segment under investigation. The 2-D resistivity structure shows subsurface sequence comprised of topsoil with the resistivity in the same range as the weathered layers usually merging into the latter (Fig 4.4). Low resistivity topsoil/weathered layers is virtually thick and up to 15m or more in places. Suspected steeply dipping common features are located at station between 24(240m) and 28(280m). The features have significant depth extent that is greater than 30m.

The 2-D inversion also shows a depression of station between 0(0m) and 15(150m). The 2-D inversion model has low percentage of correlation with the geo-section.

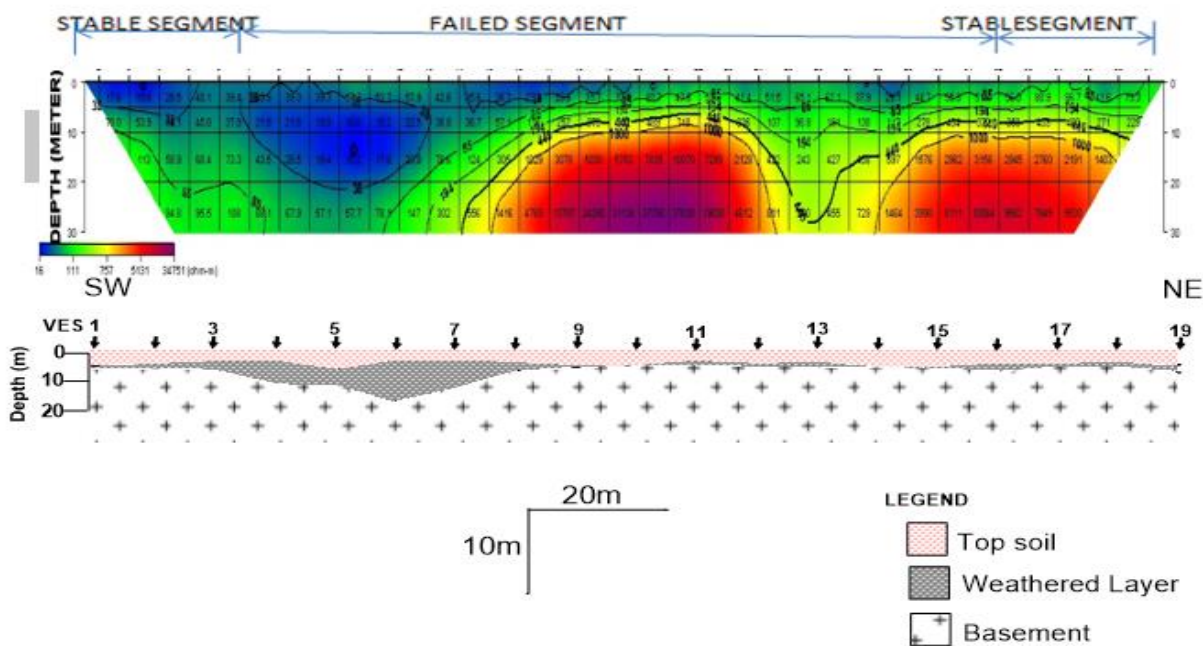
**Figure 4.5: Correlations of Dipole-Dipole and Vertical Electrical Sounding Results**

It was observed on the 2-D resistivity structure and pseudo-sections that the major areas of the failed and stable(?) segment fall between the areas of relatively low resistivity which can also be

compared to the areas which have a thick weathered layer or plastic clay lithologic unit on the geo-electric sections (Fig.4.5).
