HIGH PRESSURE VESSEL LEAKAGE IN UREA PLANTS

(A case study)

Prem Baboo

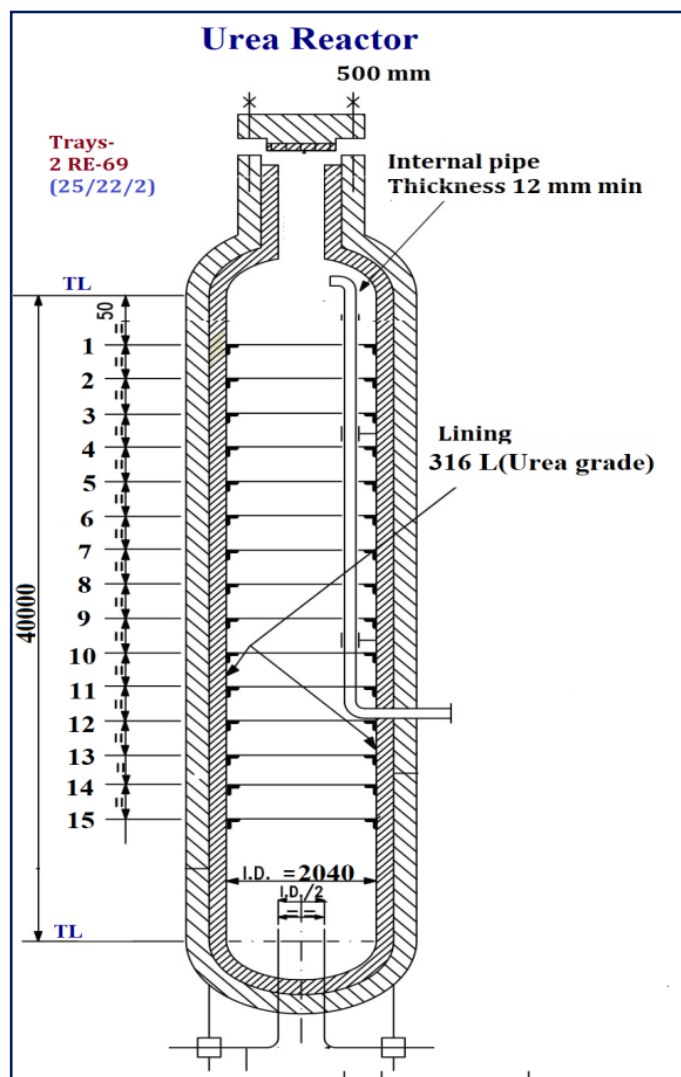
Fig-1
Reactors leakage detection and repairing
Reactor Liner Leakage on 28/01/2006.

In Urea Line-I and 2 plants all the weep holes are connected to conductivity meter based monitoring system. On dated 28/01/2006 the leakage alarm appeared in weep hole number 23 of 11 stream. The weep hole was checked physically and vapour analysed in laboratory found ammonia vapour and CO₂. Immediately shut down was taken and leakage found with

instrument air and soap solution the leakage easily detected. For find out the leakage the liner plate behind the weep hole was pressurized with instrument air at the pressure of 0.5 kg/cm^2 and other three interconnected weep holes were plugged. Soap solution applied on opposite side of liner. The pin hole leakage easily detected. The pin hole repaired by welding. The repaired portion was passivated with 10 % HNO_3 solution and rinse with Demineralised water. The repaired portion was further checked with instrument air and soap solution no leakage was found. The shutdown duration was only 69 hrs Feed cut to feed in.

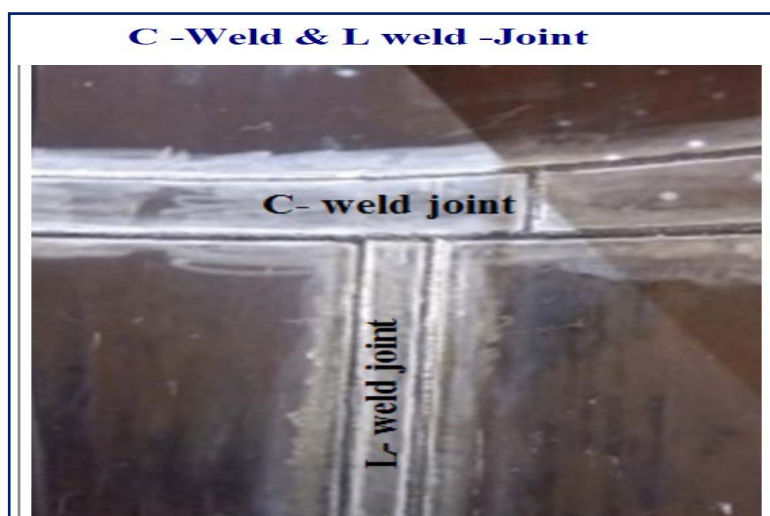
Fig-3

Welding Joint of 1st Segment System hydro-test water entered through the damaged portion of newly welded TSR cleat of the first tray into the coiled layers and reached up to the last layer of 8 mm.

As the vent holes and vent tube of the segment were in plugged condition, this resulted in pressurization of the outer shell course, causing rupturing of the 8 mm outer layer vertical joint. The coiled layer welding remained intact; otherwise it could have unwinded. Repair and Maintenance After thorough inspection of internal and external damage as well as consent and repair procedure approved from M/s. Saipem, rupture repairing company was contacted for rectification/repair of the reactor within minimum possible time at NFL Vijaipur site itself repair Procedure.

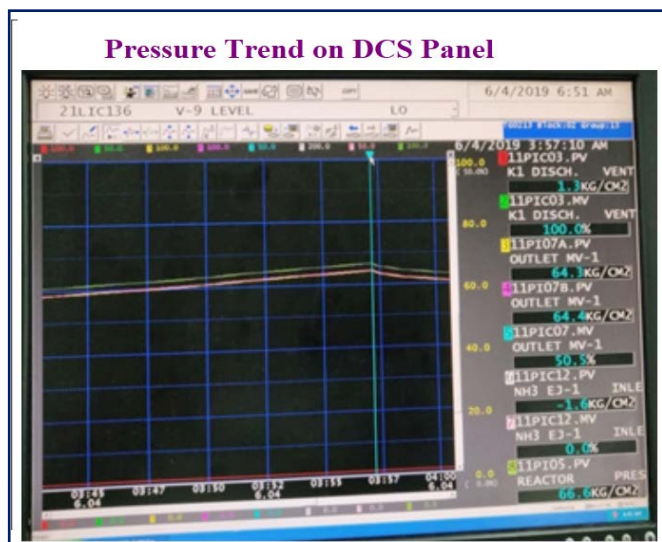
Fig -4

The Leakage observed on dated 04/07/2019, during the hydraulic pressurization of the reactor. It was observed that HP loop pressure was not increasing beyond 65 kgcm², rather started decreasing (Figure 4). It was noticed that condensate was coming outside from 1st segment (L-seam) of the reactor from inside the insulation. Immediately insulation was removed and it was noticed that the outer shell plate of 08 mm got ruptured from its vertical weld joint (400 mm in length) at 1st segment (L-seam) (Figure 3). Hence, HP loop was depressurized and draining was carried out and top manhole cover was removed for internal inspection. Simultaneously, tray man ways were opened from 1st to 5th tray. To detect the leaky portion inside the reactor, DM water was supplied through flexible hose from outer ruptured portion of the shell course and thorough physical (visual) inspection was carried out inside the reactor. It was found that water was coming out through 1st tray's TSR's newly welded cleat. After insulation removal, it was also noticed that there was bulging on outer (8 mm) layer at the first and fifth segment from the top of the reactor. Vertical joint of 1st segment outer shell 8 mm layer welding was found in ruptured condition and bulging of longitudinal pad plate of 5th segment was also noticed.

Temporary scaffolding was erected from ground floor to top of the reactor for approaching all vent. Tubes and vent holes as well as to carry out the job. Subsequently, whole Insulation was removed from reactor. All the vent holes and vent tubes plugs were de-plugged. All vent tubes' depth was measured, which was found in the range 62 mm and depth of vent holes was found as 40-42 mm. Further cleanliness of the vent tubes and connected vent holes of each segment was checked with instrument air pressure at $0.3 \text{ kg cm}^2\text{g}$ and found at clear condition. Maintenance jobs executed to rectify the damaged portion of reactor are as follows:

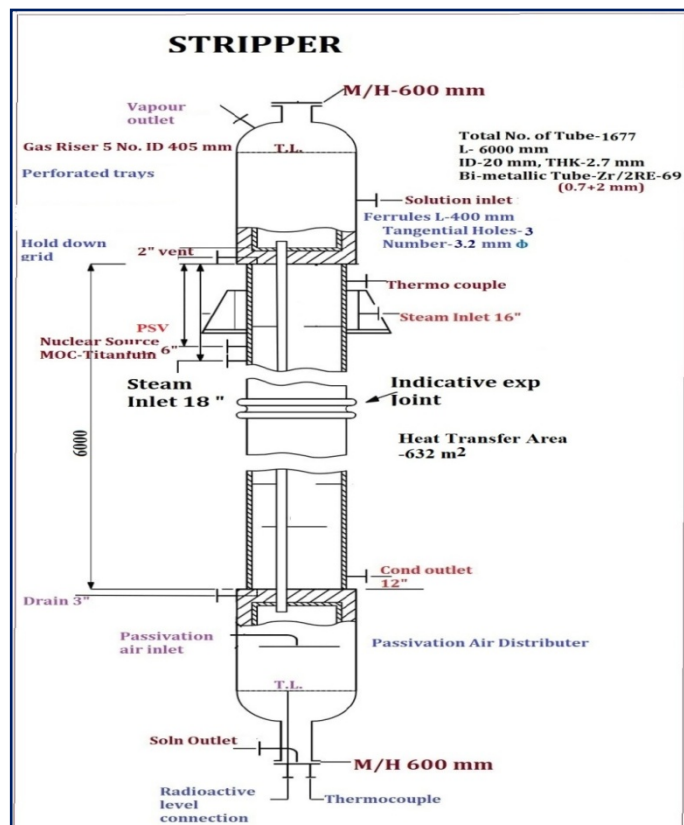
Fig-8

As can be inferred from the equation, decomposition is promoted by reducing pressure and /or adding heat. In M/S. Saipem process decomposition is carried out in three steps. Decomposition is promoted by heating and stripping CO₂ by vaporized excess ammonia, according to Henry's Law of partial pressure under the same pressure level as urea reactor. The plant commissioned in 1997 till date stripper is running. During pre-commissioning 55 no of tubes plugged in presence of Saipem representative. Tubes were plugged as Zirconium lining of these tubes was found damaged. In present shut down one damaged old plug replaced with new one and others eight numbers minor

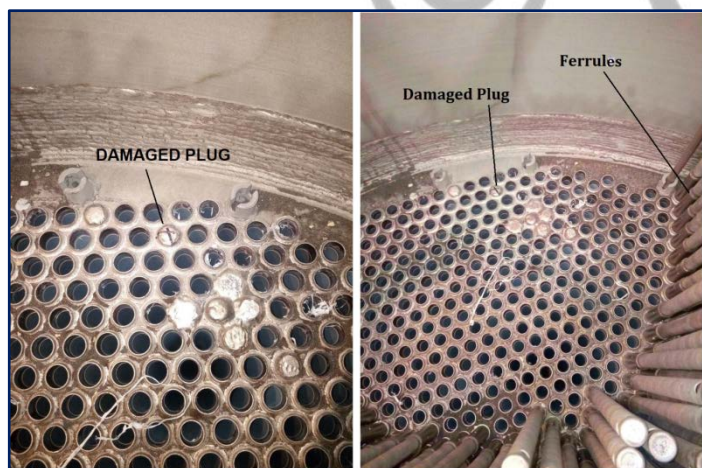
Fig-9

Besides the above, general corrosion has been observed on the bottom tube sheet, tube to tube sheet welding and bottom part of tubes (20 mm). Stripper has rendered service for around 21 years. Two types of stripping process are there; Viz: CO₂ stripping and NH₃ stripping. Both process work according to shift in partial pressure. This process is the most modern and energy efficient and therefore, widely used now a day. Decomposition at high pressure requires higher temperature, which means that much biuret has formed and the liquid becomes corrosive, but in the M/S. Saipem process the excess of ammonia and the use of Zirconium in the stripper permits minimizing these problems. The off gases generated in stripper are condensed in the high Pressure carbamate condenser where low pressure steam is generated. The NH₃ to CO₂ mole ratio of

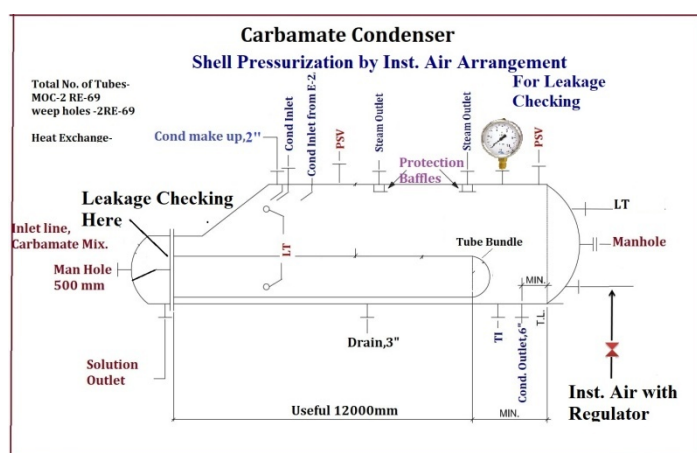
Fig-13

After providing blinds the entry done in tube side for detecting of leakages with soap solution with instrument air pressurization. The shell side pressurized up to $3.5 \text{ kg/cm}^2\text{g}$ as shown in the figure-13

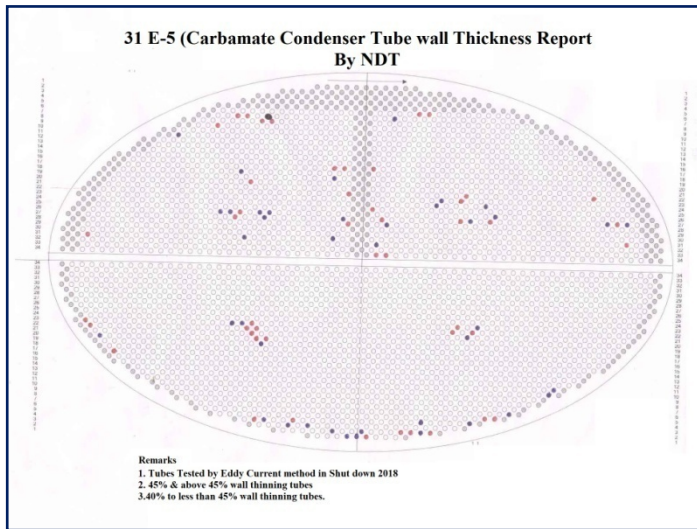
Fig-14

It is clear that this is an approach that takes into account only the direct cost of the equipment without any consideration on business losses that as in many cases like ours exceed by far the equipment cost. This option has the overall lowest life cycle cost of all the alternatives evaluated. Corrosion also observed in the stainless steel bimetallic tube next to the tube to tube sheet weld overlay. Corrosion in the 25-22-2 tube underneath the Zirconium tube caused by stagnant zone due to poor bonding.
