## OPTIMIZATION OF GRANT FISHING VESSELS BASED IN PANGANDARAN, INDONESIA

Izza Mahdiana Apriliani, Lantun Paradhita Dewanti, Achmad Rizal, Heti Herawati, Indah Riyantini, Malik Maulana

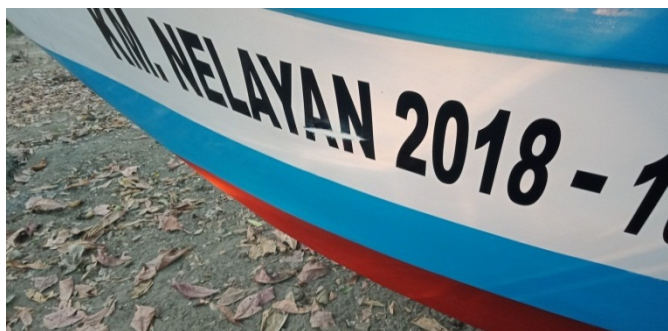
The use of grant vessels based in Pangandaran has not been felt to be optimal. That was caused by constraints with the condition of the defective vessel. There are cracks and abrasions on the hull of the vessel as in Figure 1. It can only cause more damage if it is not immediately repaired and if used for fishing activities can cause water to enter the hull. So that it can threaten the safety of fishermen who use it in fishing operations.

Figure 1 Cracks and scuffs on grant vessels

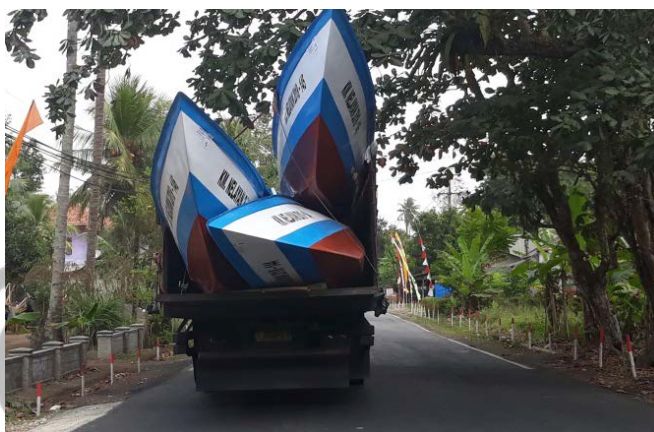
The vessel's cracks and abrasions are a result of the poor distribution process of the KKP grant vessel. Figure 2 is a portrait of how the KKP grant vessel distribution is based in Pangandaran. The vessel is distributed using a truck that is arranged neatly and is stacked irregularly. Piles between vessels that touch the hull and the keel of the vessel certainly cause friction and a heavy burden during the trip. This causes cracks in the body of the vessel and damage to certain parts of the vessel.

Figure 2 Grant vessels distribution process

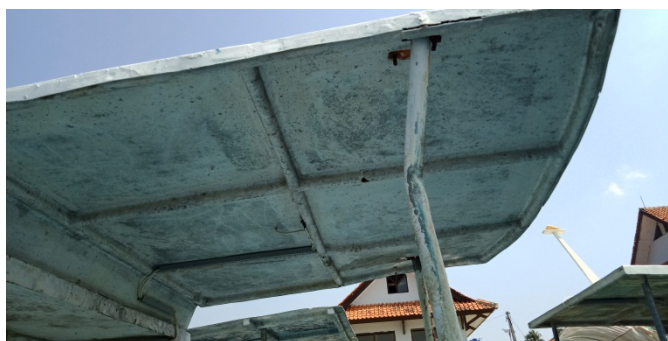
The length of the vessel rests in the waters around TPI because it is not being used. Figure 3 shows that there was a bend in the vessel's supporting ceiling and many parts of the vessel began to rust. Darmanto et al.[7] stated that the routine vessel maintenance process is carried out annually by painting the hull of the vessel. The hulling of the vessel is carried out not only on vessels undergoing major maintenance but also on vessels that are not physically damaged. Damage to the hull's protective coating (which is a paint coating) needs to be cleaned and refill every year and the painting process begins with applying paint to all parts of the hull.

Figure 3 Damage to the vessel grants

Damage to vessels was added to the length of time the vessels were anchored at TPI because they were only left to lean on TPI without being given care because of the uncertain status of the vessel causing the grant vessel to need a lot of repairs before being reused. The fishermen mentioned that the long legal process caused the vessel could not be used yet. So that the process of giving vessels to fishermen is stunted regarding the problem. Even for vessels measuring 3 GT from April 2018, the vessels were anchored at 5 TPI points, so far they have not yet dropped their vessel's matters. Even though for vessel grants anchored at TPI Cikidang with a size of 5 GT, the vessel's documents have been dropped, some fishermen are reluctant to use them regarding the cost of repairing the vessels that must be borne by the fishermen.

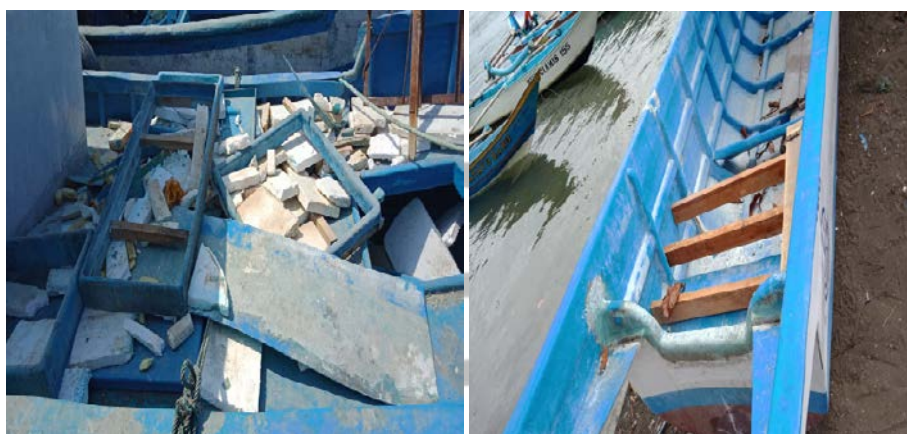
Figure 4 Grant vessel repair process

The process of vessel repair is shown in Figure 4. The process of vessel repair is done by adding accessories and reducing the part of the vessel that has been given from the vesselyard according to the tastes of the vesselowner. The addition and subtraction of parts of the vessel are intended to facilitate the work of fishermen who are per under their habits when fishing. Inadequate vessel maintenance facilities became a separate problem faced by Pangandaran Regency. In general, fishermen only repair rudimentary vessels with simple equipment. According to the results of interviews with the nearest vesselyard fishermen are in the Cilacap Regency area. So that in the repair of vessels will spend a lot of time and not a small amount of money. This is the reason why the KKP grant vessel is based in Pangandaran.

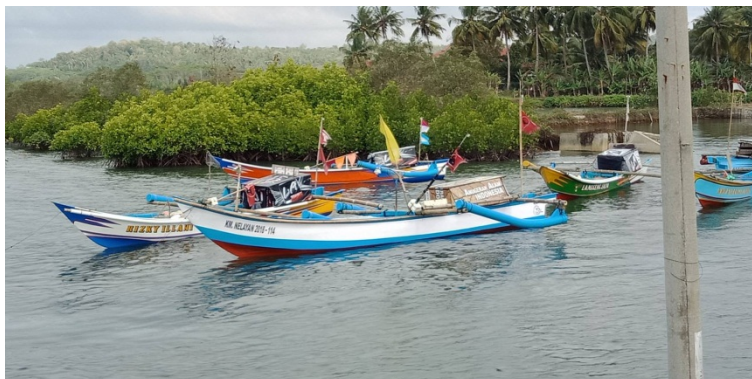
Figure 5 Utilized grant vessels

Figure 5 shows the grant vessel that was leaning in the waters around the TPI. It can be seen that the vessel can be used because there are additional accessories attached to the vessel in the form of bamboo attached to the left and right side of the free-board, the addition of vesselbuilding, addition of katir on both sides of the vessel, the addition of wood to the main dimensions of the vessel, giving the flag of the vessel and a set of fishing gear. According to the results of an interview, one of the fishermen stated that the grant vessel could have been used, but needed to be supported by improvements and changes in the part of the vessel to support the fishing operations.
