A STUDY ON NON-COMPLIANCE WITH NATIONAL BUILDING CODE IN PRIVATE HOUSING RECONSTRUCTION AT INDRAWATI RURAL MUNICIPALITY OF SINDHUPALCHOK DISTRICT

Bikram rawat

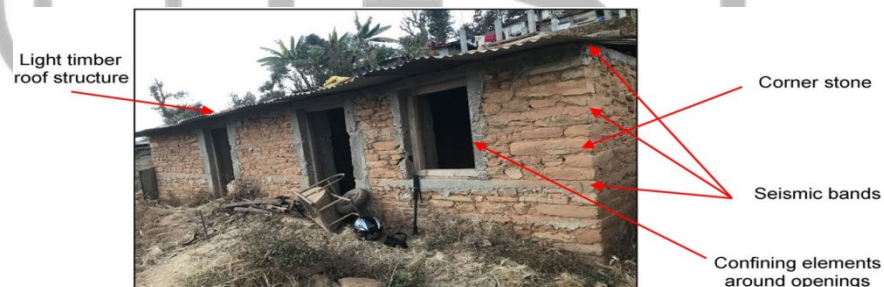
Fig 4.1: Stone masonry buildings in mud mortar

Stone masonry is the most common type of buildings found in rural areas of Nepal. The stone units used in the SMM walls are from various nearby sources such as river (fairly round shaped), naturally fractured rocks and from quarry sites. The mud mortar used in the SMM wall construction is prepared from locally available soil. Most of the PRE-SMM buildings, traditionally constructed by local masons, are unreinforced and often built with un-coursed random rubble stone in mud mortar thus displaying poor tensile and shear strength. The SMM walls are usually thick (400–600 mm) and the wythes are not properly inter-connected using adequate amount of through thickness stones (Bothara et al. 2018). The number of stories varies from one to three and the storey height is typically low at about 2 m. The POST-SMM buildings also have 400-600 mm thick un-coursed random rubble stone masonry walls as in the PRE -SMM construction. Most of the POST-SMM constructions are single storeyed with one to two rooms only, although the NBC 203: 2015 code allows multi-storeyed construction of up to two storeys plus an attic floor. The storey height is typically low at about 2 m. The RC seismic bands are typically 75 to 100 mm deep (Fig. 4.1) and extend through the whole thickness of the SMM walls. The roof is mostly gable type and is made of a timber structure with light roofing material (corrugated iron sheet) (Fig. 4.1).

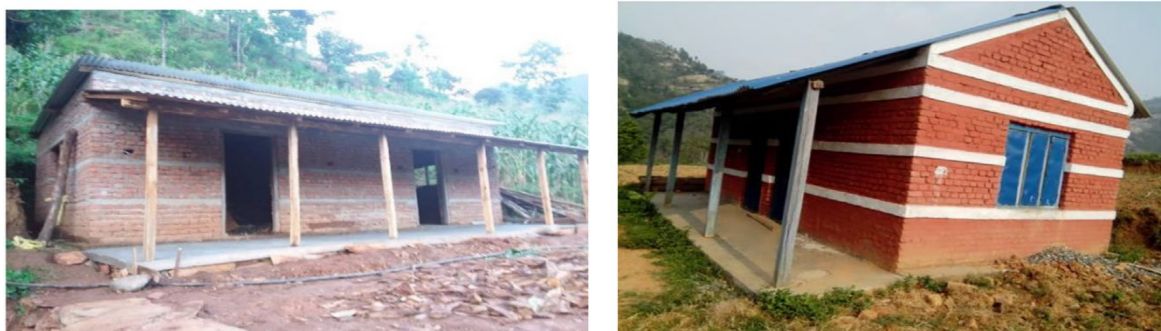
Fig 4.2: Brick masonry building in cement mortar.

In brick masonry walls are load-bearing and bricks are either bonded with cement or mud mortar. Wall construction is double brick with no cavity and is normally 230mm or 350mm thick. The height of the building can be one-story or two stories depending on wall thickness. The floor system is usually mud on bamboo or timber joists (Fig. 4.2) and sometimes reinforced concrete (generally in urban areas). The roof structures are timber or steel with CGI or tiles in some cases, a sloped roof is built using RC slabs.

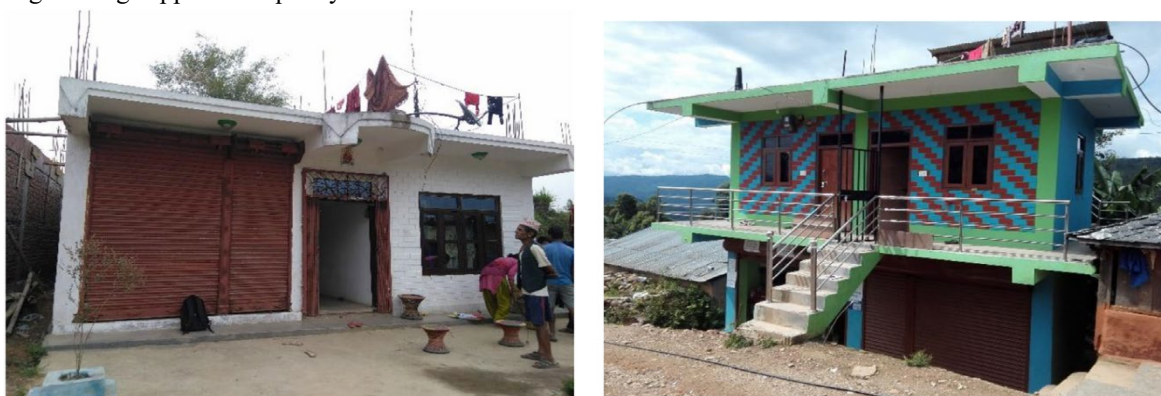
Fig 4.3: RCC frame building

RCC buildings are constructed by the cast in situ concrete columns, beams and slabs (Fig.4. 3). They have a brick wall or block wall as infill walls and can be non-engineered or engineered. There are two common ways to construct RCC buildings; the walls can be done first or the walls can come afterward. RCC structures are most prevalent in the urban area, but they are becoming more common in rural areas where access to engineering support and quality materials is limited.

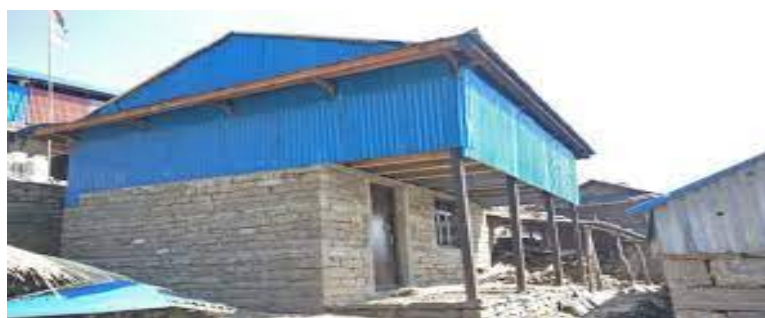
Fig 4.4: Hybrid structure with CGI covering at first floor

Hybrid structure (Mix structure) is the combination of two or more type of structural system that is generally constructed with different technology and materials in accordance with level of floor. The ground floor is constructed by masonry structure and the first floor by timber or steel frame structure with lightweight such as CGI sheet or wooden planks as shown in fig 4.4. The masonry structure at ground floor shall consist of all the earthquake resistant elements such as horizontal and vertical bands. R.C. or wood both can be used to construct these bands, but it shall be compliant with the respective minimum requirements. The first floor shall be timber frame structure. Since, no any specific guidelines have been made till date, different construction technologies resulting from connection details to materials is used for construction of timber framed structures.

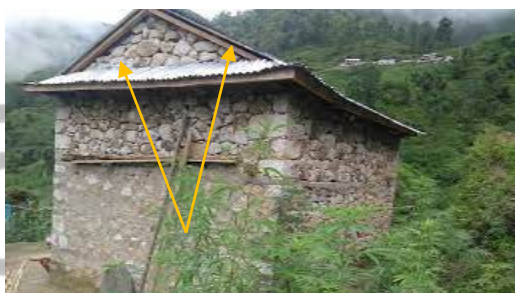
Fig 4.5: Stone masonry building with no gable wall

The households carry out vertical and horizontal extension after clearing off entire tranches which violate building codes. Fig. 4.5 shows the stone masonry building without gable band which is indispensable for building code compliance.

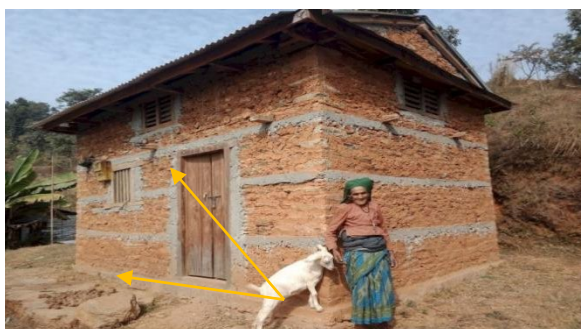
Fig 4.6: No sill band in attic level and improper band placement

The gap between the top horizontal band and rafter/purlin is filled with two or three layers of masonry units with mortar. The masonry above band has very small height. It is also restrained by vertical elements on sides so failure is unlikely to happen in this zone (Exception). Similarly, Fig. 4.6 shows the non-compliant stone masonry building without sill band in attic level and improper band placement.

Horizontal bands and vertical reinforcement are required to take lateral load. Correction is provided as per exception and correction manual and structural analysis.

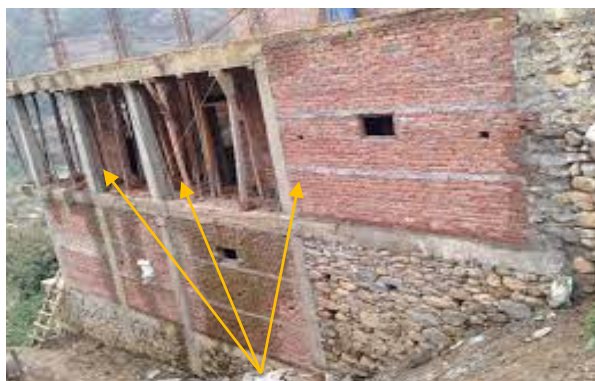
Fig 4.7: RCC building with 9x9 column

Fig 4.7 shows an example of noncompliance RCC building with 9''x 9'' column which makes it non-compliant. The minimum column size is 12''x 12'' with 12 mm reinforcement bars in compression member.
