CHALLENGES IN MAINTAINING SUSTAINABILITY OF DRINKING WATER SYSTEMS – AFTERMATH OF A NATURAL DISASTER

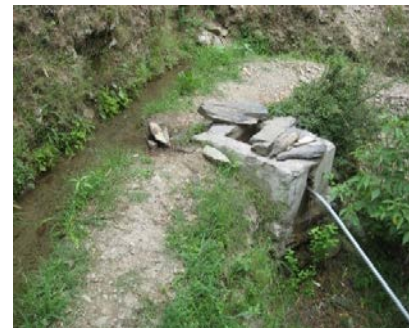
The study also found that the physiochemical parameters especially turbidity, taste, odor and color were found above permissible limits broadly due to inappropriate structures at source points exposing the source water to different contaminants, i.e. source points lack protection measures like diversion channels and catchment drains against run-off resulting in high turbidity of the drinking water (Figure 7, 8, 9).

Figure 7: An inadequately engineered and unprotected source point

- i. **Developing "Safe water sources"** - Development of safe water source is one of the key factors towards the sustainability of a water system. There are some key factors which should be considered to make the sources safe from the environmental hazards, i.e. assessment of the environmental hazards or sanitary inspection, appropriate location, pre- and post-development water quality analysis, application of apt engineering and community ownership. The principal and mandate of developing safe water sources at all stages of responding to disasters and emergencies should be adopted and executed by concerned line agencies and service providers in water and sanitation sector.

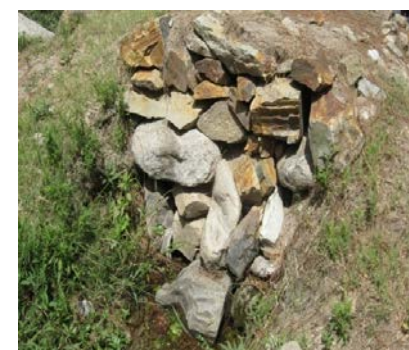
Findings from the study state that out of the total 800 water supply systems 17% were served with physio-chemically contaminated water (with high turbidity, pH levels and objectionable color, odor and smell) according to set standards by WHO, PSQCA and NSDWQ (MoE, 2008). The primary reasons found through sanitary inspection were frequent and easy and unwanted human and animal access and poorly designed source structures with inappropriate engineering (Figure 8, 9).

Figure 9: Undeveloped spring box of a sample water supply system
