DOCUMENTATION AND RESTORATION PROBLEMS OF (QISHLA AND SARAY OF BAGHDAD)

Prof. Dr. Bahiye Işık Aksulu, Hadeel Abdulkareem Almkhtar

This research focused on the documentation and restoration problems of the Qishla building and saray of Baghdad as it is considered one of the most important heritage buildings in the city of Baghdad

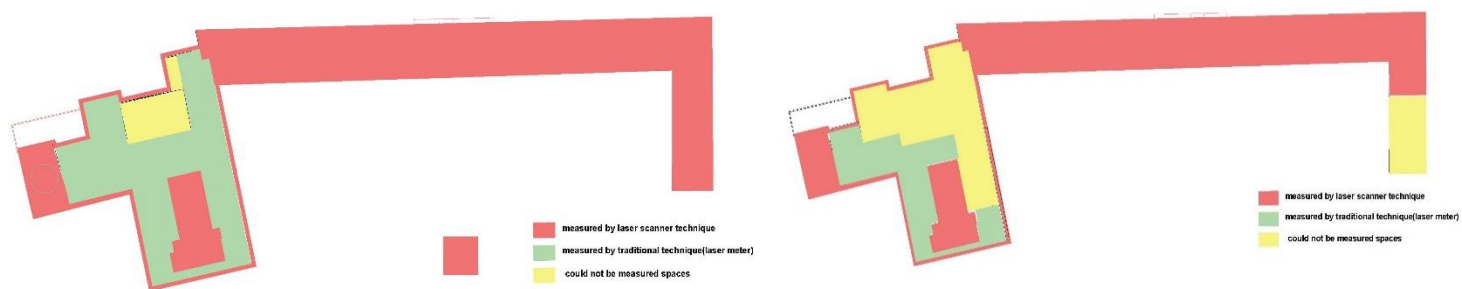
Fig ground and first floor of Qushla and saray building shows measurement technique

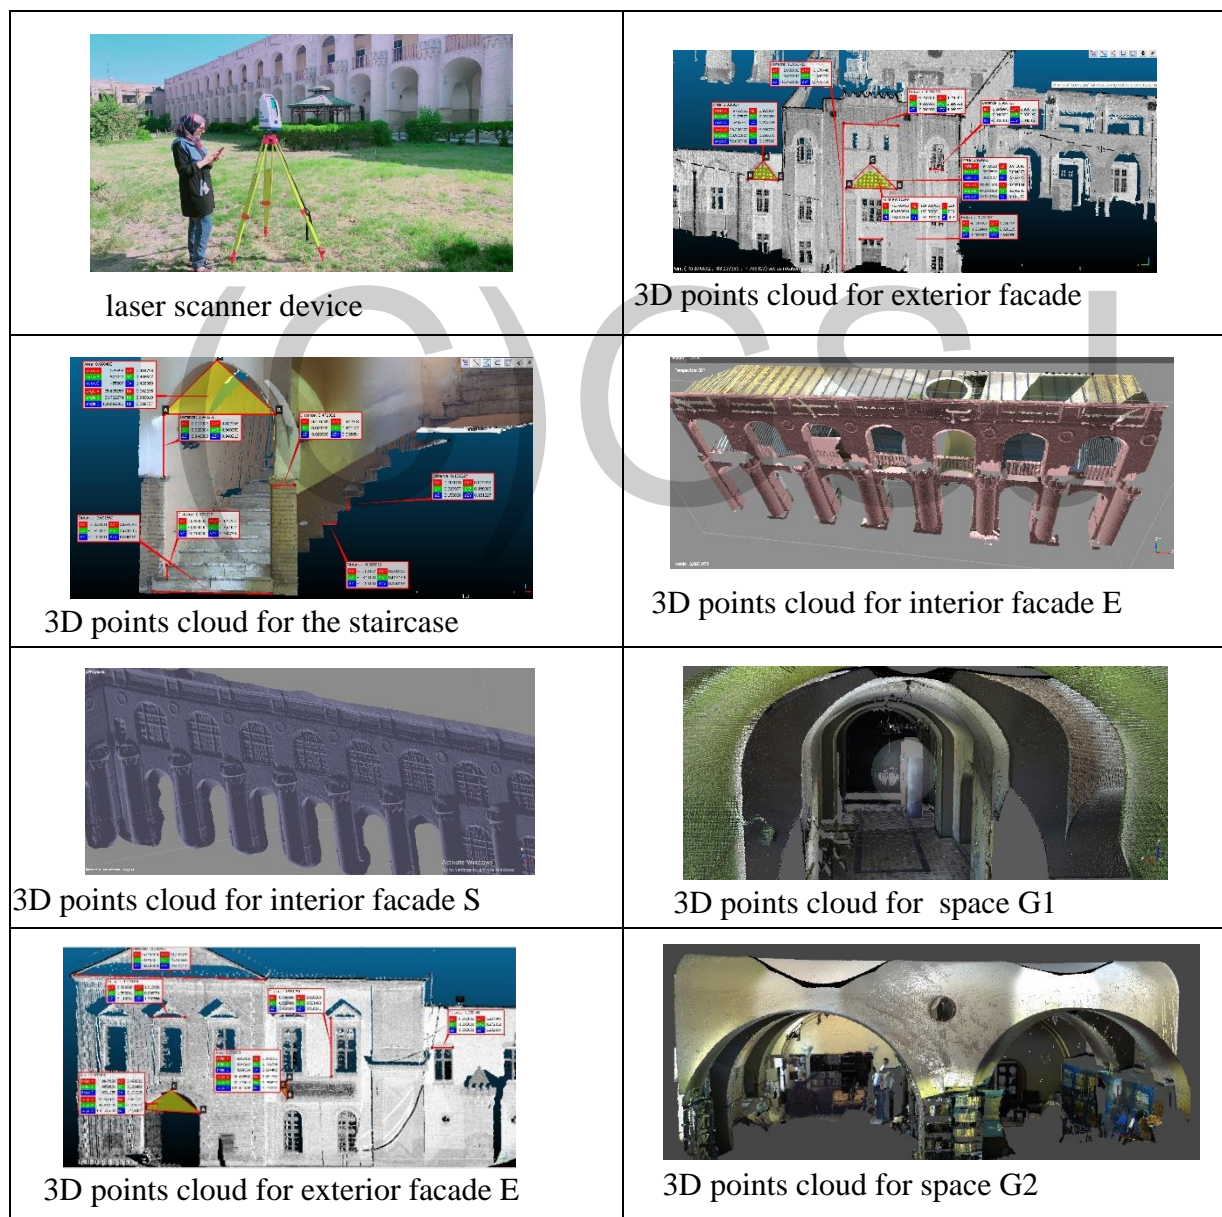
Fig () output of laser scanner survey as 3D points cloud

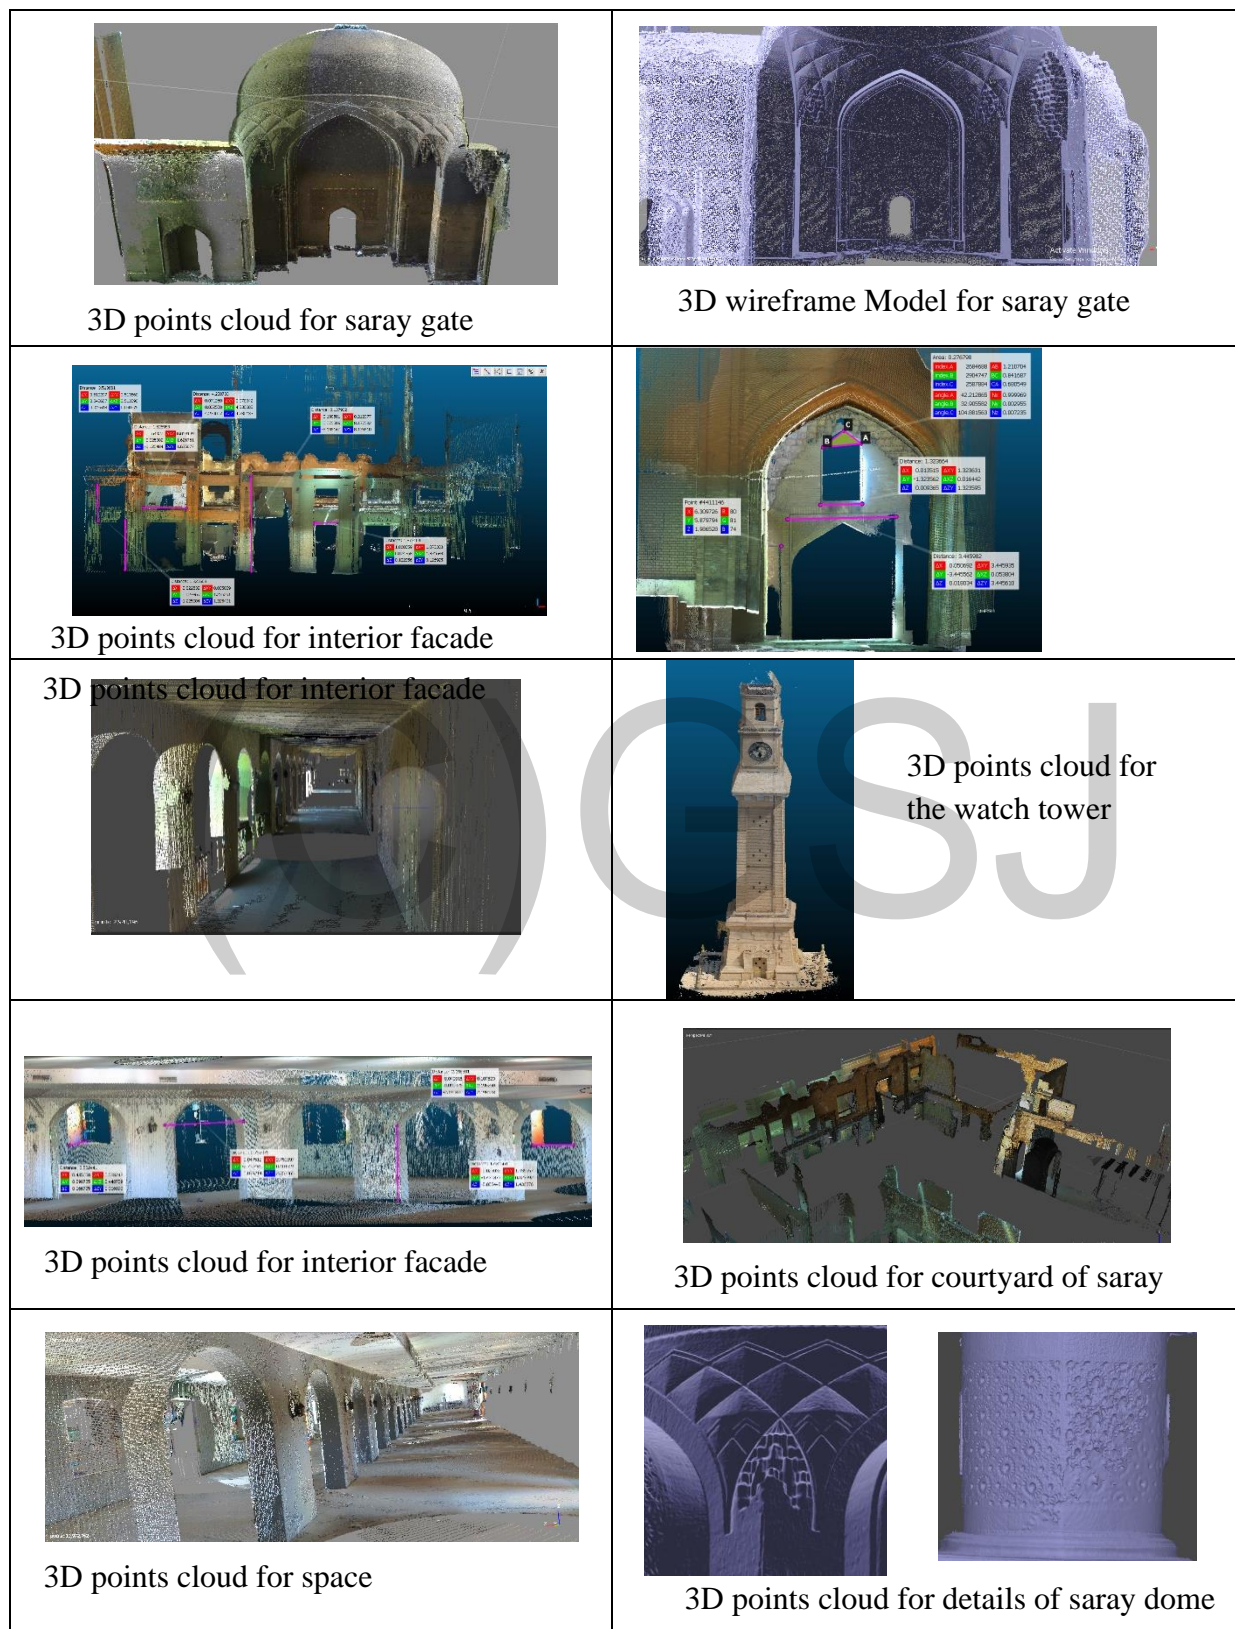
Fig () output of laser scanner survey as 3D points cloud

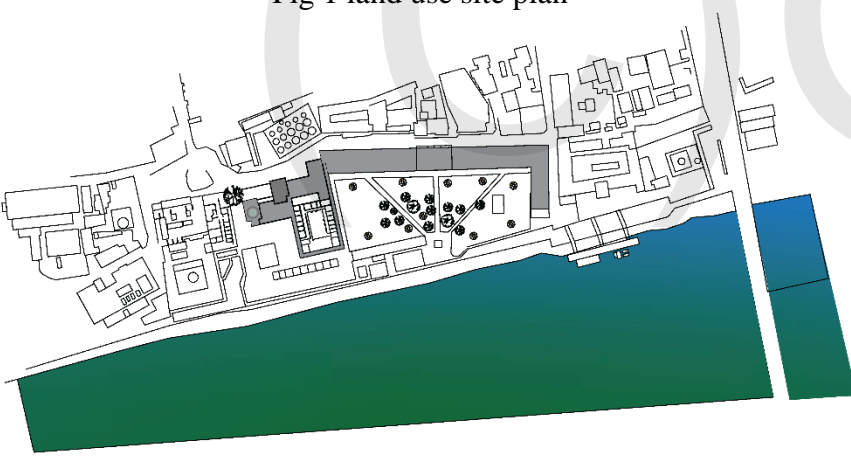
<p>Fig 2 site plan</p>	<p>Along a distance of about one kilometer on the eastern bank of the Tigris River, a complex extends that includes five main heritage buildings known as the Baghdad Saray buildings, which included a political history of Iraq in the nineteenth century.</p> <p>The oldest and largest of these buildings is the old Qishla building, which is located opposite the Saray Mosque, next to the libraries market. This building was used by his Excellency as a barracks</p> <p>Soldiers have time to camp and not leave the war in the winter</p> <p>The construction was started in 1860 AD during the reign of Governor Namik Pasha, and the second floor was added during the reign of Governor Medhat Pasha.</p>

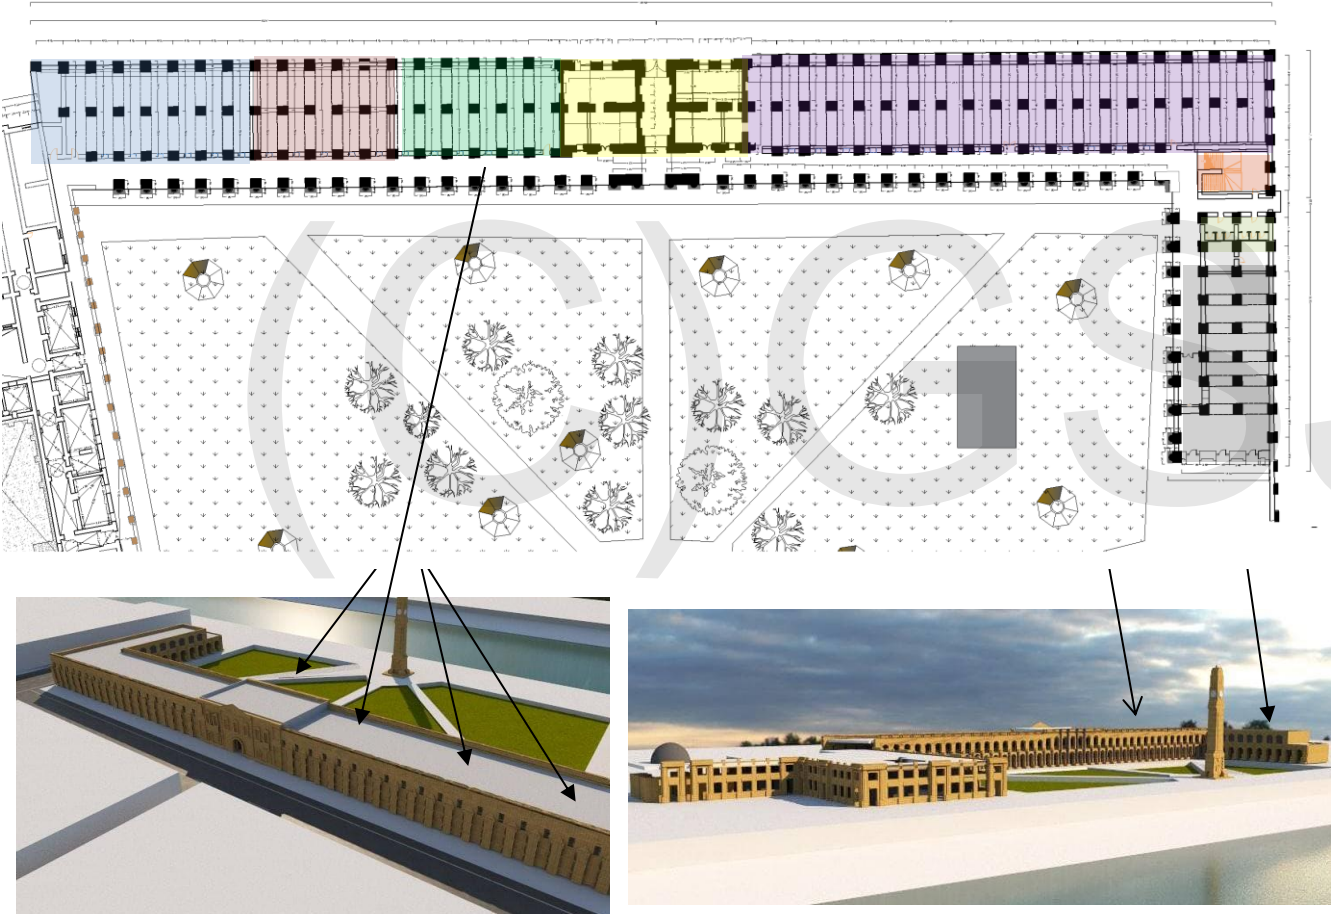
<p>The architectural drawing shows a detailed floor plan of the ground floor. The plan is divided into several color-coded zones: a yellow central entrance area, a large purple area on the right, a blue area on the left, a green area, and a grey area. Below the plan are two 3D perspective renderings. The left rendering shows a close-up of the building's facade and courtyard, with arrows pointing to specific areas. The right rendering shows a wider view of the building complex, also with arrows pointing to specific areas.</p>	<ul style="list-style-type: none">Space G1 main entranceSpace G2 (The Cultural Heritage Museum in Al QishlaSpace G3 IRAQI journalist's syndicateSpace G4 (The book store)Space G5 (theSpace G6 (the library)Space G7 (WC)Space G8 (staircase)

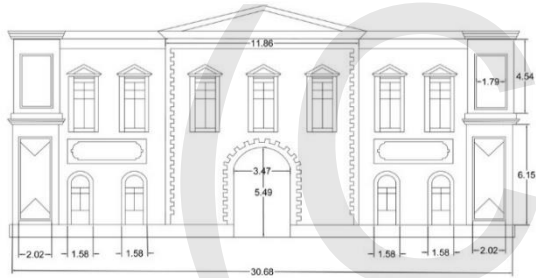
<p>Fig 7 elevation</p>

<p>Fig 8 section</p>	<p>Location: The entrance is space and is directed towards the eastern side of the building</p> <p>Size: The space is roughly rectangular with size (30M) (15M) The space has an approximate height (4.5) and it starts to rise gradually to reach a high (4.7) Start with the arched of the gate end with the arch overlooked the inner courtyard.</p> <p>The entrance goes down from the main street three Steps(0.35)</p> <p>The entrance half door with two shutters decorated with Iron nails arranged in a beautiful geometric shape.</p> <p>To the right of the entrance and within its mass there is a space with two rectangle windows topped by a semi-circle arch overlooking to the street and from rectangular window and door with two shutters overlooking to the courtyard through the Riwaq</p> <p>On the left, also the same space that means the entrance mass is symmetric.</p> <p>Finishing</p> <ol style="list-style-type: none"> 1-The door from Wood and Iron nail 2- Walls and arches from break finished with plaster. 3- The ground finished with mozaic tiles. <p>Windows: the number of windows in the entrance spaces are three windows in the left and right spaces two looking over the street one looking over the Riwaq with size 1.6*1.1m and semicircle above with size 0.5m.</p> <p>Doors: there are five doors in entrance spaces, the main gate with size (3.5) m (3.8) m and two doors for the left and right spaces have two shutters with size (2.1m), (2.00m) and two doors inside the spaces with size</p> <p>The part of entrance in Riwaq has an arched roof rests on four pillars two stuck to the wall and two pillars are free.</p> <p>The arch roof finished with Fair face break Stucco decoration, we can see also two Lantern and two ceiling lamps on the antique characters.</p> <p>Structural problems: there is above the window air-conditioning device for cooling and heating and artificial lightening on walls and other lanterns hanging from the ceiling.</p> <p>Also swelling in the ground in some part of spaces</p>	<p>Distribution</p>

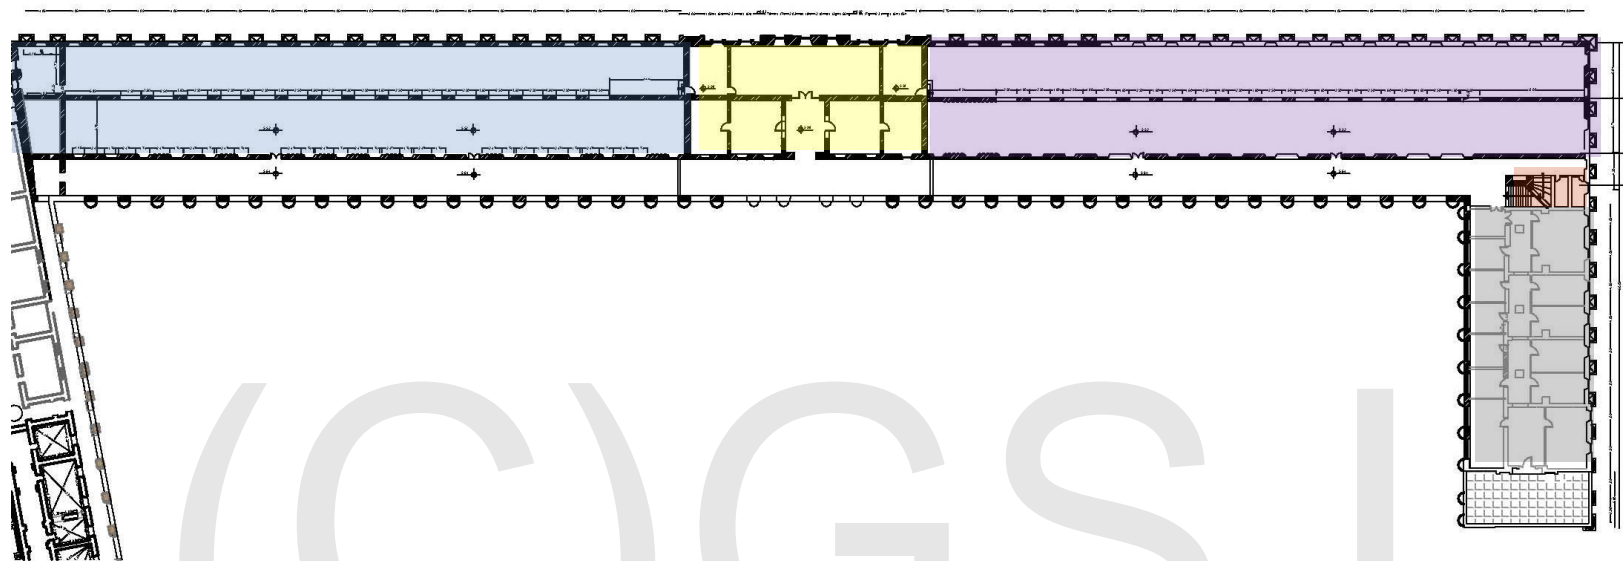
- Space F1** The main entrance of first floor
- Space F2** The gallery of martyrs holding
- Space F3** empty space
- Space F4** unmeasured wing (the Administration)
- Space F5** the stair case

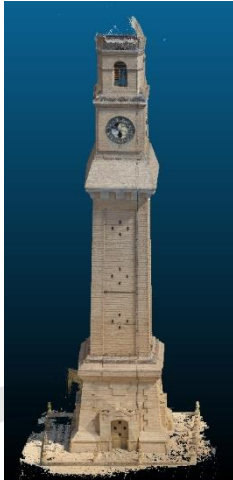
<p>Fig 3 Laser scanner model</p>

<p>Fig 2 Plan of watch tower</p>	<p>Location: the watch tower take place in the middle of inner courtyard inside Qushla building front of the main entrance on one axis.</p> <p>Size: The watch tower roughly squer with size 6.10m *6.10m and high 23 m. The structure of the tower is bearing walls on all side inside there is small space with size 1.7 m*1.7m fig9</p> <p>Finishing 1-the body of the watch from fair face brick size of brick peace 0.24m* 11.5m*0.8m 2- the circle watch from metal fig 4 also the direction axis fig6 . 3- the door from timber fig 5</p> <p>Windows: the number of windows in the tower is 4 windows opened to the courtyard with size 1.68m*0.96 m</p> <p>Doors: this space of the tower have one door from the eastern side with one shutter with size 2.4m *1.5 and around the door there is a frame wavy from the top fig 5</p> <p>CO Structural problems: there is no structural problem appear because the tower was restored in 2012 in rehabilitation of qushla fig 8</p>

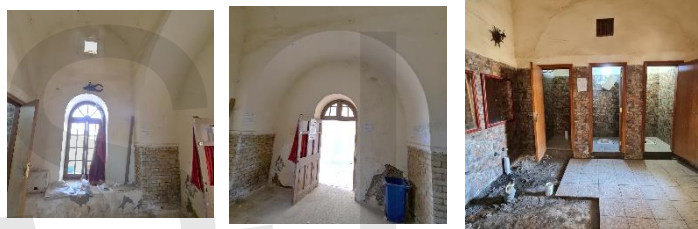
<p>Location: This is space take place in the left side from the southern gate in the ground floor.</p> <p>Size: The space is rectangular with size 4.10m *3.5m and high 4 m with arched roof and there are two WC for man and for women each one has 3 space. The structure of space is columns 160m*140m from two sides with arched roof. The annex space with size 5.2m 3.4m 6.1m</p> <p>Finishing</p> <ol style="list-style-type: none"> 1-The door from timber 2- Walls finished with plaster In the high half. 2- Walls finished with fair face brick in the lower half.

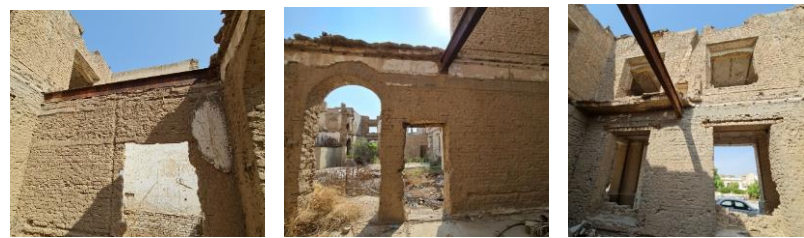
<p>windows:</p> <p>The number of windows in the space is two on the western side, as in Figure 5, with a height of about 2.4 m * 1.68</p> <p>The window lacks the wooden structure and glass, and the shape of the outside frame is somewhat irregular due to the loss of some bricks (constructive material) and the presence of some bricks inside the window, which is believed to be part of the window.</p> <p>The third window is on the southern side, with a height of 2.40 m * 1.60 m, and all the windows have their side ribs tilted outward at an angle</p> <p>doors: There is a small door on the eastern side, 2.10 m * 0.95 m high, and next to it is an arch-shaped gate, 2.96 m high, surrounded by a brick frame.</p> <p>And the third door appears in the northern side between this space and the space G1-B in the form of an opening that loses dimensions due to a change in its shape due to the loss of some structural material (bricks) in its frame and its current dimensions are approximately 1.20 m * 2.30 m</p> <p>There is an iron I section in the middle of the ceiling in the space</p> <p>Structural problems:</p> <ol style="list-style-type: none"> 1- The ceiling is completely destroyed, except a small part of the southwestern part 2- The finishing material is completely missing in this space, and from some traces it appears that it is plaster and white paint, and the building material appears, which is bricks that suffer from corrosion on the surface due to weather factors and the obsolescence of time and neglect. 3- Loss of finish material for floor 4- The absence of any trace of electrical installations and services

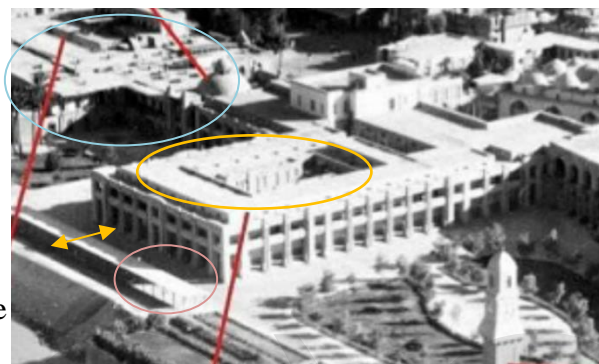
Fig 2 saray complex buildings in nineteenth century

4- the distance between saray building and the bank of Tigris River is less than now fig 2,7 orange arrow

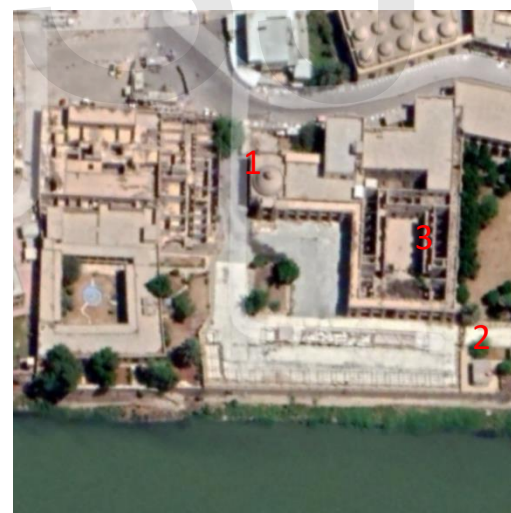
Fig 3 saray complex buildings recently (google earth)

- 1- The main stair in the inner eastern wing facade it was demolished fig 2, the white circle
- 2- there is building in the courtyard beside the watch tower it was demolished fig 2 orange circle
- 3- the layout of court yard has change also green spaces is different fig 2,3.
- 4- the building is occupied new in another function
- 5- the watch tower fig 6 is different in shape at the top from fig 4 because the tower in the Baghdad flood the upper part of it was lost and it was rebuilt differently

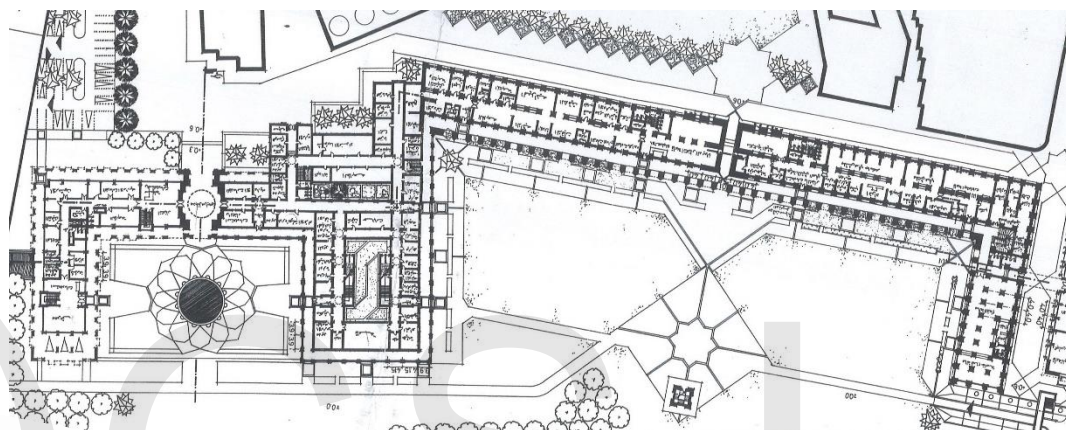
Fig 3 Qushla building ground plan
(ALhadithi thamer thesis)

4- The southern part appears as a cafeteria in the form of a large hall. Cutting it into spaces showed the reality of the situation. A library was used and pieces of wood were placed.

5-There is no corridor in the southern part
The southern corridor was created after the restoration of the building

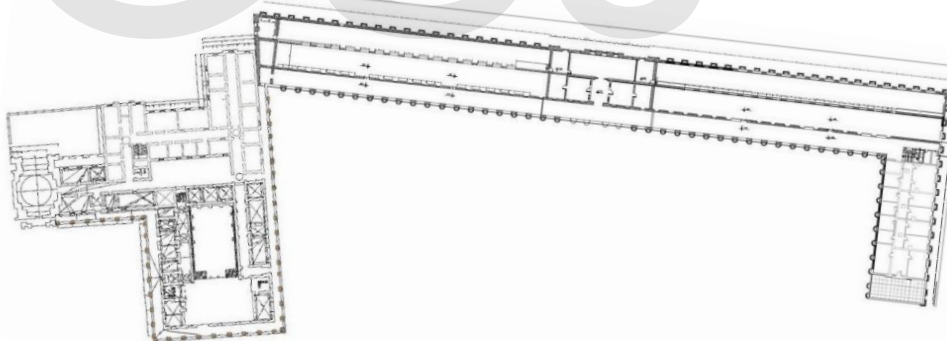
Fig 3 Qushla building first floor plan
(By author)

- 1- The spaces after restoration are different in shape where the inner partition was removed to create large halls can use it as exhibition (Qushla plan)
- 2- The southern wing (the shorter wing of Qushla) was different in partition shape it was one large space which is divide to offices by partition fig 3
- 3- (Saray plan) the important change is the courtyard Shape after demolishing the stair and some spaces
- 4- Lose the floor of some spaces in the first floor
- 5- Cannot reach all spaces of the first floor because the demolished floors and stairs

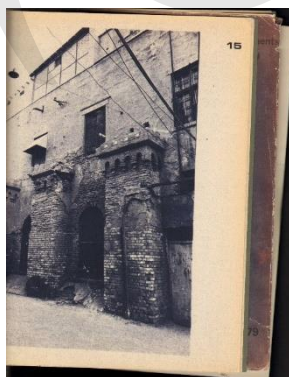
Fig 3 entrance in the southern façade
(General Authority of Antiquities)

4-Lifting the electrical installations that were distorting the facade fig 3

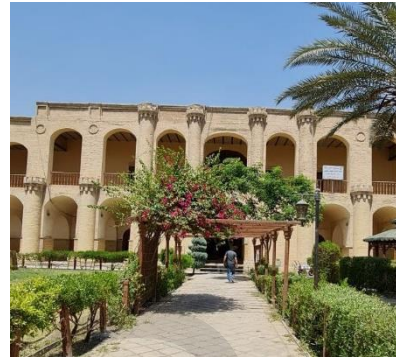
Fig 1 inner eastern façade (by author)

3-Replacing the finishing material with bricks and the cornices with new packaging fig 1,4

4- demolishing the main stair in the entrance fig 1

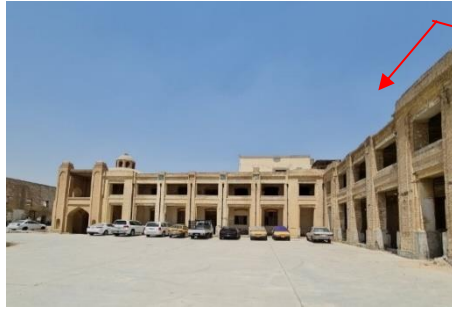
Fig 1 inner saray façade (by another)

- 1-Removing the second floor, which was added in an emergency
- 2- Closing the openings on the ground floor between the columns and placing iron nets
- 3- The windows on the first and ground floor are mostly missing
- 4- Loss of parts of the external facade at the top of the curtain and some decorative tiles. fig 1

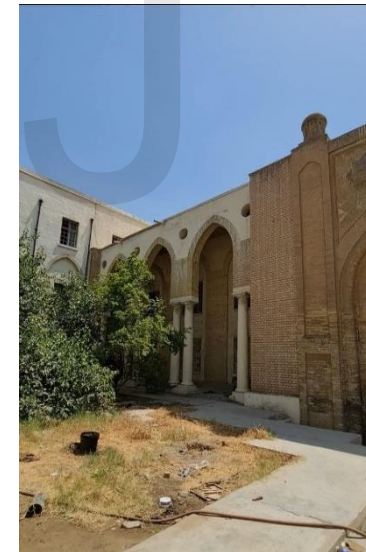
Fig 4 saray façade (by another)

- 1- the staircase behind the arches that does not exist now fig 4
- 2- garden opposite the facade that did not exist previously fig 4

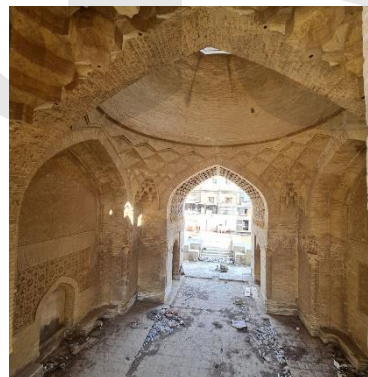
Fig 6 saray façade (by another)

1. There some changes in palace gate in outer bow grand entrance and form internal arc from other side
- 2- The existence drawer separate street from gate height 1.5 m from main street while informer gate and main street in one level and can be accessed directly from street
- 3-There is a fence opposite the gate prevents entry to the gate previously there is direct entering from the street to the gate
- 4- a small building resembling a kiosk that was removed fig 1
