INVESTIGATION OF TRAFFIC ACCIDENT PRONE AREAS RELATED TO EXISTING ROAD CONDITION AND DRIVER'S BEHAVIOR ALONG MENAGESHA- AMBO ROAD SECTION

Eyob Mekonnen¹, Emer Tucay Quezon², Murad Mohammed³

The primary objective of the research is to investigate the causes of accidents within the traffic accident-prone areas and to provide the possible countermeasures on the road from Menagesha (Addis Ababa) to Ambo. Specifically, this study aims to identify the road stretch that is highly suspected to the occurrence of the accidents, determine the causes of the accidents, identify the time of the day at which most of the accidents happened and provide countermeasures or remedial measures to address the issue.

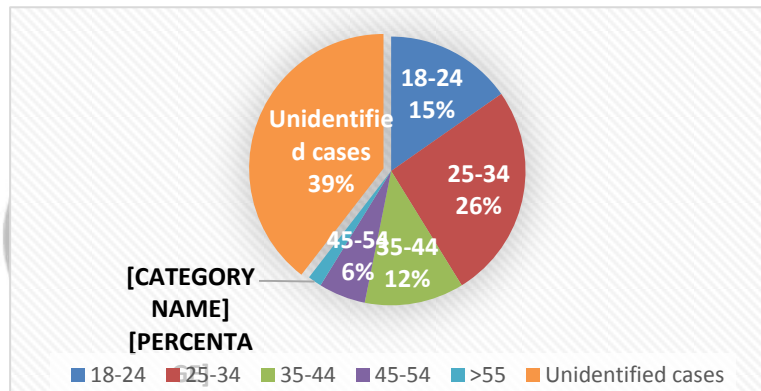
Figure 3.2 Drivers age range vs. Type of accidents

Figure 3.2 shows the age range of the driver’s together with the accident type. Most of the accidents which comprised of 39.53% under the unidentified category by the police officer. Next, it was drivers age ranges from 25-34 years of age, causing the 2nd highest percentage of accidents on the road from Ambo to Addis Ababa. This reveals that younger age group was suspected as the highest cause of accidents which must be given special attention.

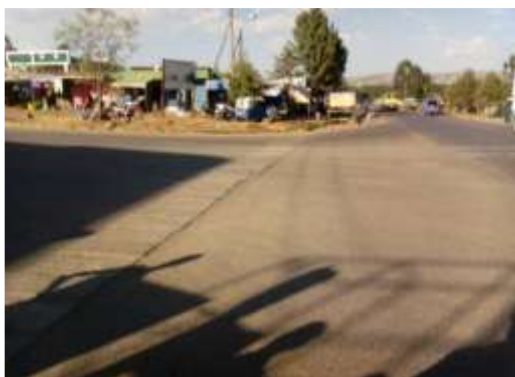
Figure 3.4 Gabriel Existing Road Condition

This location is found around Ethiopian road authorities size and weight control station. Its location is in town section. The countermeasure that should be applied on this road is: - Edge side and Central traffic marking should be painted. Also, Island should be provided in the intersection area. The sufficient pedestrian walking lane should be provided and also speed limit post should be installed.

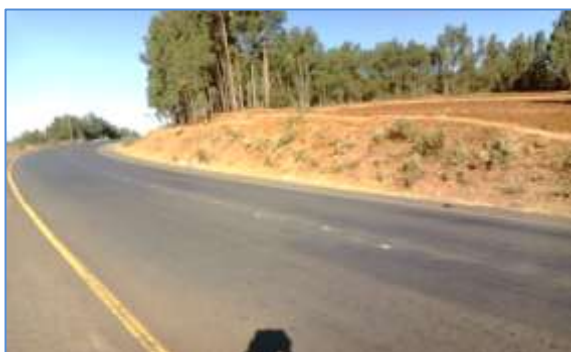
Figure 3.6 Menagesha Existing Road Condition

There are two sites identified as traffic accident-prone areas or hazardous inside Menagesha town, one at approximately 22km and the other at 20km from Addis Ababa respectively. The most stretch of the road configuration of Menagesha is covered with more than 13 horizontal curves and in connection with this; this road is a very congested type of road while viewing the traffic characteristics.

The countermeasures that should be applied are: a) Pedestrian walking lane should be provided; b) The length between the curves is so small that it needs design revision, c) The centerline marking should be re-painted, d) Speed limit post should be installed, e) There are obstructions inside the curve, so that blockage should be cleared.

The countermeasures that should be undertaken: a) the lane width is not sufficient, so that it should be widened, b) There are Equilaptus trees surrounding the curve that obstructs the vision of the drivers, so that it should be cleared, c) There is a steep gradient along the road stretch so that speed limit posts should be installed along the road, d) There is already existing concrete roadside Delineator but it was damaged by accidents, therefore, repair should be done.

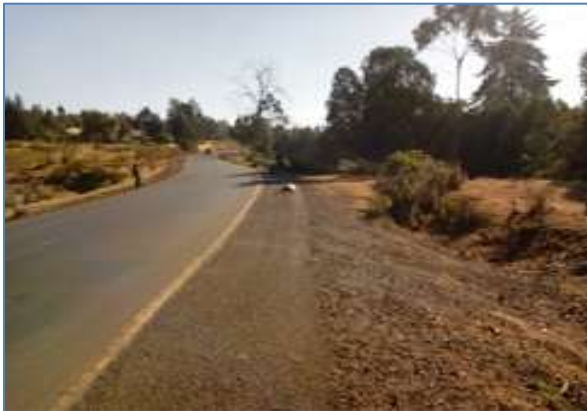
Figure 3.12 Chiri existing condition

Obstruction near the curve should be removed (trees are around). Speed limit posts should be installed. Since the shoulder width is not sufficient should be increased. Road side Delineator should be installed along the road.
