INVESTIGATION OF TRAFFIC ACCIDENT PRONE AREAS RELATED TO EXISTING ROAD CONDITION AND DRIVER'S BEHAVIOR ALONG MENAGESHA- AMBO ROAD SECTION

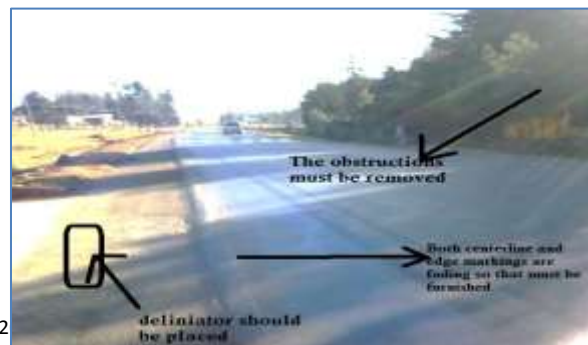
Figure 3.7 Menagesha after countermeasure applied.

The countermeasures that should be applied are: a) Pedestrian walking lane should be provided; b) The length between the curves is so small that it needs design revision, c) The centerline marking should be re-painted, d) Speed limit post should be installed, e) There are obstructions inside the curve, so that blockage should be cleared.

The countermeasures that should be undertaken: a) the lane width is not sufficient, so that it should be widened, b) There are Equilaptus trees surrounding the curve that obstructs the vision of the drivers, so that it should be cleared, c) There is a steep gradient along the road stretch so that speed limit posts should be installed along the road, d) There is already existing concrete roadside Delineator but it was damaged by accidents, therefore, repair should be done.

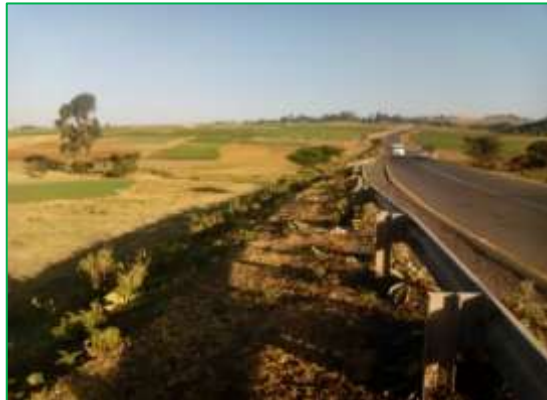
Fig 3.8 Wacan Mazoriya Existing Road Condition

The countermeasures that should be undertaken are: a) Roadway width should be increased, b) proper guardrail should be installed, c) Climbing lane should be provided to assist the faster moving vehicles to pass, d) There is steep gradient, so that speed limit posts should be installed, e) Pavement marking is faded, so that it should be re-painted, f) There is the problem of Mis-phasing so that, the design should be reviewed.

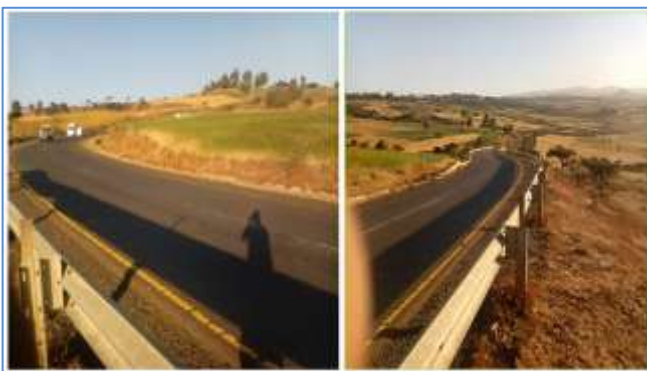
Figure 3.10 Miniinii Existing Road Condition

The obstruction inside the curve, which obstructing the driver's vision must be removed. The existing guard rail is not functioning and sufficient along with the left side so that it should be re-installed, and Traffic signs are needed inside the curve.
