GSJ: Volume 8, Issue 1, January 2020, Online: ISSN 2320-9186

**INVESTIGATION OF THE EFFECTS OF LEACHATE FROM SOLID WASTE DUMPSITE ON  
GROUNDWATER USING ELECTRICAL RESISTIVITY METHOD.**

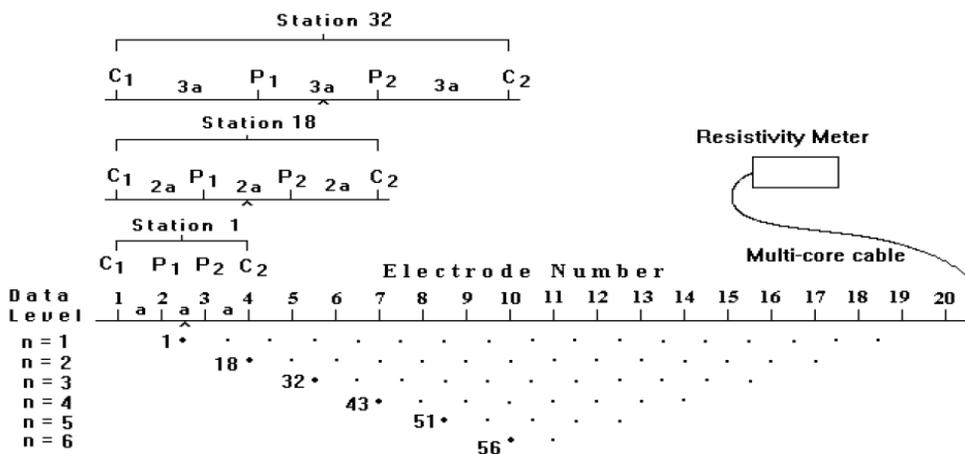
Fig. 5 Sequence of measurements to build up a Pseudo-section (Loke, 1999).

A total of ten (10) electrical resistivity imaging traverses were measured using 42 electrodes, sets of cable jumpers, hammers and four (4) sets of electrical cables each of 50m length. Wenner Alpha electrode configuration was used to carry out the study with the aid of ABEM SAS1000 Terrameter. During the measurement of the apparent resistivity, the electrical cables were laid along the designed profile and they were then linked to the ground using the electrodes through the sets of cable jumpers. The contact between the electrode cables, electrode take-outs and cable jumpers were checked for proper connections. The electrode test was performed to ensure that current was flowing through all the electrodes. Measurements were made automatically by the Terrameter system and stored with the help of special electrode selection called protocols. This protocol makes series of electrode combinations between the current and the potential electrodes. Files were saved in the Terrameter in binary formats with the file extension\*.s4k. Resistivity measurements for the 2D resistivity profiles were acquired as shown in figure 5.

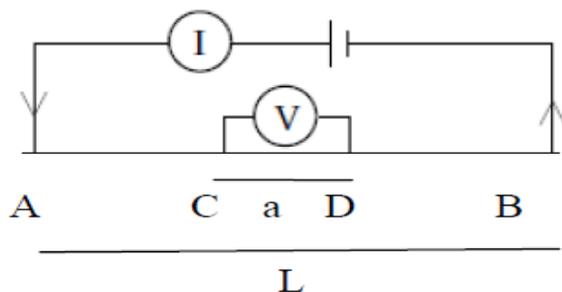
Fig.6 Schlumberger Configuration(Telford, 1990).

The current and potential pair of electrodes often has a common mid-point, but the distances between adjacent electrodes differ. Let the separations of the current and potential electrode be  $L$  and  $a$ , respectively.

$$\text{Then } r_{AC} = r_{DB} = \left(\frac{L-a}{2}\right) \text{ and } r_{AD} = r_{CB} = \left(\frac{L+a}{2}\right).$$

$$\begin{aligned} \rho &= 2\pi \frac{V}{I} \left[ \left( \frac{2}{L-a} - \frac{2}{L+a} \right) - \left( \frac{2}{L+a} - \frac{2}{L-a} \right) \right]^{-1} \\ &= \frac{\pi V}{4I} \left( \frac{L^2 - a^2}{a} \right) \quad (1) \end{aligned}$$

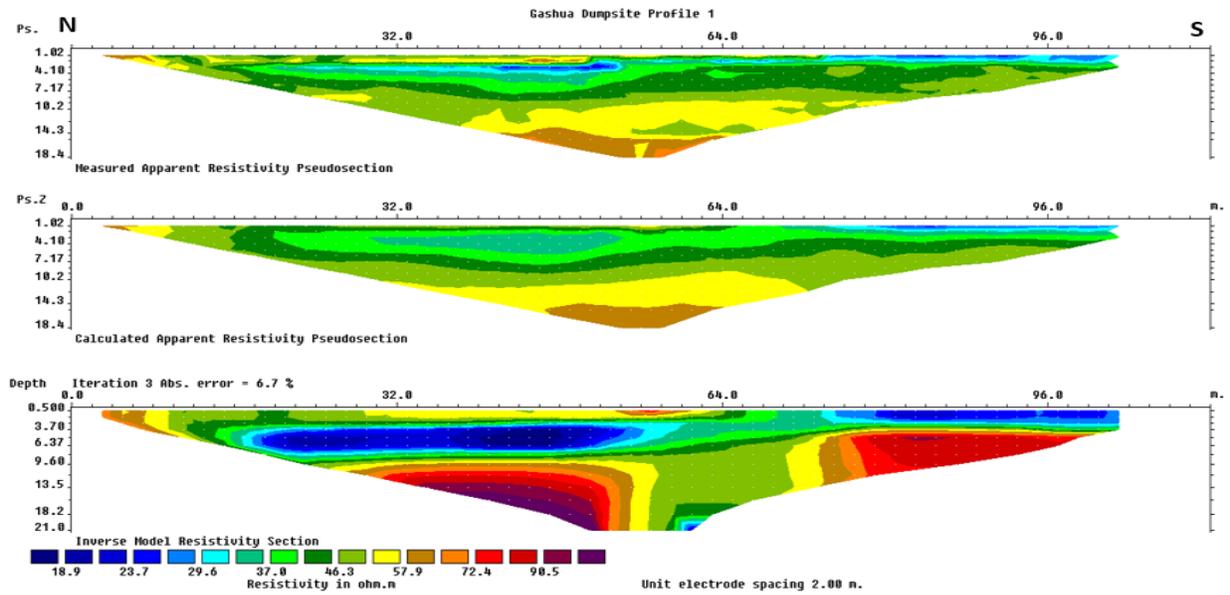
Fig.7 Inverted resistivity model for traverse 1 in the North-South direction of the study area.

Figure.7 shows traverse 1 with a length of 102m in in the North-South direction of the study area. The southern part of traverse 1 is located within the dumpsite and it is characterized by relatively low resistivity values ranging from 18.90Ωm to 29Ωm which manifest as a bowl shape structure within the topsoil. The contaminants migrated from the surface in the southern part to the northern part of the traverse. It manifested at depths ranging from 0.5m to 4.0m in the southern part of the traverse, and from 4.0m to 9.5m in the northern part of the traverse. It was observed to have seeped from the surface points to the depths exceeding 21m within the middle of the traverse.

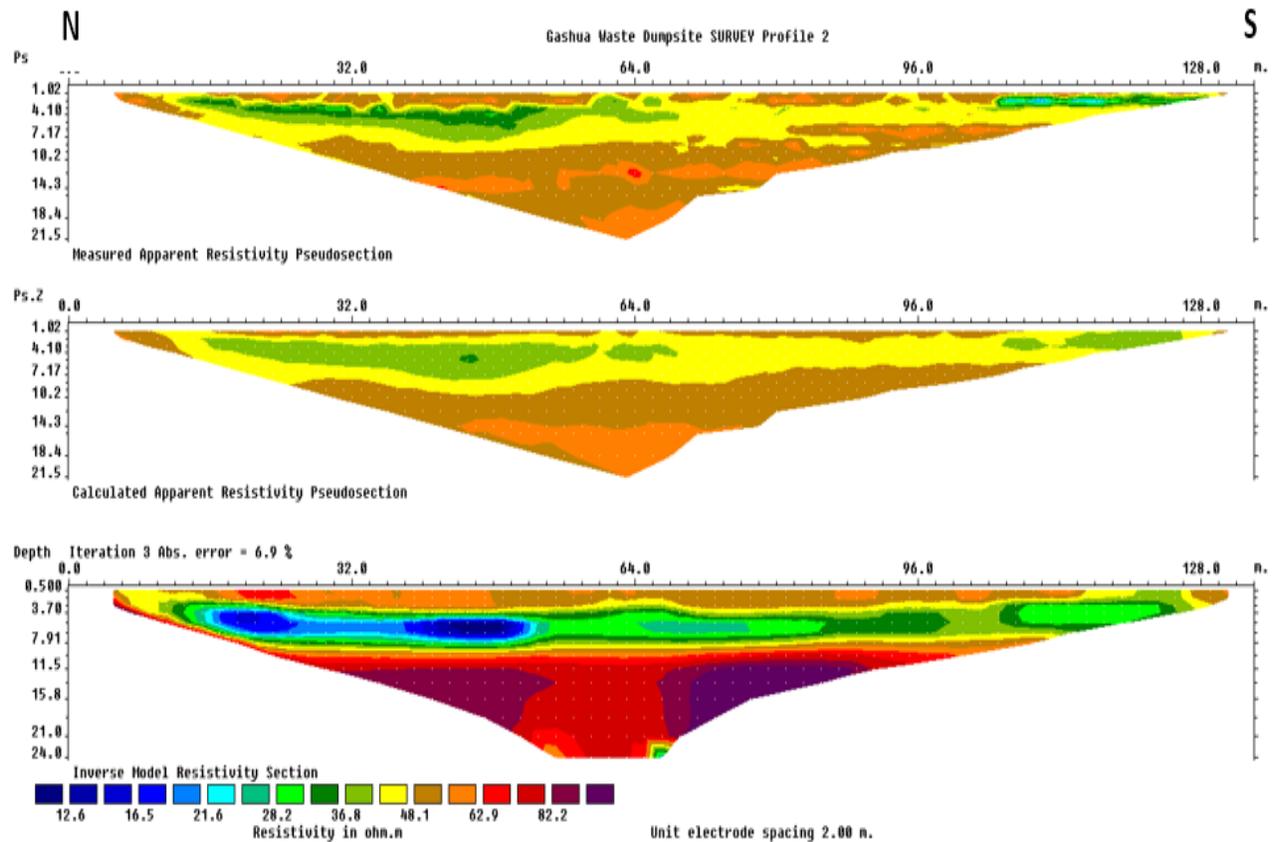
Fig. 9 Inverted resistivity model for traverse 2 in the North-South direction of the study area.

Figure 9 shows traverse 2 with a length of 128m in the North-South direction in the study area. Traverse 2 is located west of dumpsite 1, low resistivity zone was identified in the northern part of profile 2. The resistivity values ranged from 12.6Ωm to 20Ωm with a depth ranging from 3m to 9m and extend from 14m to 54m along the north-south direction.

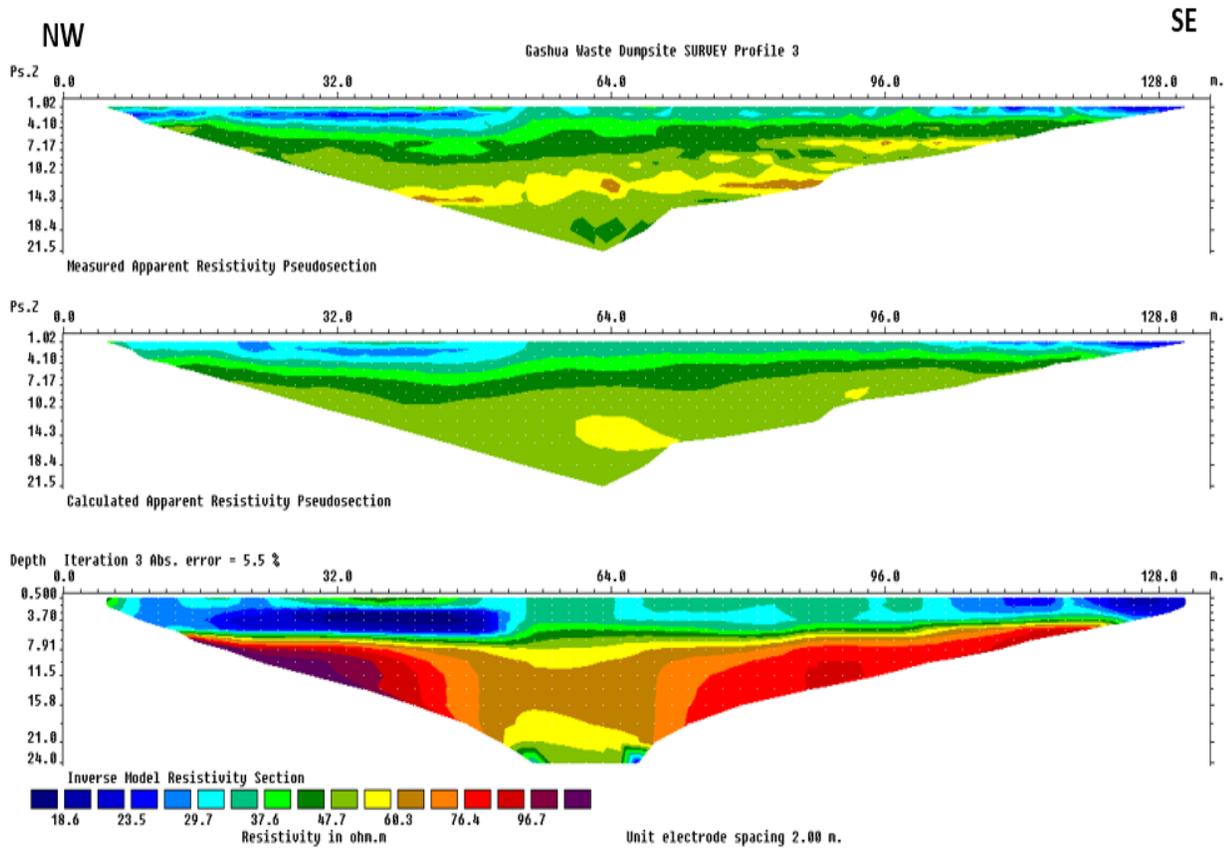
Fig. 10 Inverted resistivity model for traverse 3 in the Northwest-Southeast direction of the study area.

Figure 10 shows model section for traverse 3 comprising of low resistivity anomalies with resistivity values ranging from  $18.6\Omega\text{m}$  to  $24\Omega\text{m}$ , an indication of leachate at horizontal distance of 8 – 42m and 104 – 130m. The resistivity values throughout the traverse section were less than  $100\Omega\text{m}$ . The traverse has a length of 130m and trend northwest – southeast direction in the study area. The contaminant plume had seeped from the surface to a point beyond 24m deep. It might have impacted the groundwater in the study area.

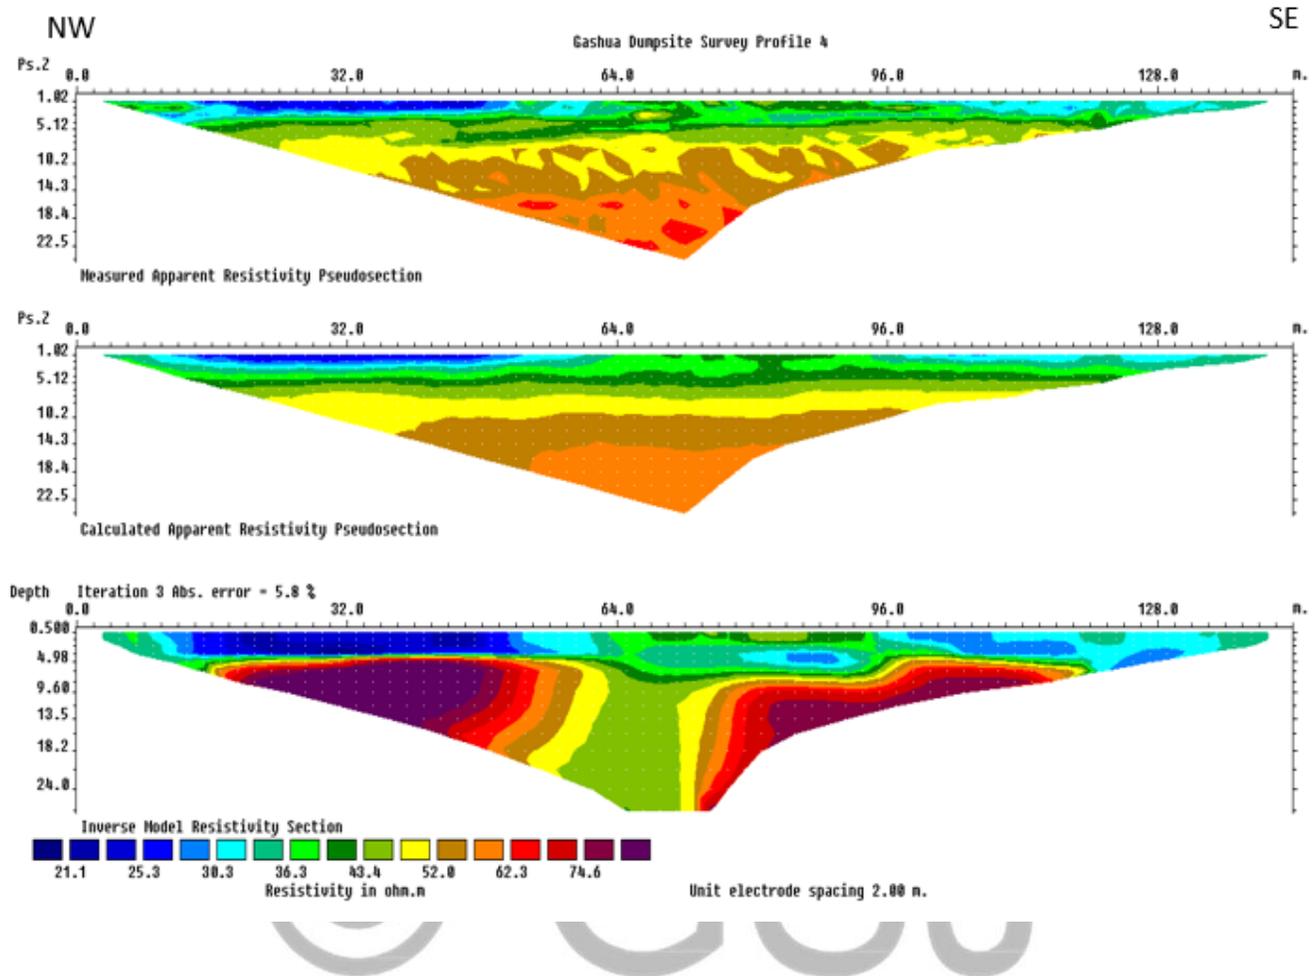
Fig.11 Inverted resistivity model for traverse 4 in the Northwest-Southeast direction of the study area.

Figure 11 shows traverse 4 with a length of 140m in a Northeast – Southwest direction to the study area. It was observed from the traverse that this part of the study area is made up of continuous horizontal spread of leachate plume from the ground surface to a depth of 10m deep. The leachate might likely seep deeper into the subsurface with time. The leachate migration in this area originates from the northwestern end of the traverse and extends to the southeastern part of the traverse. The leachate is characterized with resistivity values ranging from 20 - 25Ωm.

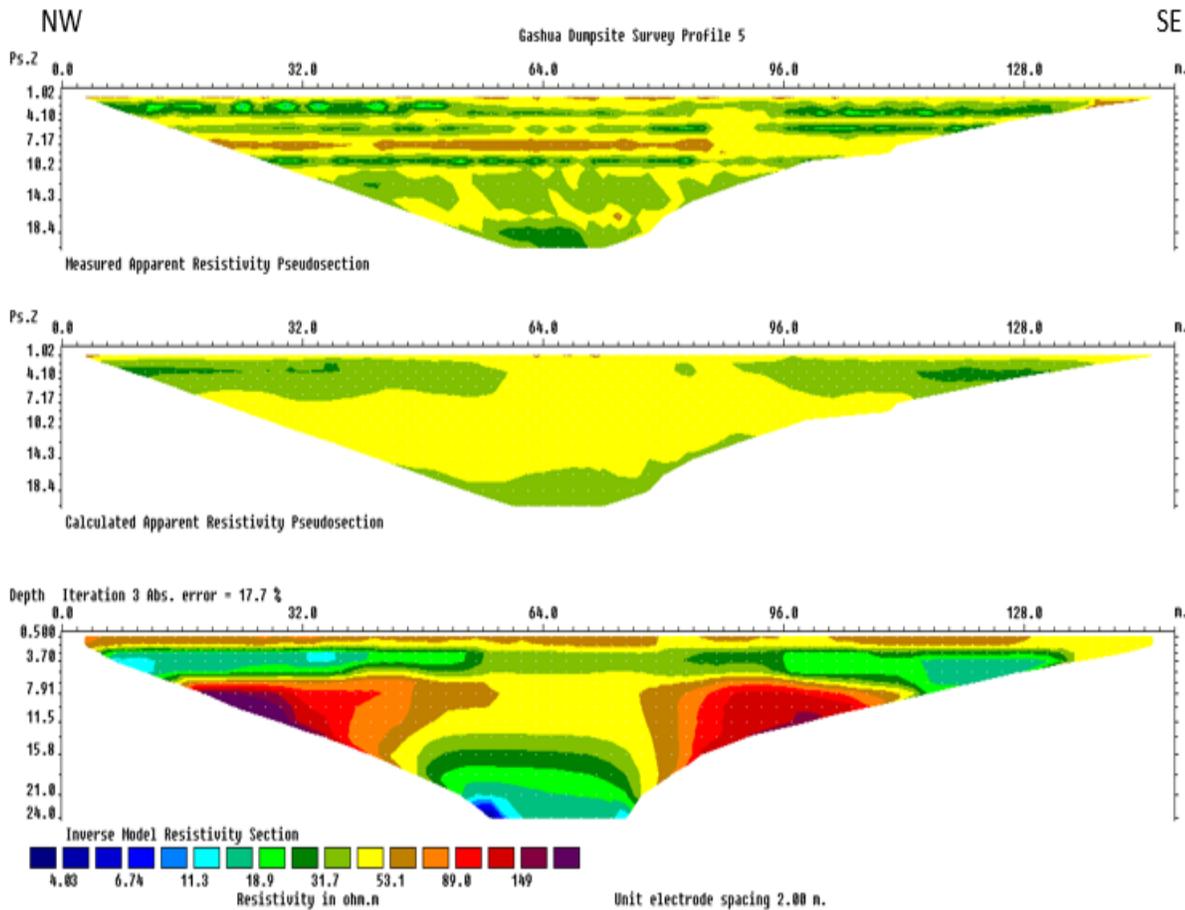
Fig. 12 Inverted resistivity model for traverse 5 in the Northwest-Southeast direction of the study area.

The inverse model section of traverse 5 is the control traverse which is shown in figure 12. The topsoil is characterized with moderately high resistivity values along the horizontal spread which is an indication of non-invasion of the area by contaminant plume. The sandy clay and sand formations below the topsoil were free of contamination. But at a depth beyond 22m in the subsurface within the middle of the traverse there is an isolated low resistivity anomaly whose value ranged from 4 - 11 $\Omega$ m. The presence of the anomaly indicates that the contaminant plume might have migrated from a distance dumpsite to the domain of traverse 5. The contaminant plume is suspected to have contaminated the groundwater in the area because of its deep location within the area.

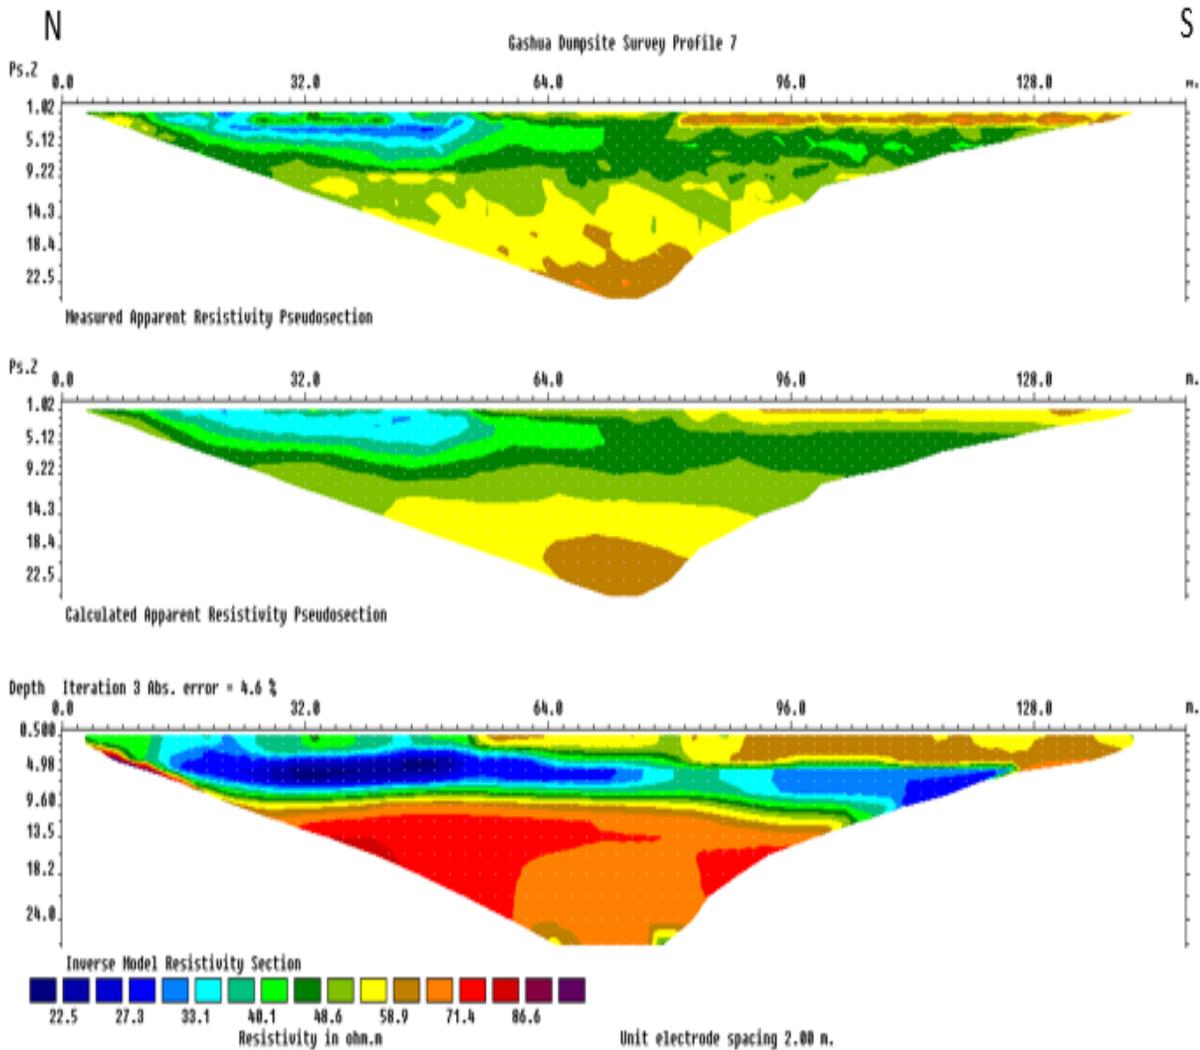
Fig.14 Inverted resistivity model for traverse 7 in the North -South direction of the study area.

The inverse model section of traverse 7 shows low resistivity values between 22 and 27Ωm in figure 14 above. The low resistive anomaly indicated in a deep blue colour is an evidence of leachate contaminant plume formation with nearly uniform horizontal and depth extent. The contaminant plume originates from the surface and migrate from the northern side of the traverse towards the southern part. The leachate plume migrated from the dump site and infiltrated the area to a depth greater than 10m below the dump. Below the leachate invaded area is a sandy clay formation which helped to impede the leachate migration. Under the sandy clay formation lies the sand formation with resistivity values ranging from 50 - 85Ωm. This formation is highly porous and could easily be invaded by the contaminant plume.

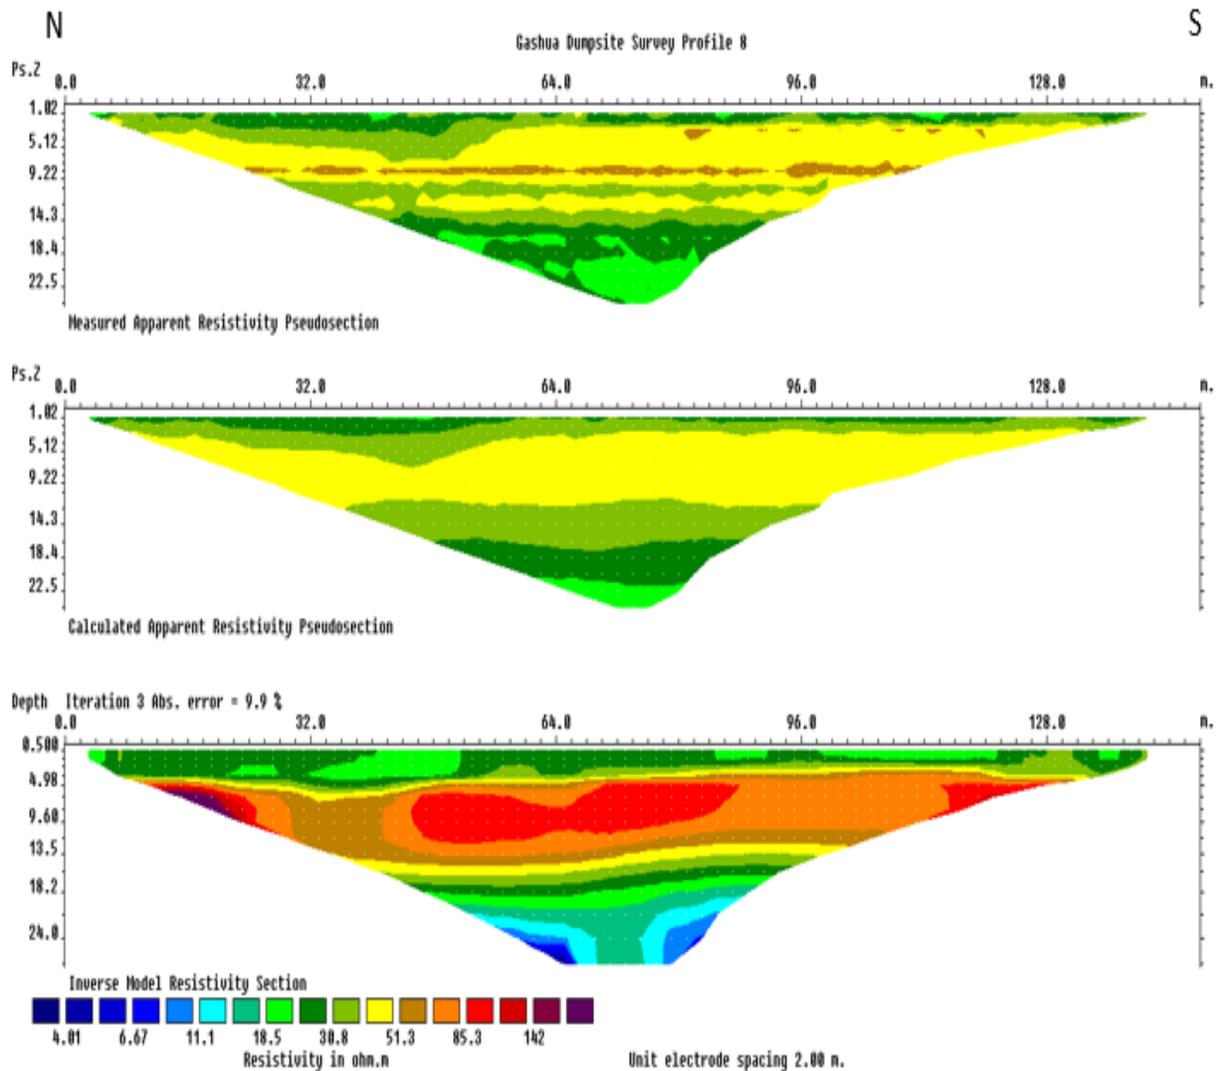
Fig. 15 Inverted resistivity model for traverse 8 in the North -South direction of the study area.

The inverted resistivity model for traverse 8 showed two resistivity anomalies in figure 15 above. The resistivity values of the anomalies ranged from  $4\Omega\text{m}$  to  $11\Omega\text{m}$  and the anomalies which are interpreted as leachate contaminant plumes manifested from a depth of 22m and went deeper into the subsurface. The contaminant plume migration to the deeper part of the subsurface is enhanced by the porous and permeable nature of the dominant sandy formations of the aquifer materials. This contaminant plume that occur deep in the subsurface in the study area might have polluted the groundwater.

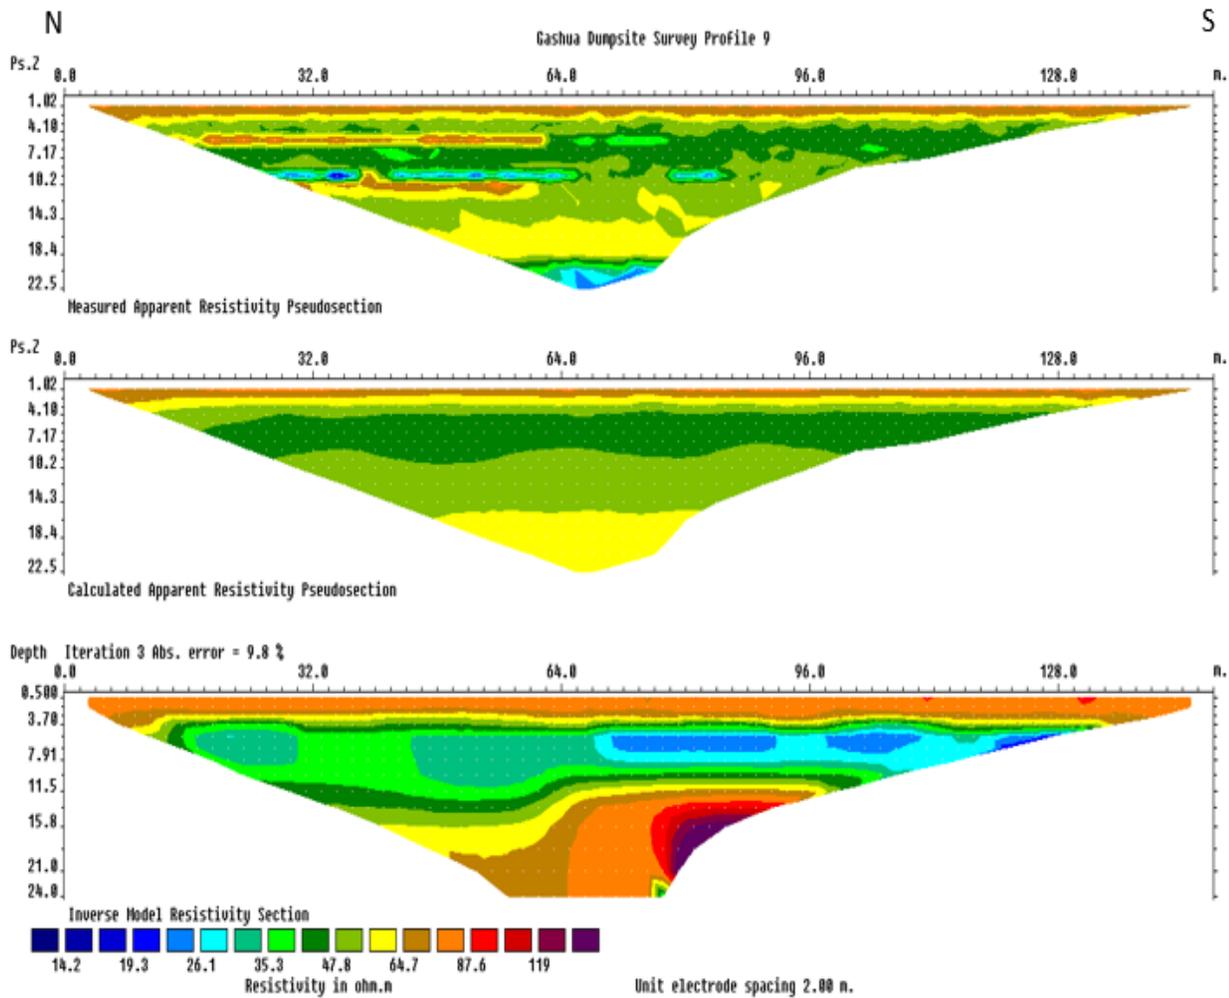
Fig. 16 Inverted resistivity model for traverse 9 in the North-South direction of the study area.

Figure 16 shows the model section for traverse 9 which has low resistivity anomalies with resistivity values ranging from  $14\Omega\text{m}$  to  $20\Omega\text{m}$ , the anomaly is an indication of leachate contaminant plume which occur at horizontal distance of 70 to 128m towards the southern direction in the study area. The contaminant plume manifested at a depth of 5m below the surface and extends to a depth of 10m deep. Following this plume is a sandy clay at depth of 10 to 13m with resistivity values ranging from 30 to  $50\Omega\text{m}$  indicated in green colour in figure 16. Beyond this zone is the sandy formation with resistivity values ranging from 60 to  $120\Omega\text{m}$  indicated in yellow, brown and purple colour in figure 16 above. The sandy formation is prone to groundwater contamination as the dumpsite ages.

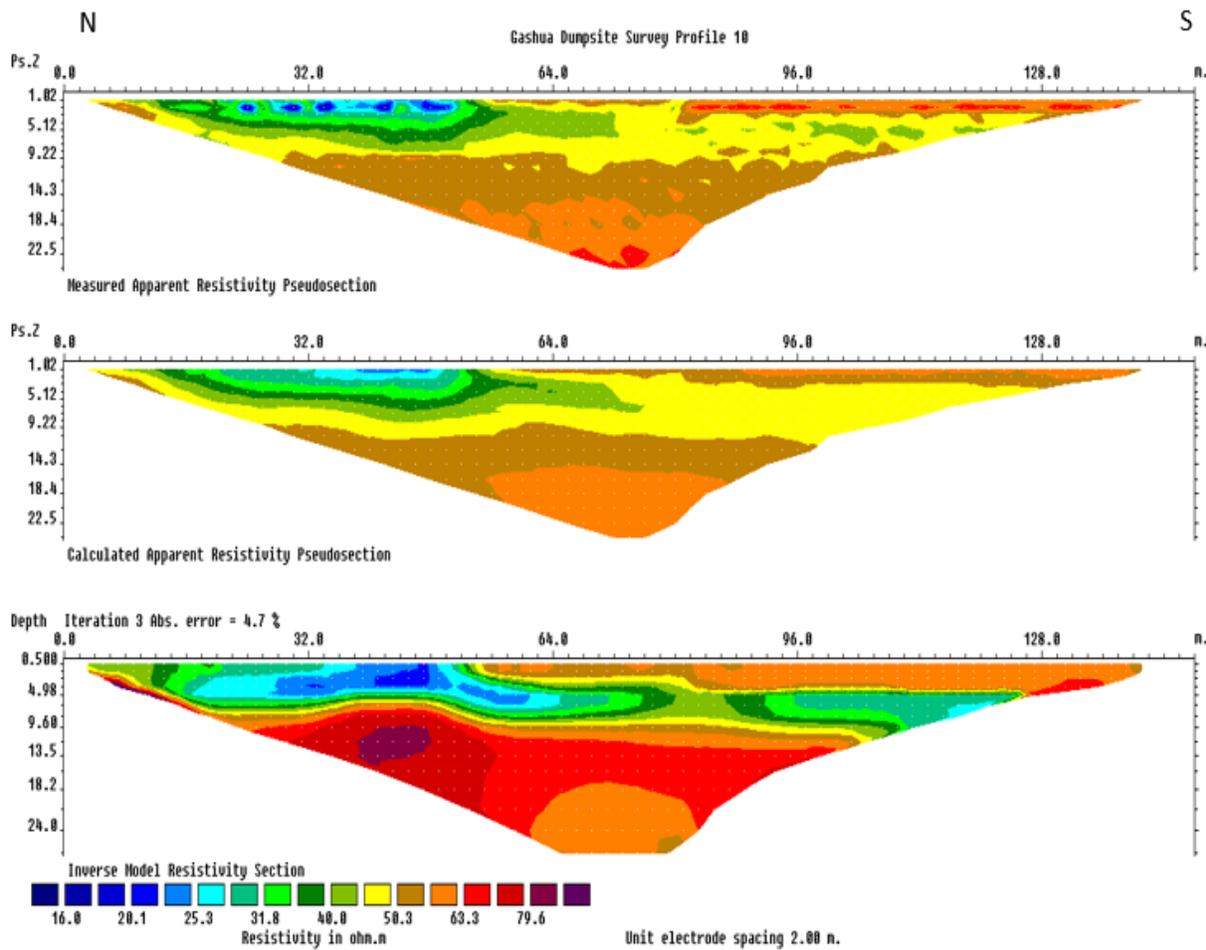
Fig.17 Inverted resistivity model for traverse 10 in the North-South direction of the study area.

The inverse section of profile 10 is shown in figure 17, the 2D section shows low resistivity anomaly towards the northern part of the traverse at position 34 – 52m and spread deep into the subsurface. The anomaly is characterized by resistivity values ranging from 16 to 22Ωm as shown in figure 17 in deep blue colour. The anomaly is a leachate contaminant plume which migrate from the surface to a depth of about 6.5m below the surface. It has not penetrated deeper into the subsurface, but as the dump ages with stead percolation of leachate into the subsurface, the contaminant plume will reach the groundwater zone and spread across the area.

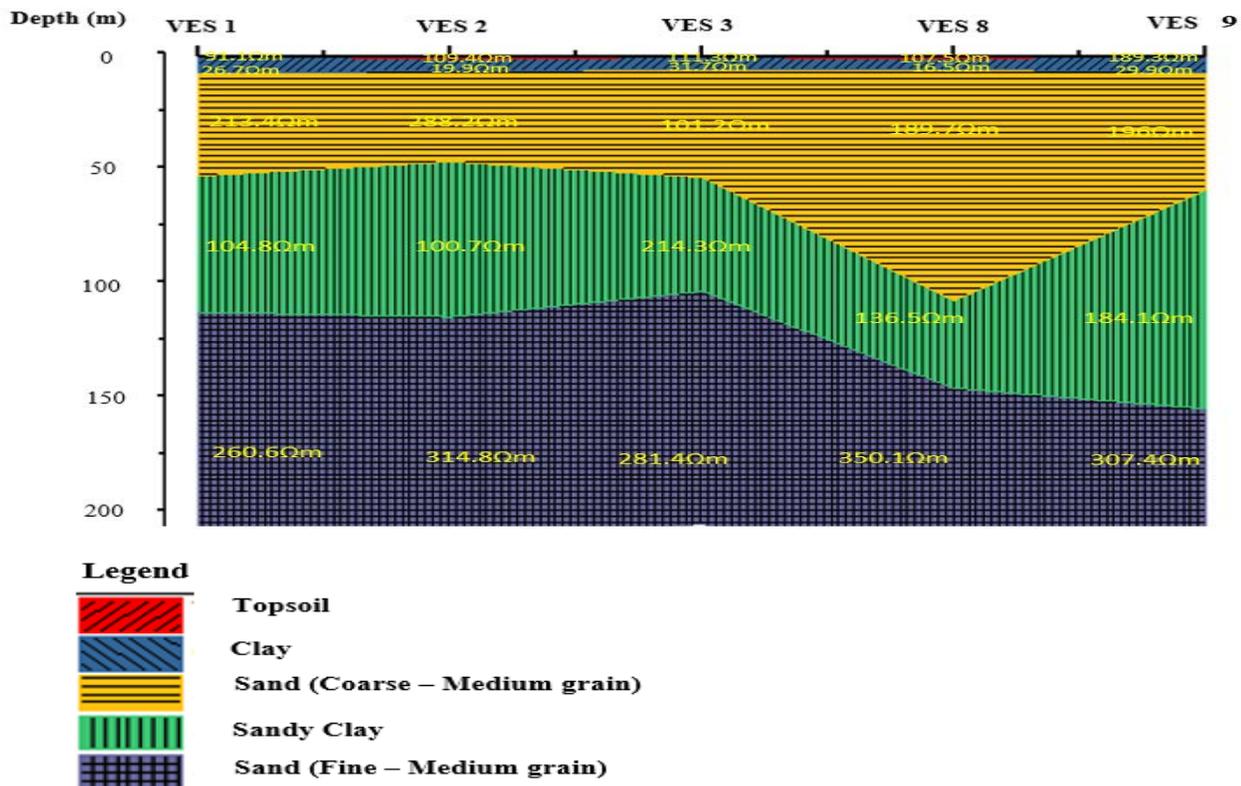
Fig. 18 Geo-electric section of VES 1, 2, 3, 8 and 9 in the Northeast-Southwest direction towards dumpsites 1 and 2.

Figures 18 and 19 show the Geoelectric sections for VES 1, 2, 3, 8, 9 and VES 4, 5, 6, 7 and 10 around the four solid waste dumpsites in the study area. To greater extent, the results show good correlation in terms of number of layers when compared with an existing borehole log (figure 20). The VES results are presented as the resist graph/VES curves (Appendix A). Several iterations were carried out to ensure low root mean square (RMS) and accuracy of the results. The results of the VES helped in characterizing the subsurface geology around the dumpsite (figures 18 and 19). The geologic layers delineated were characterized into five layers (table 1). These are; the topsoil, clay, sand, sandy-clay and sand. The topsoil has resistivity ranging from 42.7 to 199.7 $\Omega$ m and 0.6 to 1.9m thickness, the second layer is a clay formation which has resistivity ranging from 16.5 to 37.9 $\Omega$ m and thickness ranging from 4.1 to 10.7m. The second layer is characterized with low resistivity values suggesting the presence of clay mixed with non-degradable contaminant. This observation is consonance with the results of the ERT survey discussed earlier. The ERT results showed that the contaminant plume is most prominent within shallow depth in the study area. The clay content in the second layer is minimal and the thickness of the layer in all the VES points is generally small, thus providing little or no protection to the aquifer beneath them. The sand formation whose resistivity ranges from 101.2 to 288.2 $\Omega$ m is the third layer with thickness ranging from 38.9 to 99.7m. It is the first aquifer in the study area where all the hand dug wells and shallow boreholes were drilled. It is vulnerable to pollution by contaminant plume considering its shallow nature, porosity, permeability and dominance of sand formation in the study area. The third layer is unconfined and it is highly susceptible to pollution from leachates. The fourth layer is made up of sandy-clay which has resistivity values ranging from 100.7 to 214.3 $\Omega$ m with thickness ranging from 28.5 to 94m.

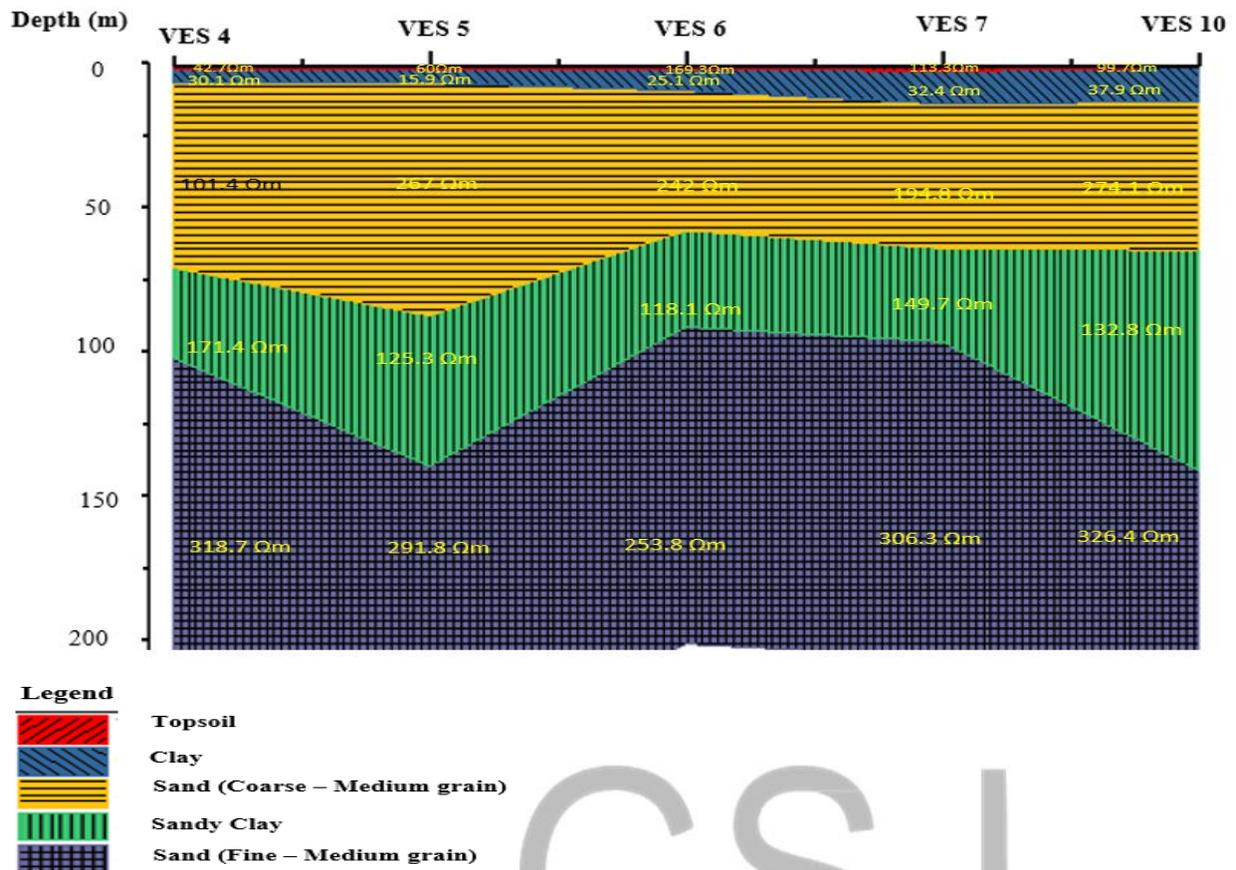
Fig.19 Geo-electric section of VES 4, 5, 6, 7 and 10 in the Northeast-Southwest direction towards dumpsites 3 and 4.

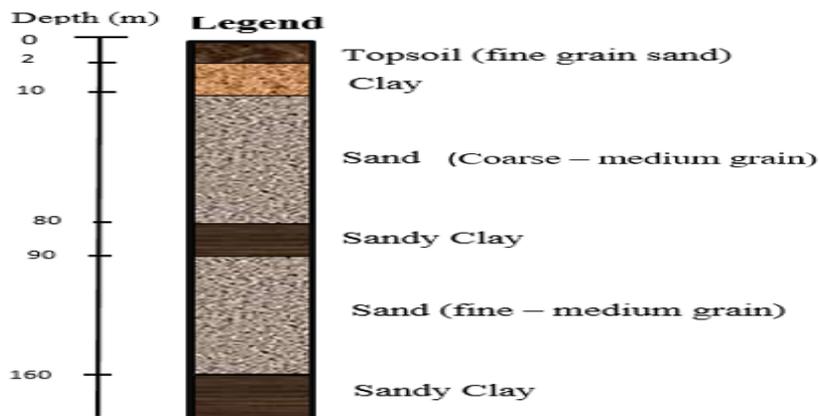
Fig. 20 Typical borehole log of Katuzo in Gashua (Modified from Ministry of Water resources Damaturu).

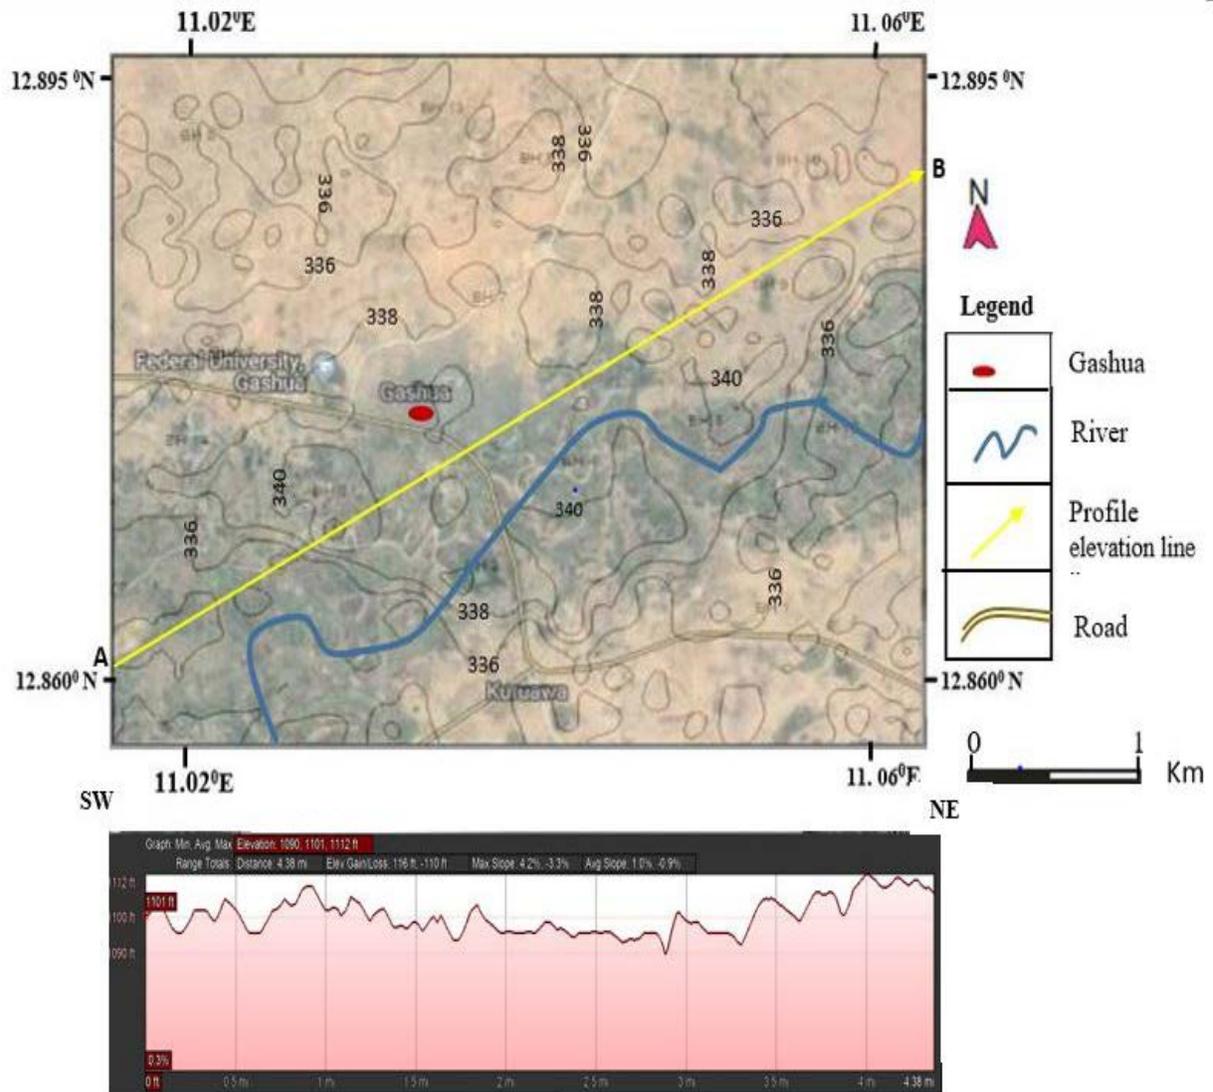
The contaminants flow direction was determine by obtaining the elevation profile section of the study area using the topographic map of the area. The elevation profile section shows that the contaminant plume flow from Southwest to the Northeast of the study area.

Fig. 21 Elevation contour map showing the direction of contaminant flow.

The contaminant flow in the study area is aided by the dominant sandy formation which constitute the first aquifer in the study area. Results of the electrical resistivity survey showed that the first aquifer is unconfined, therefore the contaminants easily seep into the groundwater.

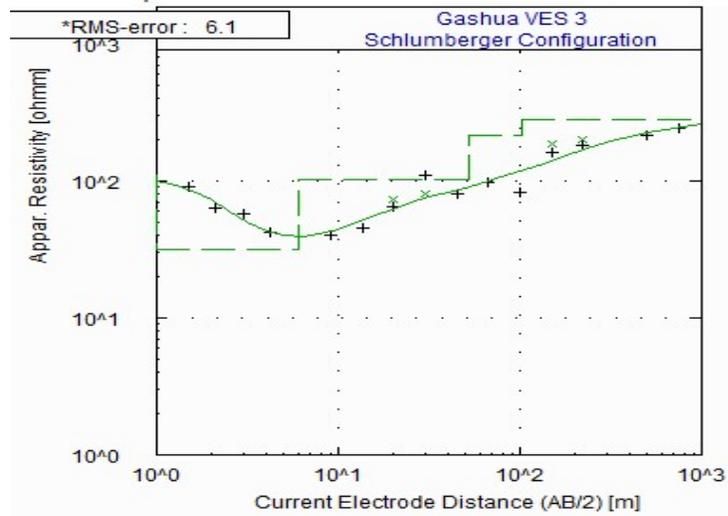
Resist Graph

No	Res	Thick	Depth
1	111.3	1.0	1.0
2	31.7	5.0	6.0
3	101.2	46.5	52.5
4	214.3	49.0	101.5
5	281.4	--	--

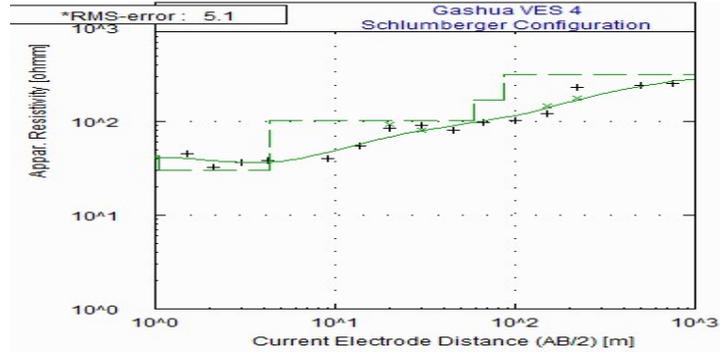
Resist Graph

No	Res	Thick	Depth
1	42.7	1.1	1.1
2	30.1	3.3	4.3
3	101.4	54.2	58.6
4	171.4	28.5	87.1
5	318.7	--	--

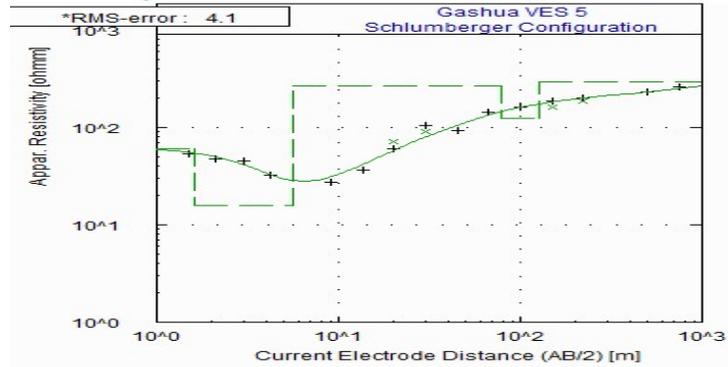
Resist Graph

No	Res	Thick	Depth
1	59.9	1.6	1.6
2	15.9	4.1	5.7
3	266.9	73.4	79.1
4	125.3	47.5	126.6
5	291.8	--	--

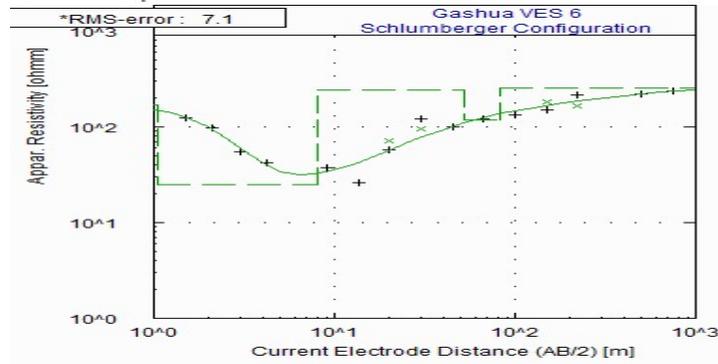
Resist Graph

No	Res	Thick	Depth
1	169.3	1.1	1.1
2	25.1	7.0	8.0
3	242.0	44.1	52.1
4	118.1	30.5	82.6
5	253.8	--	--

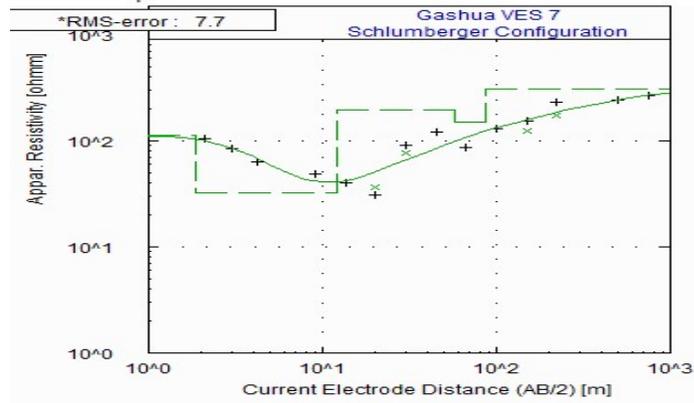
Resist Graph

No	Res	Thick	Depth
1	113.3	1.9	1.9
2	32.4	10.3	12.2
3	194.8	45.6	57.8
4	149.7	29.5	87.3
5	306.3	--	--

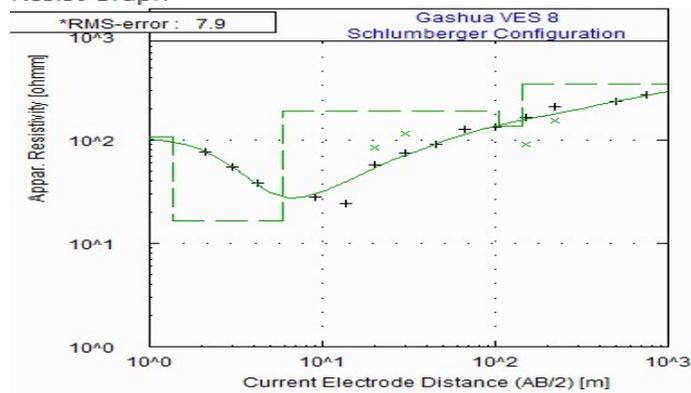
Resist Graph

No	Res	Thick	Depth
1	107.5	1.4	1.4
2	16.5	4.5	5.9
3	189.7	99.7	105.6
4	136.5	37.6	143.2
5	350.1	--	--

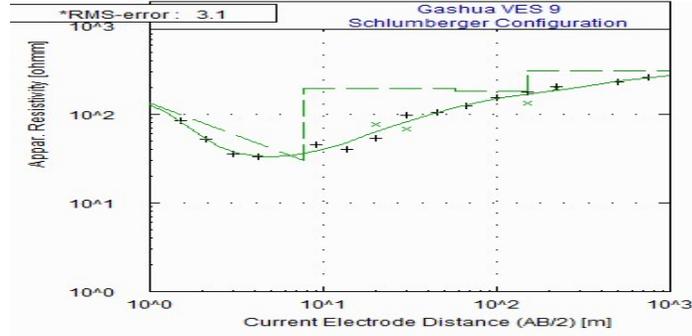
Resist Graph

No	Res	Thick	Depth
1	189.3	0.6	0.6
2	29.9	7.0	7.6
3	196.0	50.5	58.1
4	184.1	94.0	152.1
5	307.4	--	--

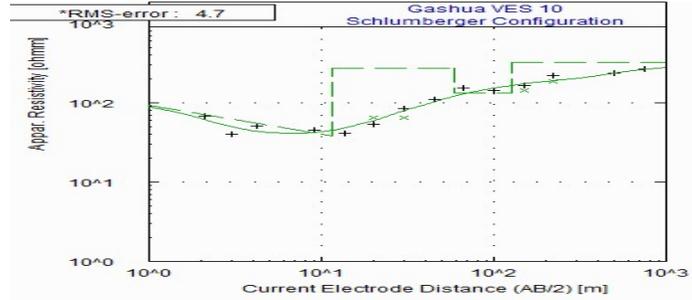
Resist Graph

No	Res	Thick	Depth
1	99.7	0.8	0.8
2	37.9	10.7	11.5
3	274.1	46.9	58.4
4	132.8	69.4	127.8
5	326.8	--	--
