**SLOPE DYNAMIC RESPONSE TO THE GROWTH OF SPONTANEOUS  
SETTLEMENTS ON THE BAMENDA ESCARPMENT ZONE,  
NORTH WEST REGION OF CAMEROON**

**EDWIN MUA KANG<sup>1</sup>, CORDELIA GIVENCHEH. KOMETA<sup>2</sup>, EUGENE NDZIFION ATEH<sup>3</sup>**  
**DEPARTMENT OF GEOGRAPHY AND PLANNING, THE UNIVERSITY OF BAMENDA<sup>1</sup>,**  
**DEPARTMENT OF TOPOGRAPHY AND REAL ESTATE MANAGEMENT, HTTTC,**  
**KUMBA, UNIVERSITY OF BUEA<sup>2</sup> & DEPARTMENT OF GEOGRAPHY**  
**AND PLANNING, THE UNIVERSITY OF BAMENDA<sup>3</sup>**  
[kangemua@gmail.com](mailto:kangemua@gmail.com)/[ckgiven@yahoo.com](mailto:ckgiven@yahoo.com)

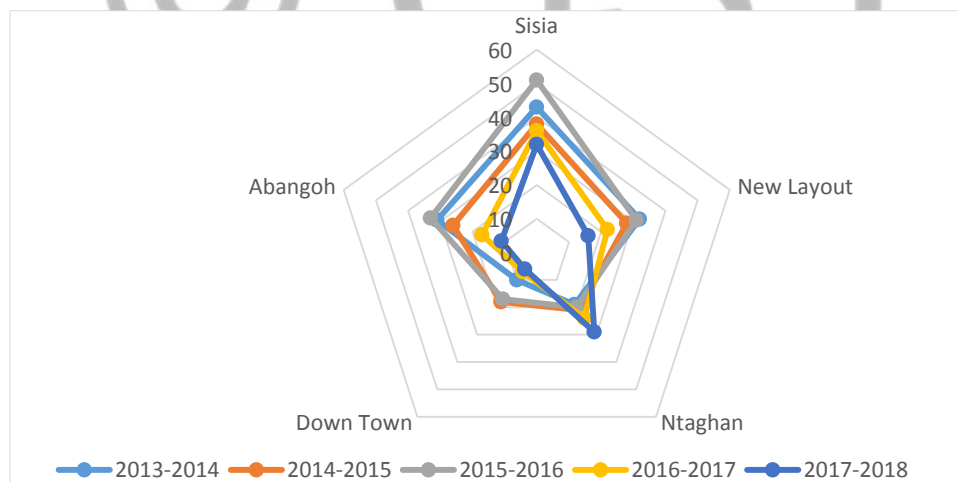
Figure 5: Yearly density of houses on the Bamenda escarpment  
 Source: Fieldwork, (2019)

The findings revealed that the degree of spatial expansion of settlements on the Bamenda escarpment show differential density. Sisia I, II, III and IV have, over the years, been a pressure zone for settlement construction. This is equally the case for the New Layout area that has witnessed a considerable housing sprawl effect. The average housing density on the Sisia steep slopes was estimated at 60houses/km<sup>2</sup> while at New Layout it was 40houses/km<sup>2</sup>. On the other hand, the south western slopes present a different

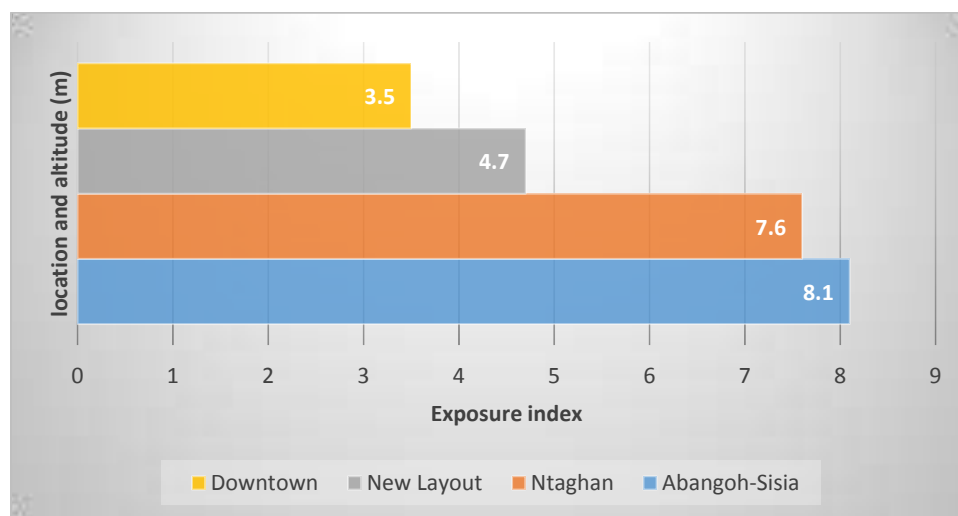
Figure 4: Altitudinal determinant of households' exposure to slope instability on the slopes of the Bamenda escarpment  
 Source: Fieldwork, (2019)

The results revealed a direct relationship between altitude and exposure of households to threats of slope failure. Households in high altitude areas above 2000m corresponding to Abangoh and Sisia are more exposed to slope dynamic impacts with exposure index of 8.1 (81%). At Ntaghan, the households present an exposure index of 7.6 (76%) while that of New Layout and Down Town areas at low elevations on the escarpment slopes show exposure index of 4.7 (47%) and 3.5 (35%) respectively. In a similar way, the more houses are being constructed on the steep slopes of the escarpment, the higher the degree of exposure. This explains why households at New Layout and Down Town Bamenda revealed a lower exposure index as these areas have over the years witnessed a reduced incidence of rock fall and landslides compared to Abangoh, Sisia and Ntaghan. The illegal encroachment and acquisition of land by city dwellers in the green zone in recent years has been criticized by poor planning and planning lapses to sustainably maintain slope stability.

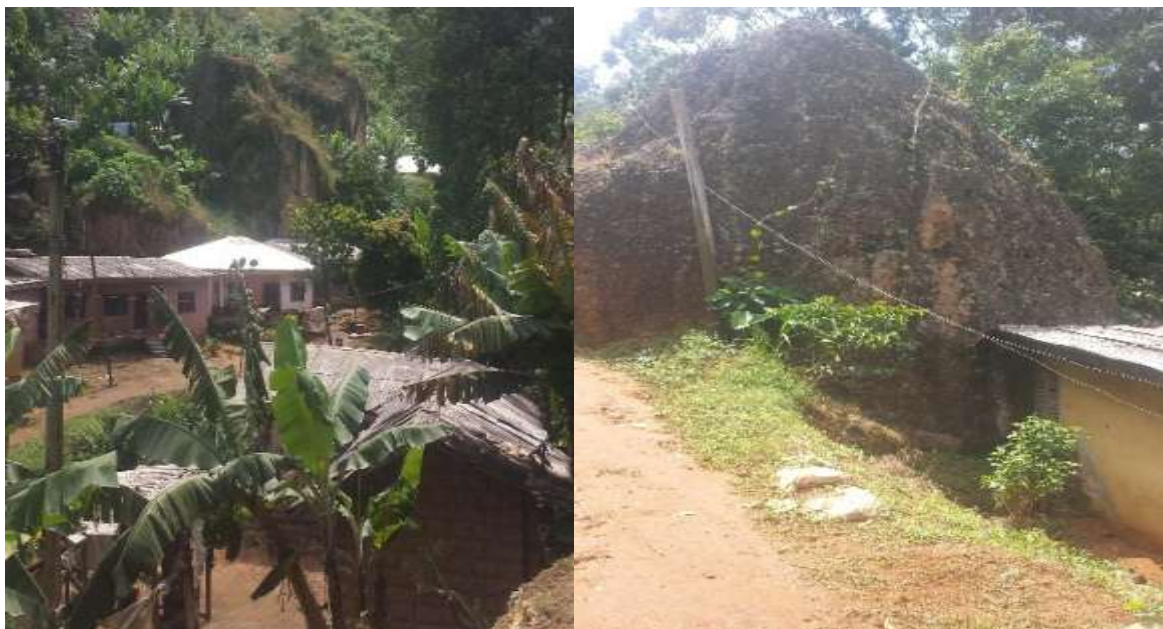
Fig 6a: Construction of houses around rock fall zone at Sisia III-Nkwen

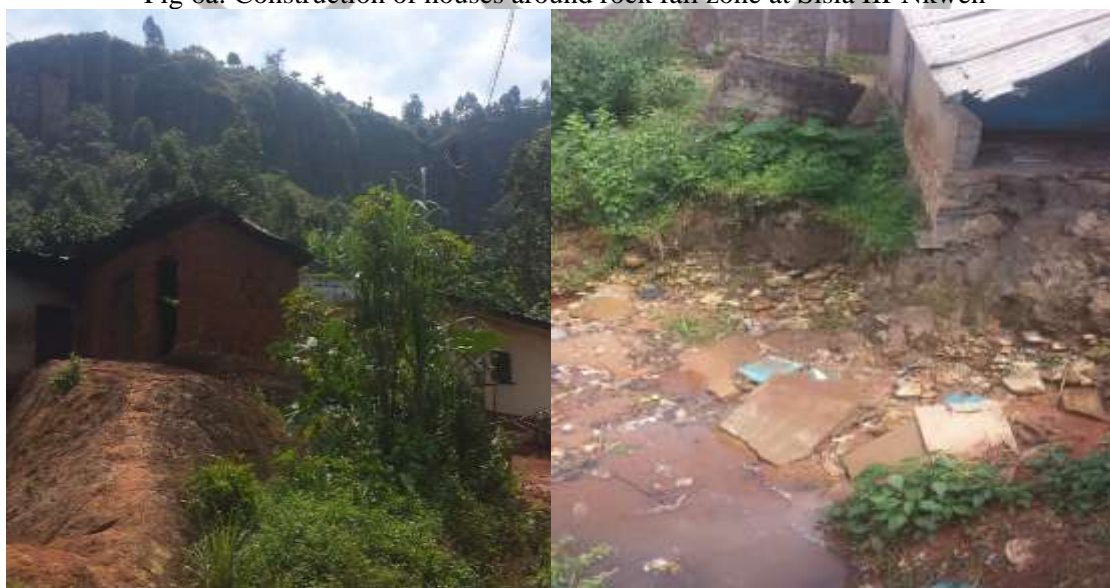
Fig 6b: Construction of houses on rocks and close to widening stream channel at Sisia
