THE MODERN CONSTRUCTION AT KONGO MOSQUE DIANI HERITAGE SITE, KWALE COUNTY: AN INITIAL SITE ASSESSMENT REPORT

Philip M. Wanyama
Coastal Archaeology, National Museums of Kenya
P.O Box 82412 GPO 80100, Mombasa
pwanyama@museums.or.ke
Url: www.museums.or.ke
30th of July 2020

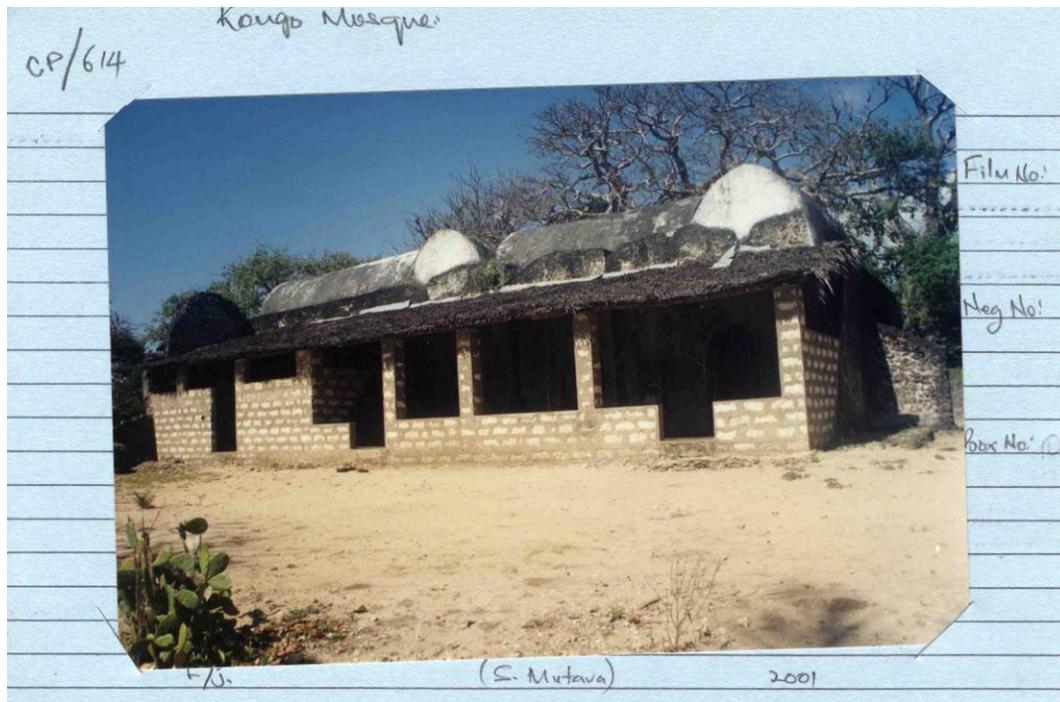
Figure 1a. Kongo Mosque national monument in 2001. Notice the unique dome shaped roof and assigns architectural heritage value. Phot by S. Mutava National Museums of Kenya.

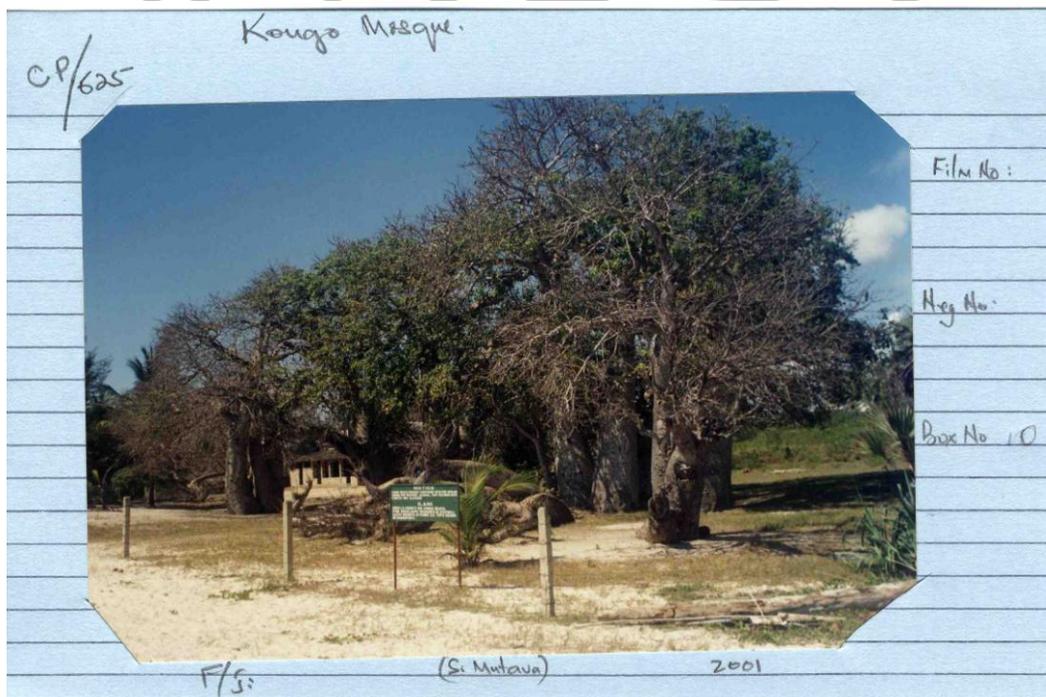
Figure 1b. Physical setting at Kongo Mosque Diani site observed from the beach in 2001. Photo by S. Mutava, National Museums of Kenya.

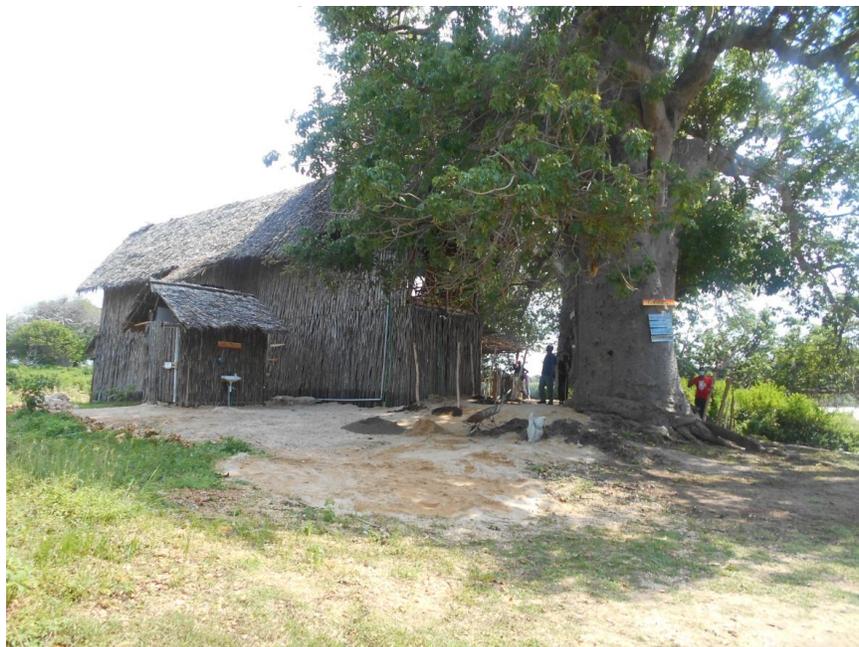
Our survey around the building found that the wooden structure was already constructed and final touches were being done, such as the erection of roof supports at the entrance. At the southern side of the building, the debris from the holes that were being dug a short distance from the baobab tree, for instance, had deposits of charcoal and ash inclusions. The toilet and the concrete septic tank were complete (see figure 2). From outside the concrete floor was visible meaning the site was dug and levelised before construction. (Our team did not manage to enter

Figure 3. The new second constructed structure at Kongo Mosque site, Diani, Kwale County. Notice the toilet behind which is located the concrete septic tank. The archaeological material deposit were seen in debris from the holes being dug for the front roof supports. Photo by George Ghandi, Coastal Archaeology.

Recommendation One: The National Museums of Kenya should formally write to instruct M/S Miriam Kanini and partners to stop any further activity at new construction including the launching of the Kite Training School pending full assessment study of negative impact to Kongo Mosque heritage property.

Recommendation Three: Coastal Archaeology Department (of National Museums of Kenya) to urgently develop the study proposal for heritage impact assessment. This study will assess and study negative impacts of new construction to Kongo Mosque heritage property, covering the construction, operation and decommissioning phases of the development. The study will provide mitigation measures including rescue archaeology work, which will support sustainable conservation of Kongo Mosque site. Outcomes of this HIA will inform NMK's decision regarding the new constructed structure at Kongo Mosque.

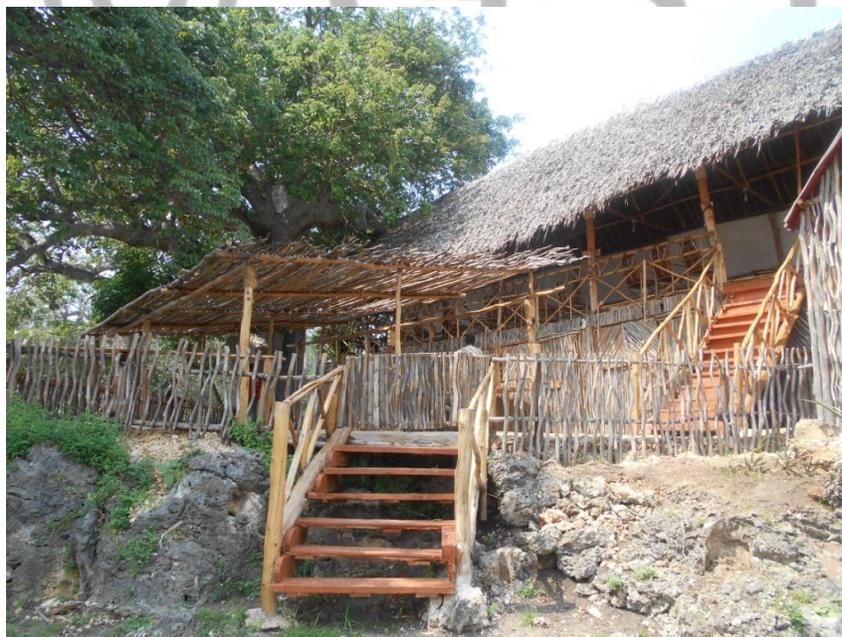
inside as the rooms were locked and the owner was not present). On the northern side of the building, there are wooden stair cases that lead into the open ground area under a roof, from the beach and above into terrace area that overlooks estuary and the ocean (for illustration see figures 3, 4 and 5 below). Shown in figure 6, is an extension in which an electric cooking facility is installed. Our informant told us that this facility would be used just once- during the launching ceremony of the training school, an explanation that was not convincing. Why would they invest in such an equipment for it to be used only once? The informant in our view tried as much he could to gloss over the essential details regarding the new development at Kongo Mosque. Figure 7 shows cultivated maize farm adjacent to the constructed structure, where the sporadic presence of archaeological material on the surface was noted. This suggests that constructed structure was set on a site with high archaeological potential. In our opinion, the structure appears like a restaurant that would attract huge foreign and local tourists and will pose significant negative impacts to the national heritage of Kongo Mosque.

Figure 4. The new second constructed structure at Kongo Mosque site. The ground close up view of the wooden stair case, ground sitting area and the balcony area above. Photo by George Ghandi, Coastal Archaeology.

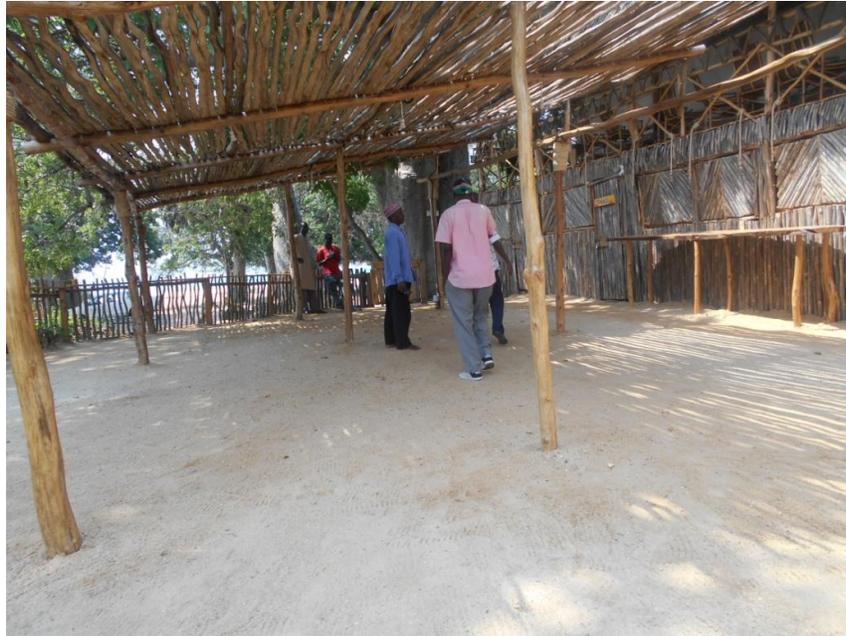
Figure 5. The new second constructed structure at Kongo Mosque site. Notice the spacious ground floor area facing the beach front. Photo by George Ghandi, Coastal Archaeology.

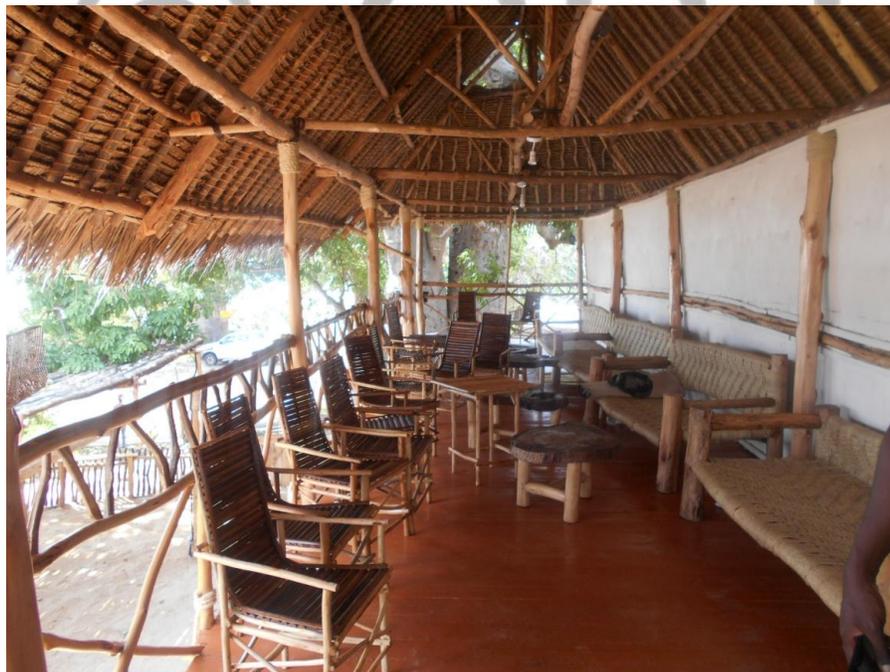
Figure 6. The new second constructed structure at Kongo Mosque site. Notice the terrace on the balcony, overlooking the beach. It is well furnished and fitted with furniture, suggesting the building is a restaurant rather than a training centre. Photo by George Ghandi, Coastal Archaeology.

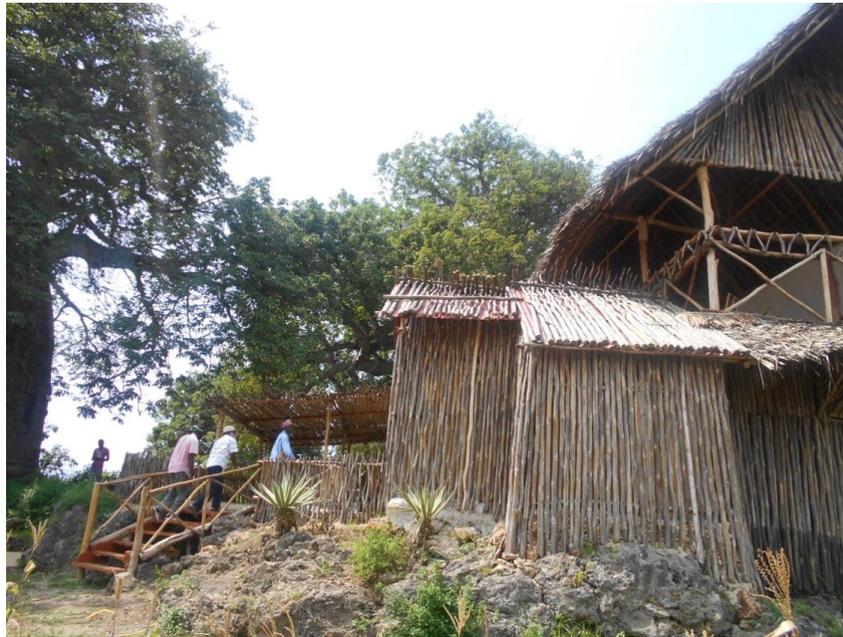
Figure 7. The new second constructed structure at Kongo Mosque site. Notice the wooden staircase that lead into the facility from the beach. Photo by George Ghandi, Coastal Archaeology.

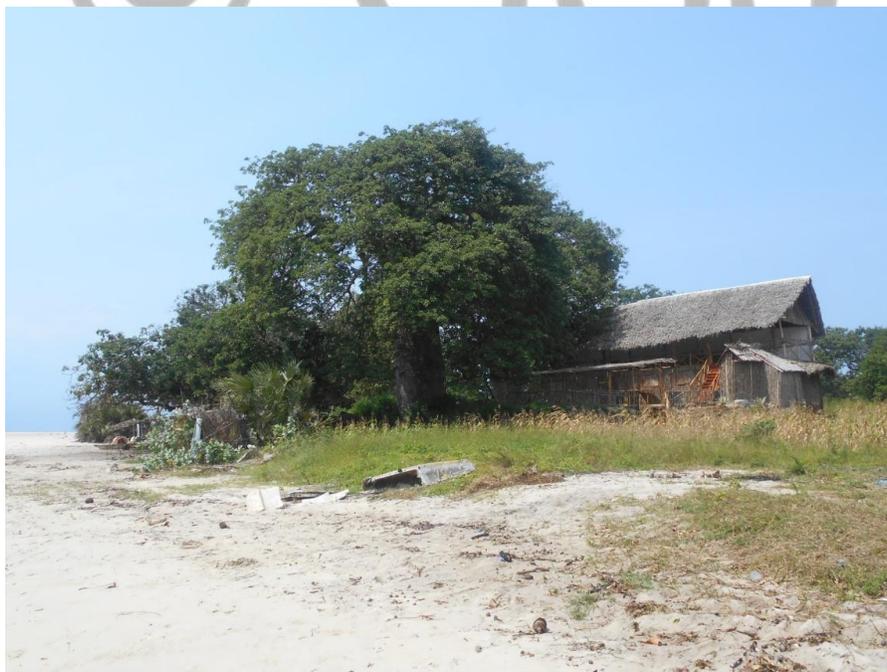
Figure 8. The new second constructed structure at Kongo Mosque, as observed from the south bank of River Mwachema/Kongo. Notice maize crop cultivated on protected heritage site.

Surface archaeological pottery sherds were observed around the constructed structure and in the maize field. Photo by George Ghandi, Coastal Archaeology.
