THE IMPACT OF SCARCITY OF BEIRA CITY SHORE PROTECTION

Jacinto Emília Laquene, Albano Sâlzon Maparagem, Vasco Munguare Penente

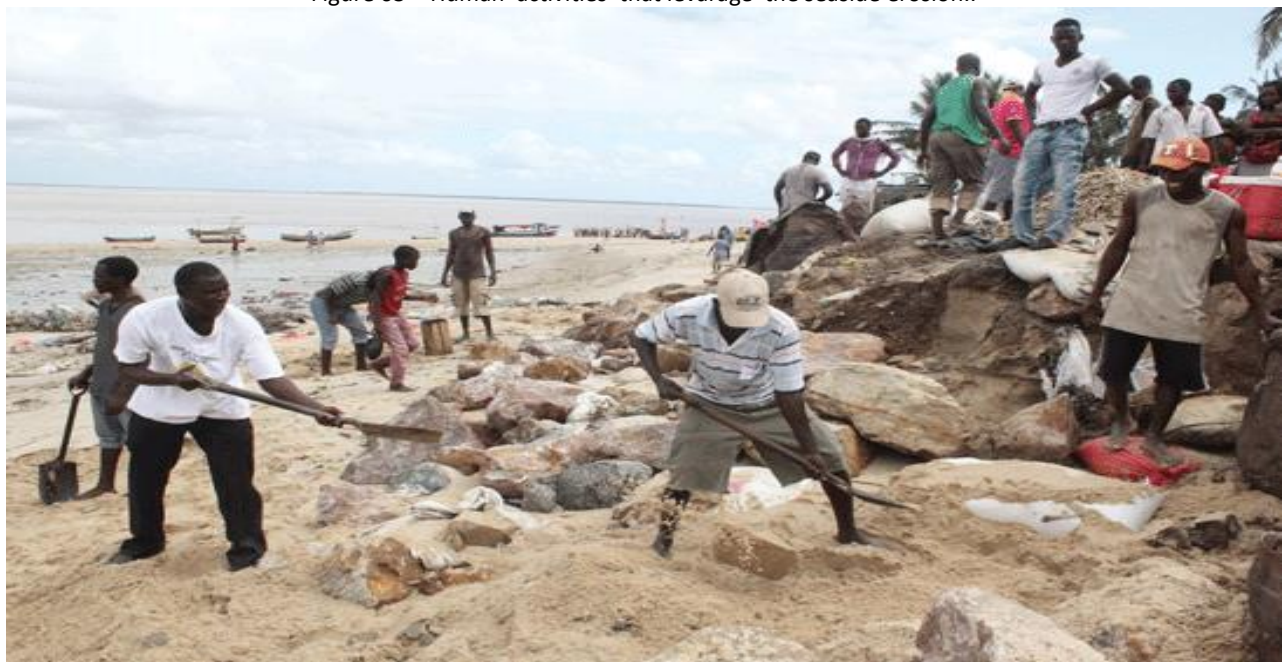
Figure 04 – Praia Nova's Population Placing bags with sand for shore safeguard.

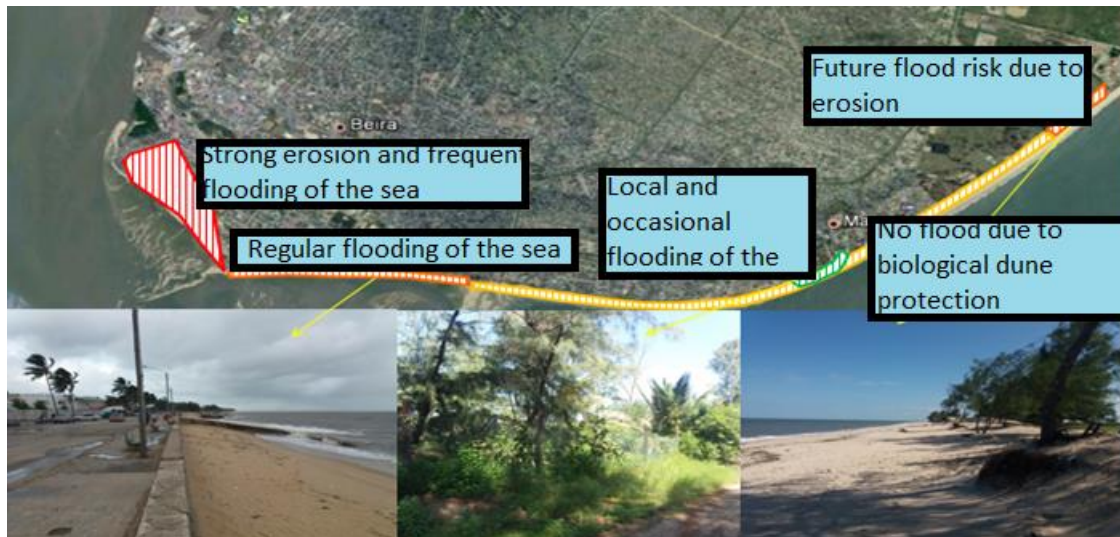
As the City of Beira is a deposition zone of the Pungue River, it presents itself with the entire coast as being at risk, however there are areas that suffer more impacts than others. The areas of Ponta Gêa and Chaimite, as you can see in Figure 06, are the ones that are most exposed to strong erosion and flooding from the sea, which are well below sea level which makes it always suffer the impacts when the climate changes. These are the areas that deserve more attention, along with the area of Praia nova. They show studies that are the areas that most reduced their coastline perimeter compared to the rest of the city of Beira. We also have a part of Ponta Gêa and all Chipangara that suffer a regular flooding of the sea, this due to its elevation in relation to the level of the sea. The Macuti area presents more local and occasional sea flooding, a scenario that has been observed more in the Clube Náutico and Praia dos Biques area.

Figure 06 - Levels of risk to coastal erosion.

The estoril zone is where there is no flooding of the sea due to the biological protection of dunes, which are physical units formed by sandy sediments that are transported by the action of the winds. In coastal areas, dunes, or so-called frontal or ante-dunes, often have the role of reducing wave energy, especially during the occurrence of undertow (Reis, 2001).

In this area, a greater risk of future flooding is expected due to the erosion that occurs on the coast, coupled with urbanization works that are taking place.

This will be the reality of several inland areas of the city of Beira, if the drainage of the chiveve that is currently benefiting from rehabilitation is not maintained by basic maintenance works, if the buildings along the ditches that block in large areas are not removed part of this maintenance activity and that urbanization be stopped in areas with natural water retention basins. Figure 06 shows the risk levels of different areas of Beira City, que bloqueiam em grande parte esta actividade de manutenção e que seja estancada a urbanização em zonas com bacias naturais de retenção de água. A figura 06 mostra os níveis de risco de diversas zonas da Cidade da Beira.

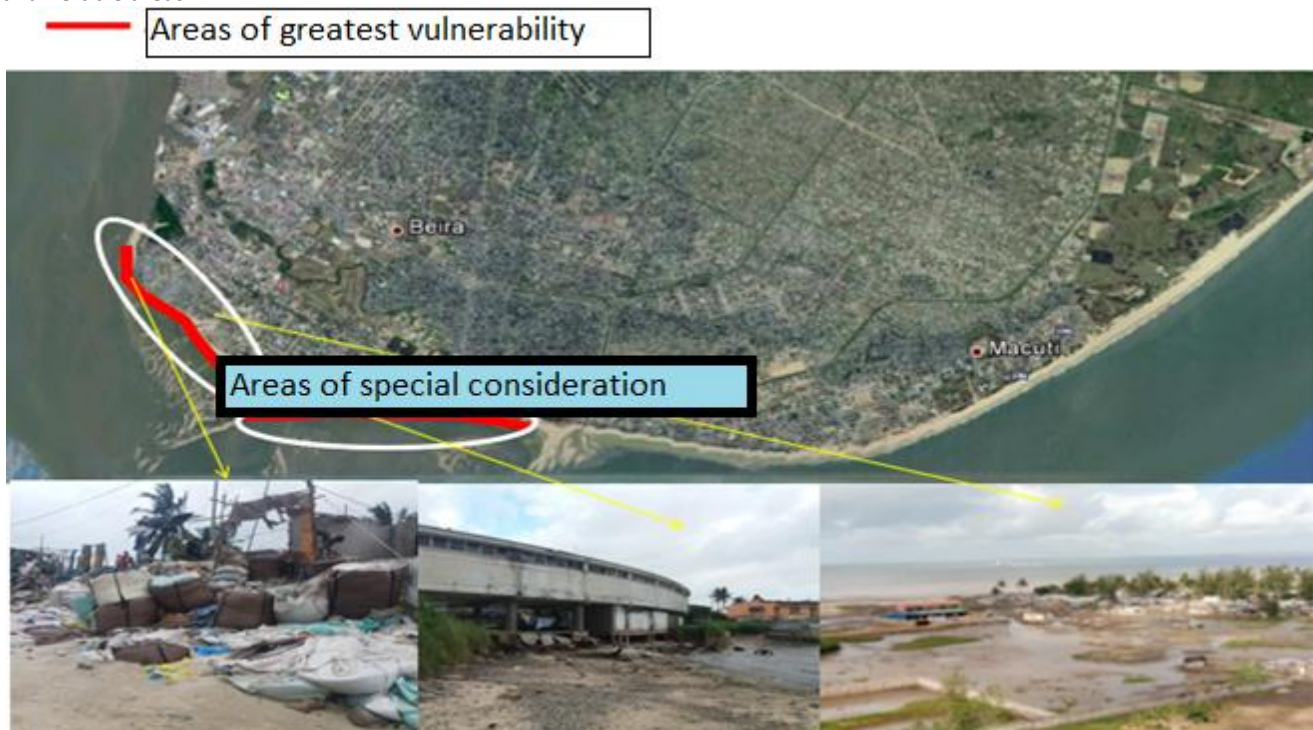
As Figure 07 illustrates, the most vulnerable areas are Chaimite and Ponta-Gêa (Praia nova, Palácio dos Casamentos, Mira-Mar). Note its greater degradation over time in these areas, and as mentioned above, most of the infrastructure at this time is already in the aquatic environment. These are the areas that deserve careful attention by the authorities, as well as anyone interested in analyzing the impacts on the coast, this due to their level of degradation, as well as the lack of placement of resistant protection infrastructures. Figure 07 illustrates the most vulnerable areas.

Figure 07 - Areas of Beira City with greater vulnerability to coastal erosion.

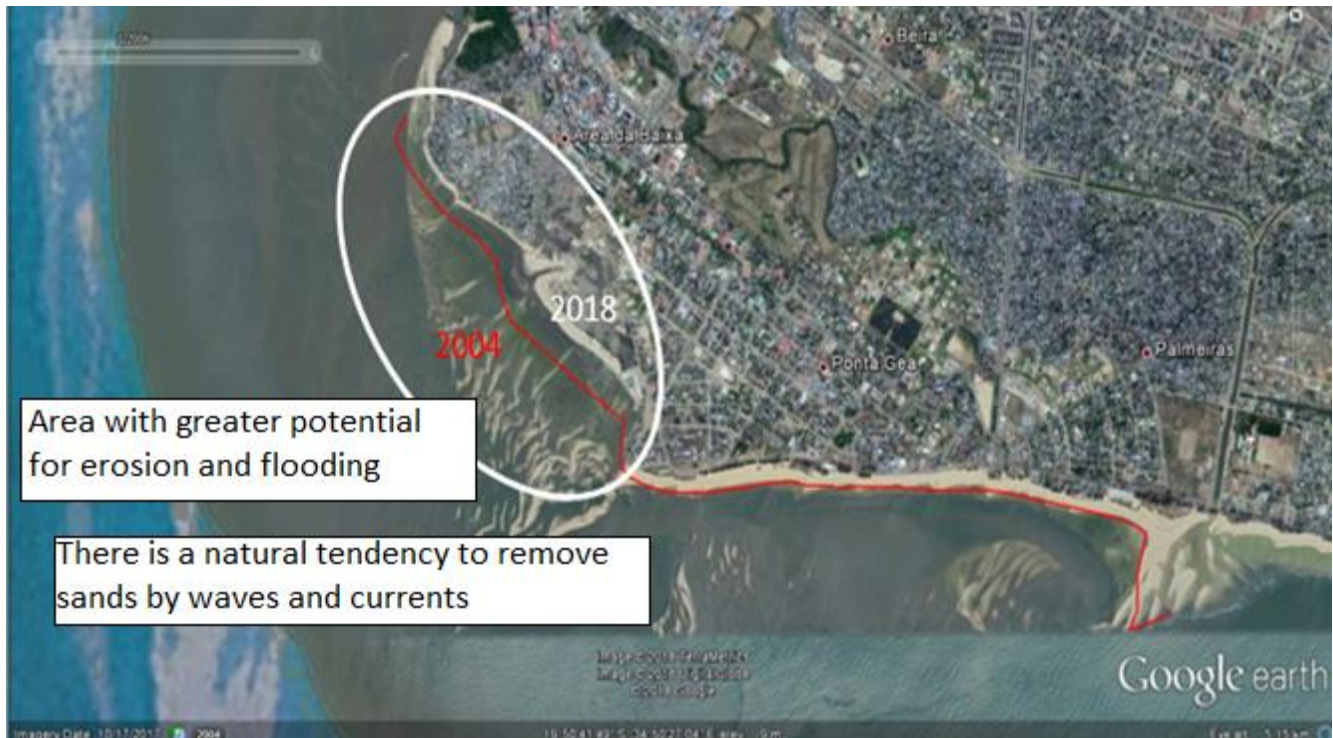
As can be seen in figure 08, there is a tendency to reduce the coastline in the entire shore area of Beira City, with more advanced effects in the Ponta Gêa and Chaimite areas.

Figure 08 - Areas of Beira City with the greatest potential for erosion and flooding.

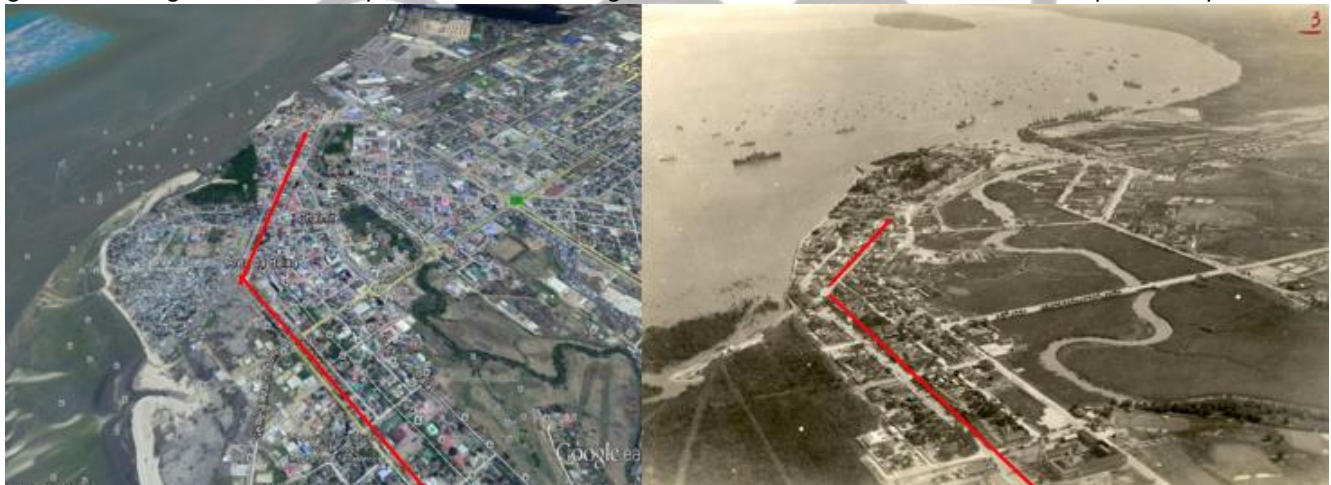
Figure 9 shows the problem of urban growth in the area of Praia Nova, which causes the mangroves that protected the coast to be destroyed, leaving the area with greater vulnerability to erosion and flooding. Situation of the new beach from 1920 to the present day..

Figure 09 - Urban Growth in the Praia Nova Area (1920-2018).

In the 1920s, Praia Nova was an area covered by a plenty of mangroves, but due to the search for the support of sundry families, they were destroyed without proper replacement (in search of wood fuel, means of housing construction, invasion of the mangrove area for housing), and that these days are completely gone. It is an area that immensely receives the sand from dredging activities on the coast.

Urbanization has been happening practically in the body of water, and at this moment all attempts to vacate the area have been frustrated because the population recurrently retakes this area.
