THE CONTRIBUTION OF COMPUTER TECHNOLOGY IN ANALYSIS OF FLOODING DISASTER IMPACTS A LONG MUVUMBA RIVER USING GIS IN NYAGATARE DISTRICT. Case study Karama sector.

University of Rwanda, College of Sciences and Technology Department of Geography and urban planning and Faculty of Computing and Information Sciences, University of Lay Adventists of Kigali

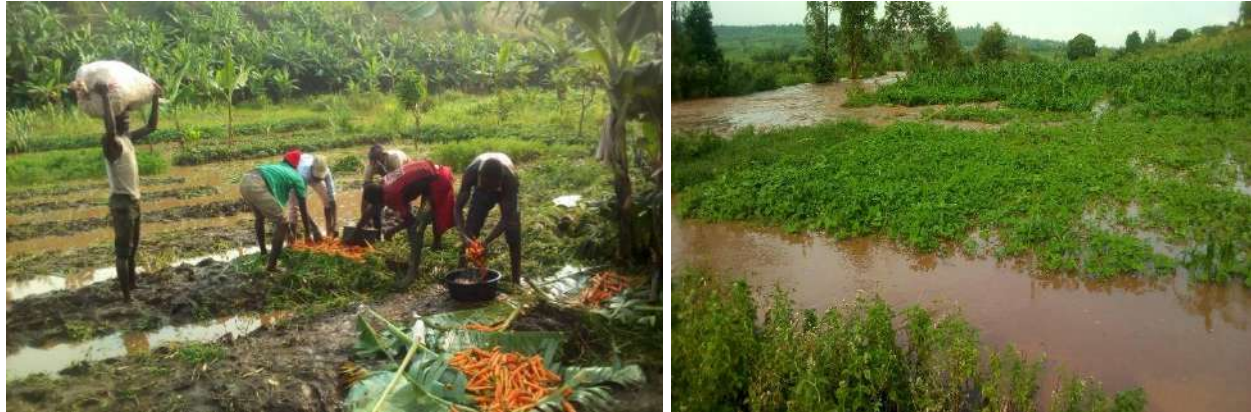
Fig. 1 Impacts of flooding disaster along the river Muvumba in Karama sector, April 2020

Accessibility of basic facilities and services is one of the most impact of the flooding disaster along the river as many of residents in this sector are likely to be limited on health facilities and young students gets absents due to the flooding that destroys bridges and roads connecting their homes and schools. properties, infrastructures are devastated as well as the flooding creates a strong impact on land by washing away the fertile soil leading the low production of the next agriculture season.

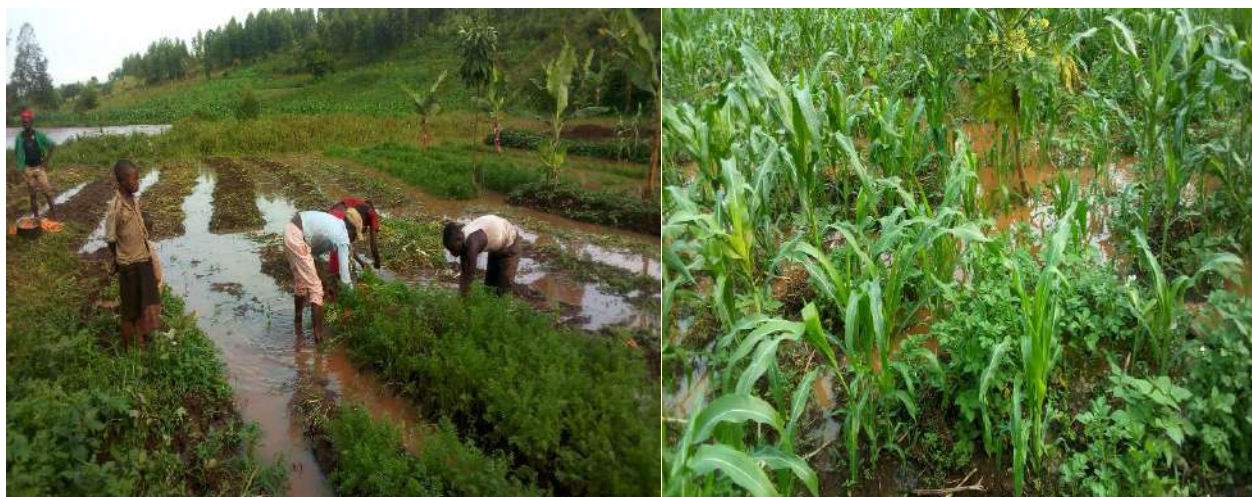
Fig5. Major crops affected by flooding disaster along the River Muvumba in karama sector. Apri, 2020

Agriculture is the most important economic activity in Karama sector as the area is domonated by agriculture and most of people live in agriculture life. Throuh the field observation the impacts of flooding disaster on agriculture production has been observed, we found that, Beans, Maize Sugarcane, Sorghum, Potatoes, Carrote and Bannana plantation are major crops that are likely to be affected by the floods. Referring to the interview with the local people they urged that floods along the river Muvumber make them suffering from hunger and poverty as they invest in agricultute to cater for their families and ends up being deverstated by floods.
