**GEOPHYSICAL INVESTIGATION OF CAUSES AND CHARACTERISTICS OF ROAD FAILURE ALONG PART OF ILARA-IPOGUN, ONDO STATE, NIGERIA.**

Authors: Festus Olusola Eebo & Obaloluwa Abiodun  
Federal University of Technology, Akure Nigeria.

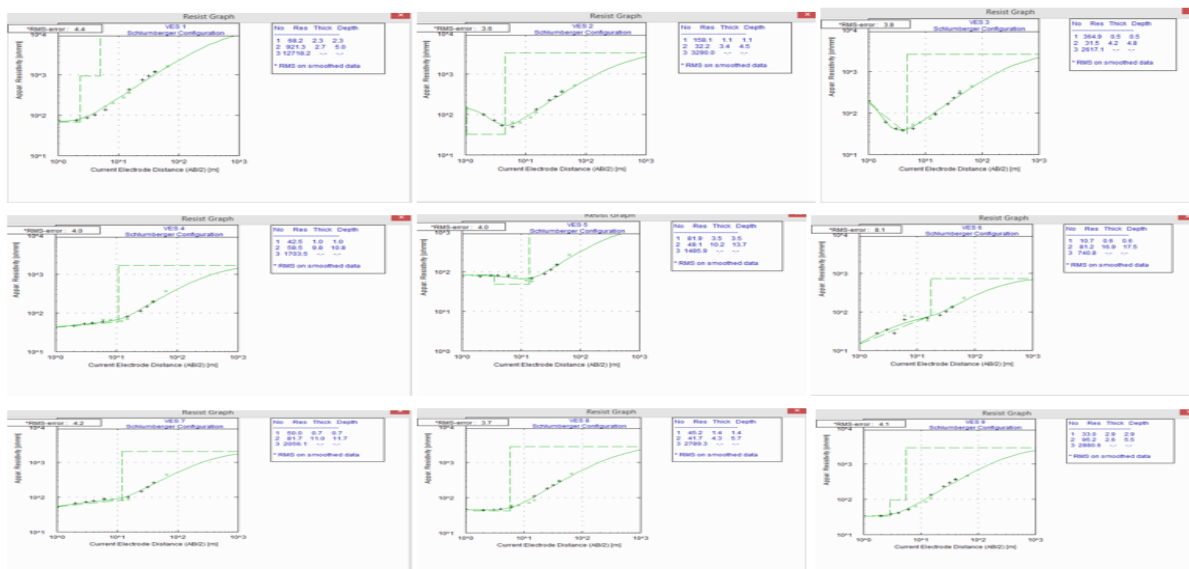
Figure 4.1: Shows VES Curves 1 to 9.

The results of the interpreted VES curves are presented in Table 4.1. Depth sounding curves obtained from the study are presented in Figures 4.1 and 4.2 . The resistivity sounding curve types obtained along the traverse are the A and H curve types.
