HIGH PRESSURE VESSEL LEAKAGE IN UREA PLANTS

(A case study)

Prem Baboo

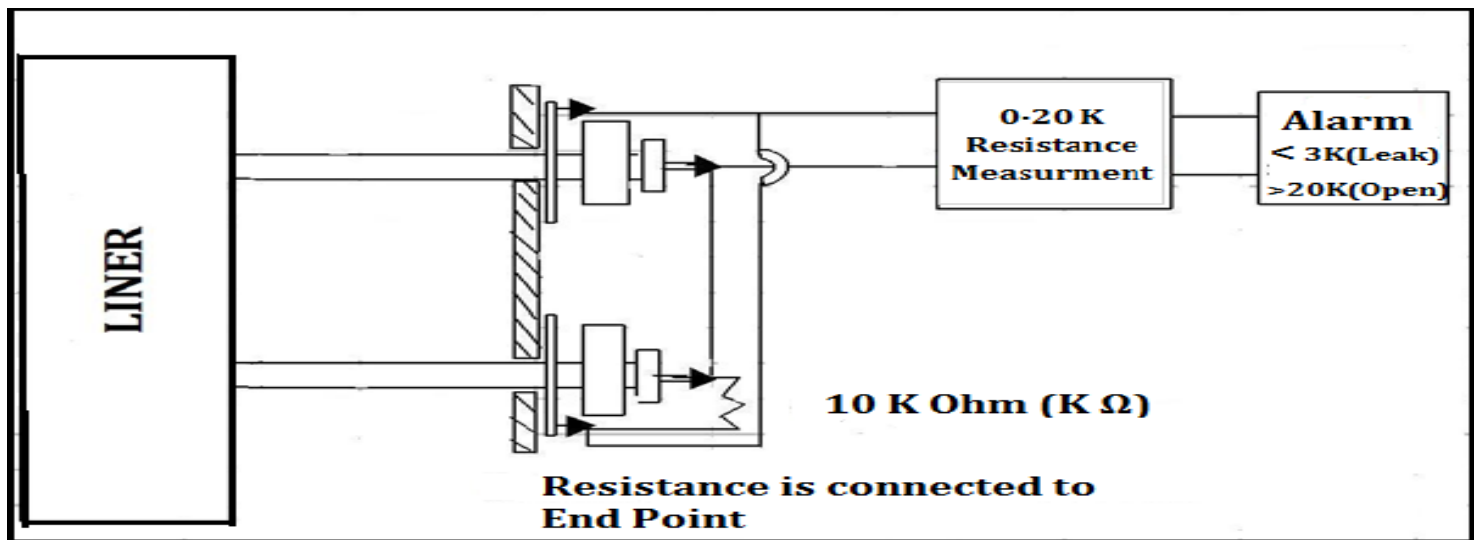
Fig-2

Urea line-1 weep hole monitoring with lectrotek system (Pune). In Urea line-2 Masibus weep hole monitoring system is incorporated. The Micro genie scan is a microprocessor based scanner which has been specially designed for resistance input to monitor reactor leakage easy and very simple in installation low pricing equipment's and easy in maintenance. This programme containing non-volatile memory for setup data, 4 duals and 4 digit display and LED bar for information RS -232 -C serial port. The instrument is housed in a $\frac{1}{2}$ DIN extruded Aluminum rack suitable for control room mounting. A small but highly functional Keyboard consisting of 4 membrane keys is provided as the as the instrument operator interface electrical and I/O temperature are instruments rear Via Screw type terminals. As shown in the figure-2. The electronics is located on modularly designed board for easy field trouble shooting and maintenance. All cards are plug in type and segregated by their function Viz -including power supply CPU, A/D display. All the weep holes have to be checked by passing instrument air every week/fortnight for any leakage and blockage & the pressure of the testing medium should not be more than 0.5 kg/cm^2

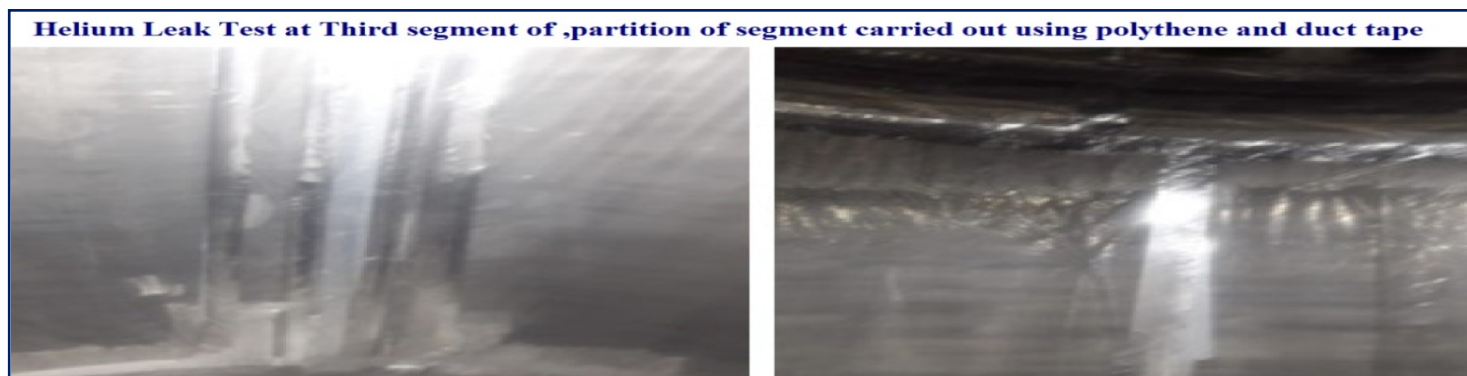
Fig--7

NDT test was done and clearance received from mechanical team & M/s. L&T for leak test by air and ammonia on 12-07-2019 at 02.00 hours. This time air & ammonia tests were performed at 0.4 kg cm-2g for 2nd and 3rd segment and 0.3 kg cm-2g for 4th segment which was completed on 12-07-2019 at 21.20 hours. No leakage was found with air and ammonia leak test. Further, hydro test of reactor was carried out but water started coming out through 70° vent tube and 250° vent hole (bottom) of 3rd segment at HP loop pressure of 90 kg cm²g. The leak observed again. Finally system was depressurized and drained. Air leak test as well as Helium test was carried for 2nd, 3rd and 4th segment on 19th and 20th July(Figure-6) The same instrument

tapings that were used for the air and ammonia test were used for the helium test. First the system was purged with Nitrogen and then helium was charged from helium cylinder through the vent hole/tube and weep hole system, the system was kept at hold for 4.0 hours at a pressure of 0.3 kg cm²g, to ensure the permeation of helium through leakage and cracks. Inside the reactor the segments were divided into smaller isolated portion using sheets and tapes for leak detection. After the hold duration was complete, the leak test was carried out by puncturing the sheet and inserting the analyzer in it. No leakages were detected in the test. Plant Start-up and Monitoring.

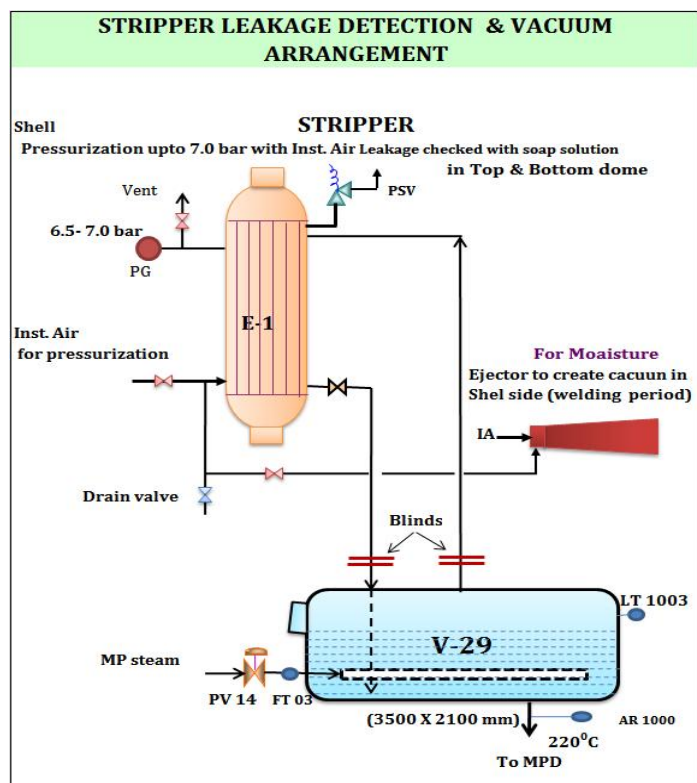
Fig-12

Lack of passivation air. Leakage was so heavy that steam to stripper turned to zero immediately and stripper shell immediately pressurized up to PSV set value i.e. 26 bar, as shown in the Arrangement as shown in the figure- 12, was done for getting tube leakage detection. Blind are provided to following equipment lines.

1. Grinding was done effectively in order to flush the pin hole completely. Ineffective grinding would never rectify the leaking point.

2. Welding was made after dye-penetrant testing of ground off area.
3. TIG welding with lower heat input was used for rectification.
4. Adjacent tubes and tube sheet weld joints avoided. Certain jigs used for the same in order to concentrate the welding heat where required.
5. Qualification of welder was made before welding in this sensitive area. High heat input will cause burn thru / HAZ area which would eventually be a potential point of leakage.
6. The 2 RE 69 (25/22/2) material plugs were applied on defected tubes. Each and every time leakage was detected with DPT and air/soap solution.
