Prediction of Dam Breach Flood Hazard Using GIS

Segni Wandimu Gudeta

Department of Hydraulic and Water Resources Engineering, Jimma Institute of Technology
Jimma University, Jimma, Ethiopia

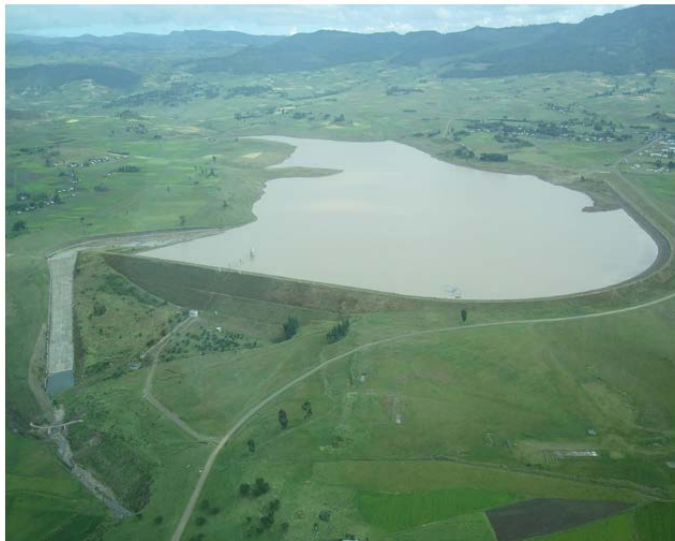
Study area is located in Oromiya region, in the east of Addis Ababa city. Dire dam is an embankment dam of impermeable central clay core. The dam is constructed for water supply purpose of Addis Ababa city. The dam was bounded between $38^{\circ}56'02''$ E longitude and $9^{\circ}08'53''$ N latitude.

Figure 1. Photograph of the study area

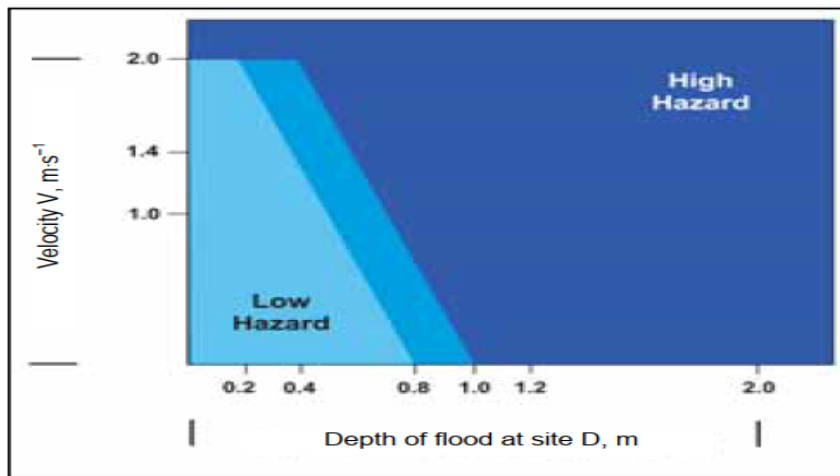
The risk to public safety and to situate infrastructures damage triggered through floods based mostly upon the velocity and depth of flood occurred from breached dam. The larger these elements become, the larger the hazard to downstream civilian population and infrastructures. This hazard is categorized as high hazard, medium hazard and low hazard based on the risk related to magnitude of flood hazard detection factors.

Figure 2. Flood Hazard zone classification as a function of velocity and water depth; source: (Derdous *et al.*, 2015).

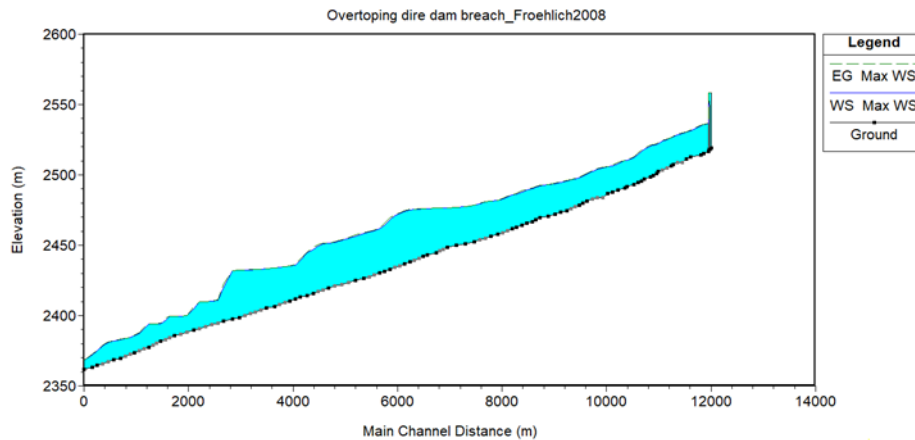
The Legadadi River longitudinal profile consist of the water surface elevation, the base elevation, the energy grade elevation, and the main channel distance from the upstream boundary condition to the downstream boundary condition. This profile was analyzed during dam breach by overtopping failure mode.

Figure 3. Longitudinal bed profile of Legadadi River

S/N	Legadadi river characteristics	by dam Overtopping
1	Energy grade elevation (m)	2558.30
2	Maximum channel depth (m)	38.93
3	Maximum water surface elevation (m)	2558.24
4	Top width (m)	1107.12
5	Minimum channel elevation (m)	2519.31

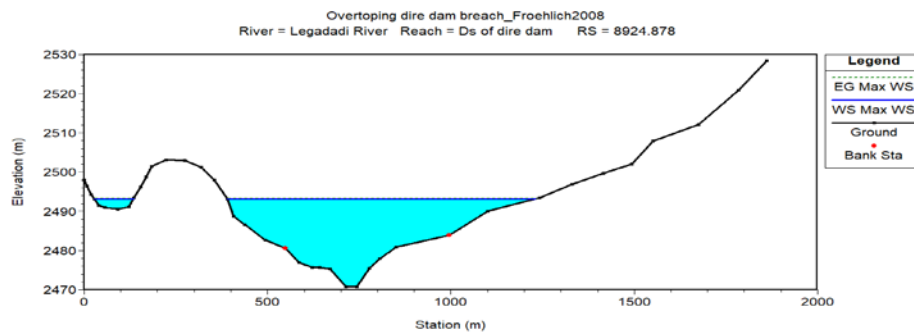
The cross sectional profile of Legadadi River was analyzed during dam breach due to overtopping failure mode. This cross sectional profile of the river contains maximum energy grade surface and maximum water surface.

Figure 4. Cross sectional profile of Legadadi River by overtopping of RS (8924.878)

The maximum depth of flood and top width over the banks at different river stations of RS (8924.878), RS (4701.743), and RS (26.77806) were analyzed.

S/N	River stations	flood depth (m) by overtopping	Top width (m) by overtopping
1	RS (8924.878)	10.97	946.18
2	RS (4701.743)	13.11	1740.92
3	RS (26.77806)	11.24	1629.27

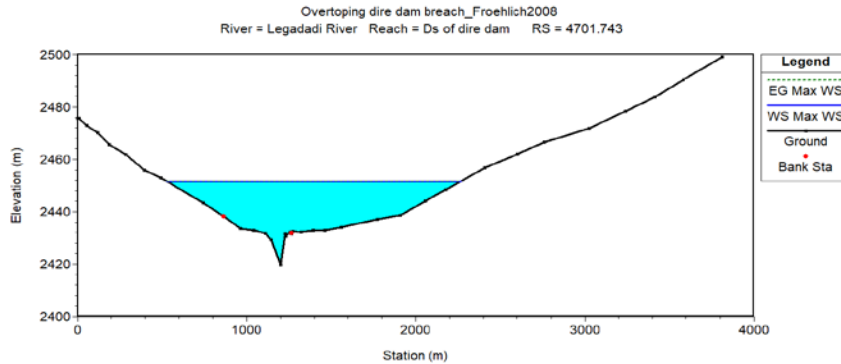
Figure 5. Cross sectional profile of Legadadi River by overtopping of RS (4701.743)
